## Technical Service Bulletin

Transaction No.: **2082553/2**

90 Panoramic display: noises in area of panoramic display, noises between panoramic display and background light module

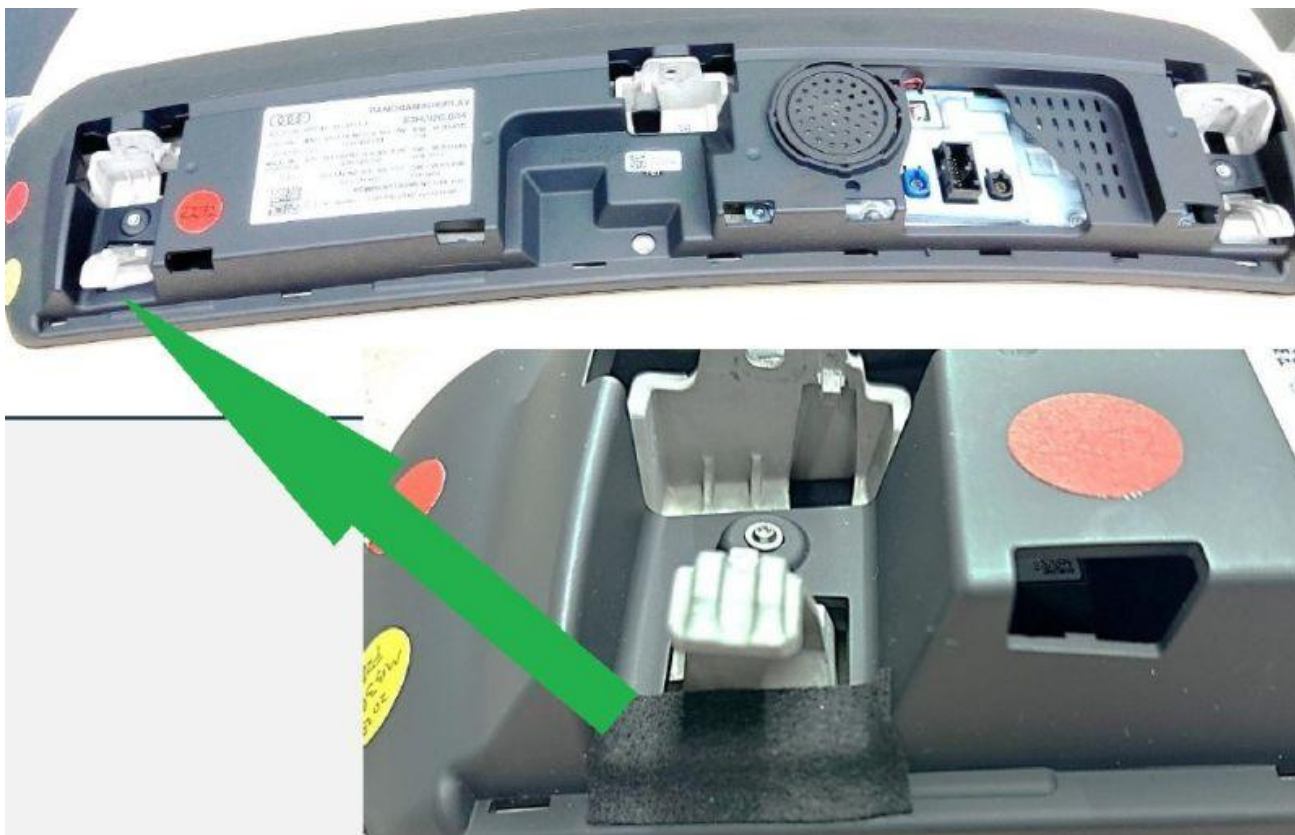
Noises can be traced to the area between the panoramic display and the background lighting module under the panoramic display.

Noises between panoramic display and background lighting module on vehicles fitted with the optional **background lighting package**.

**Figure 1.** Attaching a piece of felt (example image).

Please attach a piece of **felt (part number 443 857 991 Q)** in the area indicated by a green arrow in the image.
