## Technical Service Bulletin

Transaction No.: **2082615/1**

38 ATF pipes leak - Q7 with 0C8 gearbox

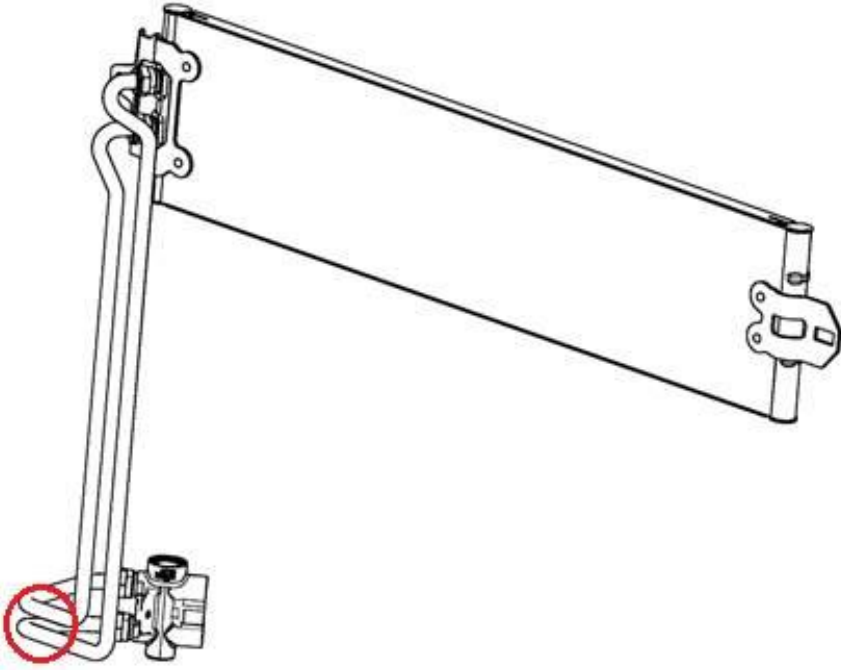
**Figure 1.** The ATF pipes.

- Leaks around the ATF lines on the automatic gearbox. Visual inspection shows leaking gear oil (ATF) at the connections or along the line.
- During diagnosis, it was found that the ATF lines fitted at the factory were not installed with enough play in the affected area.

The ATF pipes to the cooler (Figure 1) are fed through the sealing section 7L0.121.332.B in the marked area (Figure 2). Under unfavorable circumstances the pipe can touch the sealing section when driving.

**When replacing ATF lines, make sure the lines can move freely near the sealing strip.**
