| <b>Topic</b> | Service info: Paint Damage/Anomalies All Models |
| <b>Transaction No.</b> | 2078038/4 |

Service info: Paint Damage/Anomalies | All Models

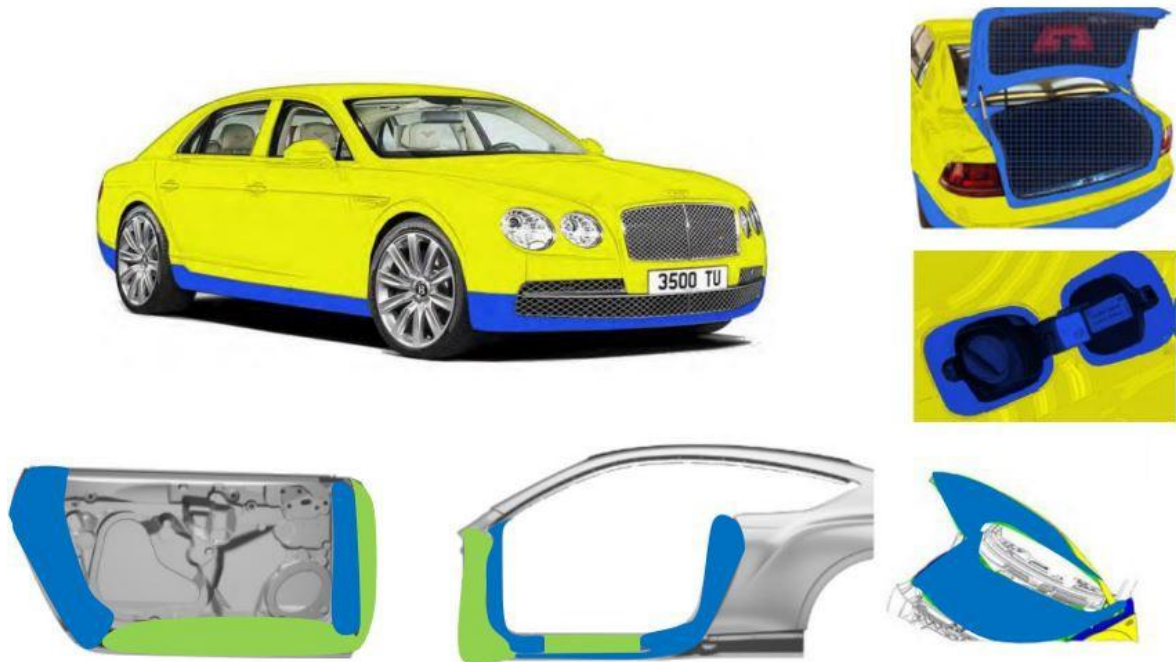
### Continental GT/GTC/Flying Spur

Zones to be considered:

**1** Zone 1

**2** Zone 2

**3** Zone 3

- Inspection of the vehicle surfaces must be carried out WITHOUT artificial lighting.
- Attach both photographs and include a brief description of the location of the anomaly including if it is Zone 1, 2 or 3 (see diagrams below for zone criteria).

**If a defect cannot be seen from a distance of 80 cm then the defect should not be identified as requiring rework.**
