## Technical product information

| <b>Topic</b> | Sunroof blind not retracting Bentayga Series |
| <b>Transaction No.</b> | 2078373/3 |

Sunroof blind not retracting | Bentayga Series

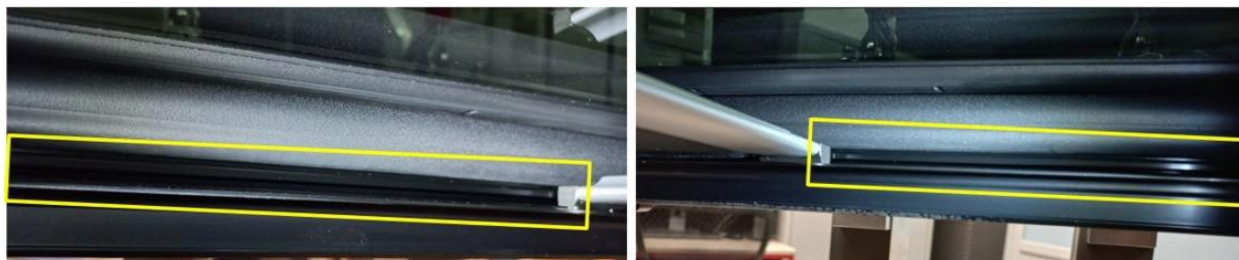
**Figure 2** Contamination of roof / guides for sunblind slide shoes

1. Inspect the sunroof blind frame for contamination of the guides (located under rear glass).

2. While the sunroof is stationary, visually inspect the rear section of the guide channels from underneath the rear glass. Check for small materials such as:

- Small stones
- Excessive dirt or dust
- Organic matter (e.g., pine needles, leaves).

The guides must be completely clean and free from all contamination to ensure smooth operation.

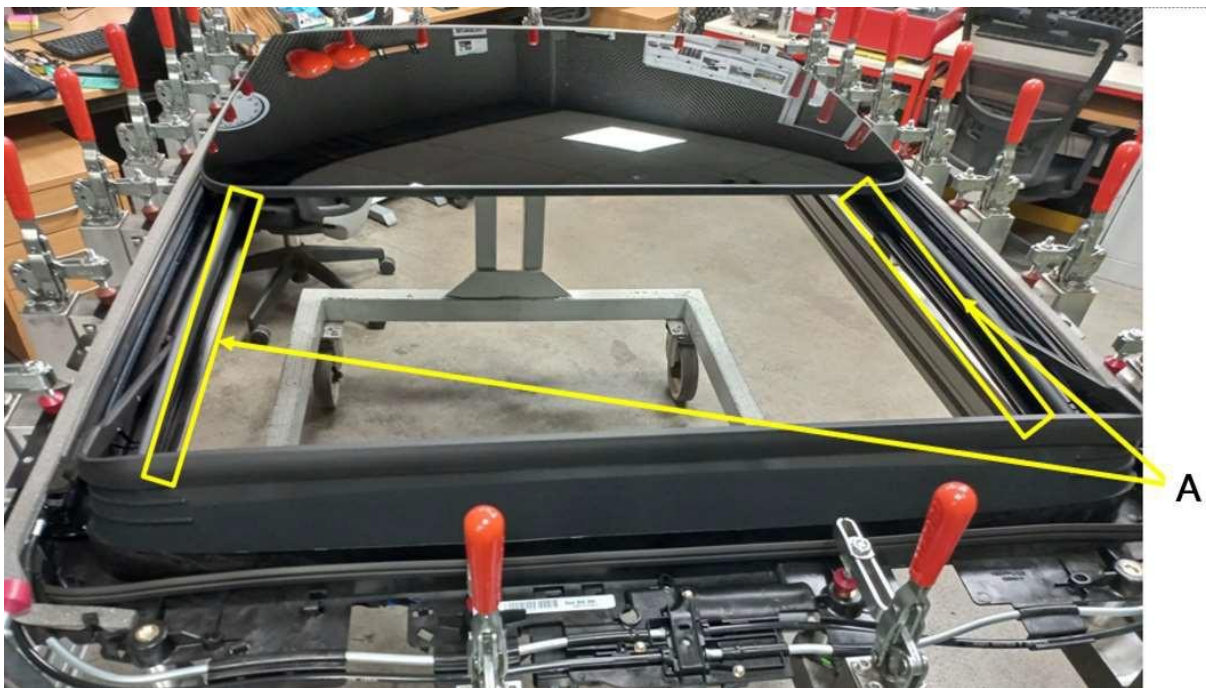
**Figure 3** Contamination of roof check

3. Inspect areas 'A' labelled in figure 3 of the frame for contamination.

The yellow markings highlight the area most likely to become contaminated when the roof is opened.

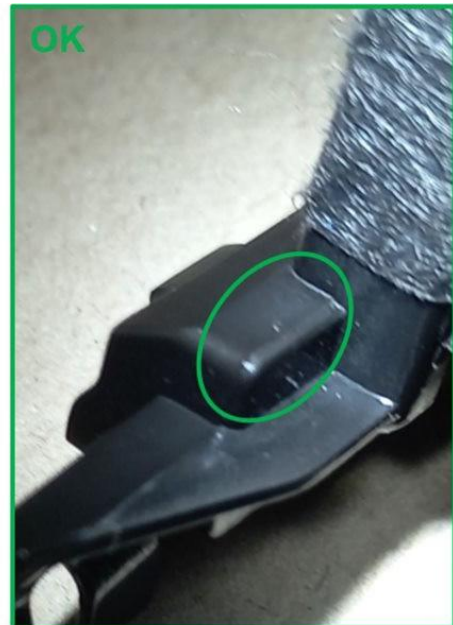
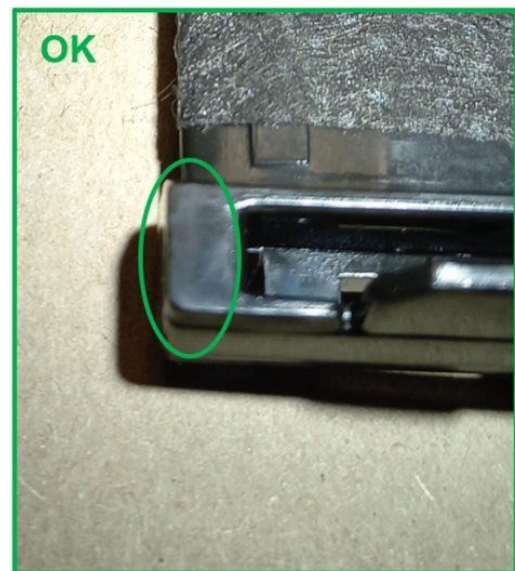
**Figure 4** Damage of the sunroof blind slide shoes due to contamination check

4. Inspect the sunroof blind slide shoes for:

- Cracks
- Wear
- Missing plastic components
- Distortion from misalignment.

**All slide shoes must be intact and free of visible damage.**

| Part Number | Description | Replace If.. |
|---|---|---|
| 4M0 877 307 A/B | Sunroof Blind | Blind is damaged, off runner, or slide shoes broken. |

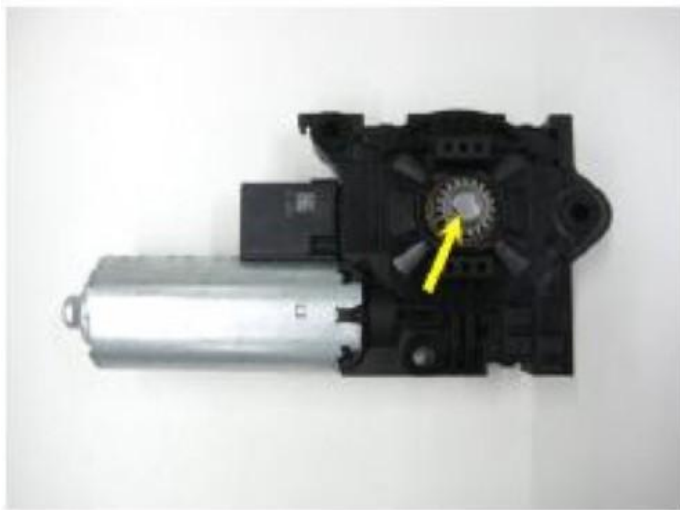
**Figure 15** *Position of motor shaft*

10. While the motor is disengaged from the drive cables, rotate the motor shaft using a soft jaw wrench and verify that it operates correctly in isolation.

If operation does not resume, replace sliding motor 4M0 959 591/A (refer to ElsaPro Repair group 60 'Sunroof motor – To remove and fit').

11. Apply grease to the motor unit pinion and reassemble the motor to the sunroof blind.

Use CARBAFLO® 2160 or an equivalent high temperature grease that meets the attached specification. The equivalent may be sourced locally.

12. Operate the blind in one direction, then again carefully detach the sliding electric drive unit from the drive assembly.

13. Re-apply grease to the motor unit pinion and finally re assemble the motor to the sunroof blind.
