## Technical product information

Transaction No.: **2081085/2**

V8 Engine - Ticking Noise, Misfiring and Possible Low Oil Pressure Indications

Release date: 16 Jul 2026

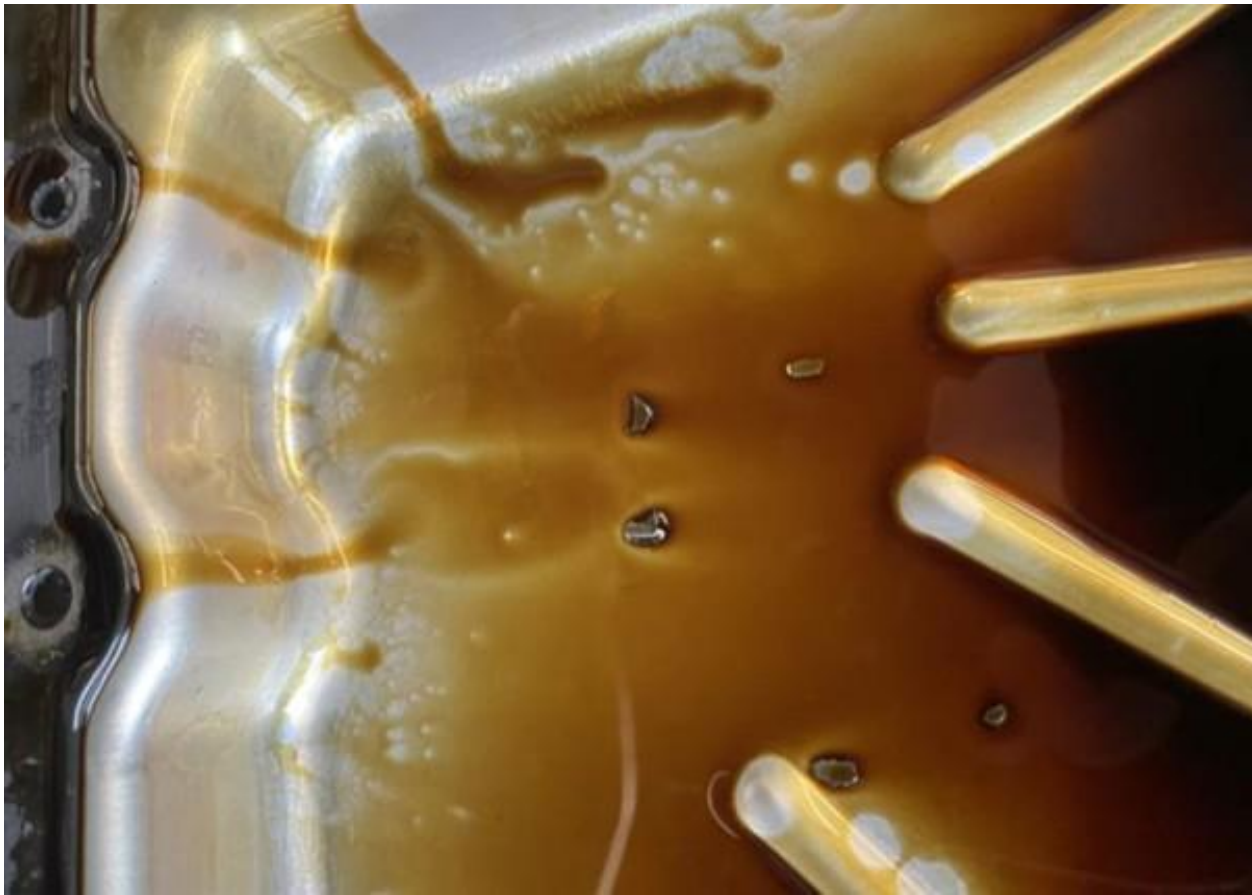
**Figure 1.** Large debris present in oil example

### 1. Inspect Oil Sump

Remove the oil sump (bottom section) and inspect for large metal debris.

Refer to *ElsaPro* → Rep. Gr. 17 – Sump (Bottom Section) – To Remove and Fit

Document all findings with photos and/or video.
