## TECH TIP

TT-26-008

### Driveshaft Center Bearing Damage

2022 through 2026 model year Hino L-Series trucks

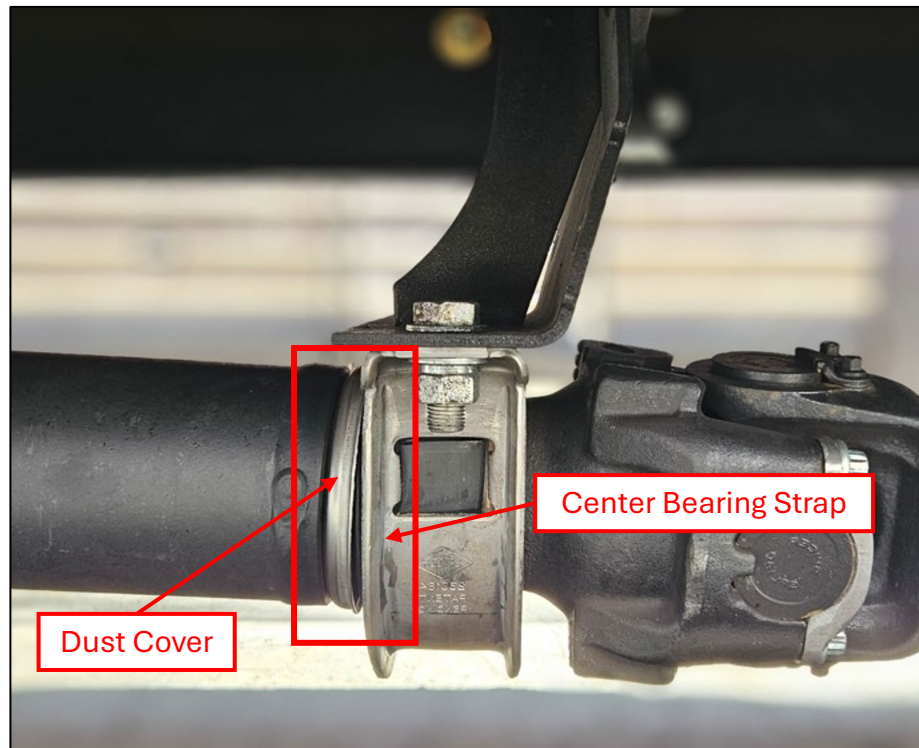
If the truck experiences driveshaft center bearing damage or repeated damage, visually inspect the installed position of the center bearing, specifically the relationship between the dust cover and center bearing strap. If the installed position reassembles the photograph below, open a TechAssist case describing the condition/concern and attach an image of the trucks driveline dust cover to center bearing alignment for further direction.
