# RSB-93-26-002-1: B-Pillar Rattle on Rough Road Surfaces

Rivian is launching a technical service bulletin for some model year 2022-2026 R1T and R1S vehicles that might have an audible rattle originating from the B-pillar area when driving on rough road surfaces. Upon customer complaint, Rivian will apply anti-rattle tape near both 1st row seat belt retractors to prevent rattling.

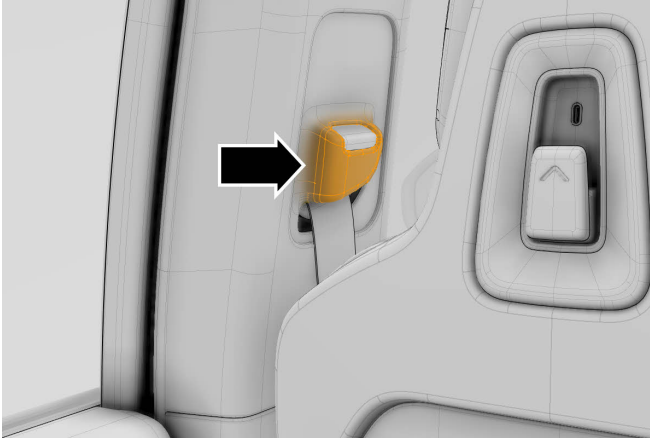
1. Sit in the 2nd row seat on the affected side while the customer or another technician test-drives the vehicle.
2. When the noise occurs, hold the highlighted area.

**Note:** LH shown, RH similar.

3.
  - If the noise stops: Continue to the next section.
  - If the noise continues: This bulletin is not applicable. Discontinue this procedure.

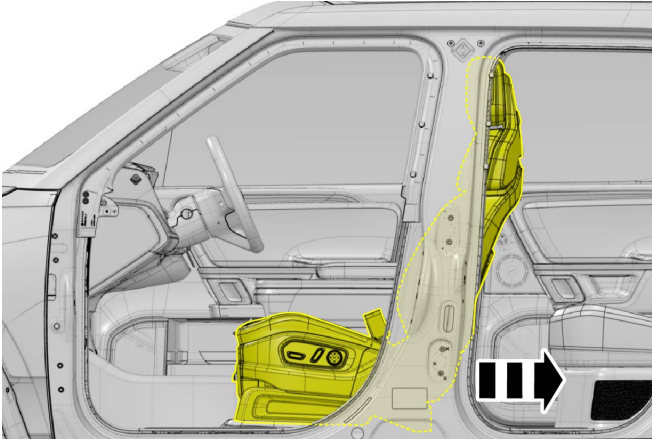
1. Remove: Trim Panel, B-Pillar, Lower, LH (refer to service manual procedure 642817010).
- 2.

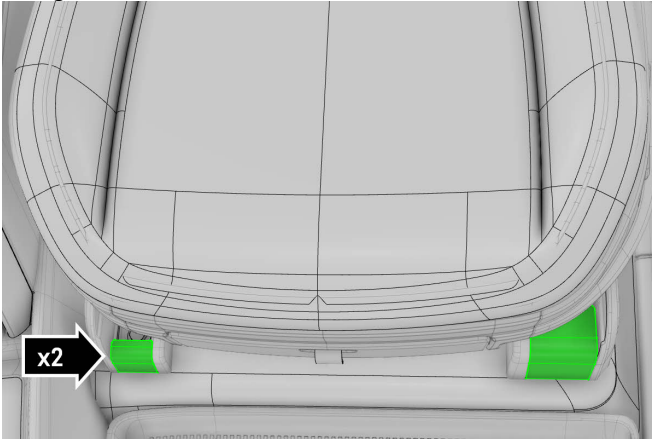
3. Using a trim tool:

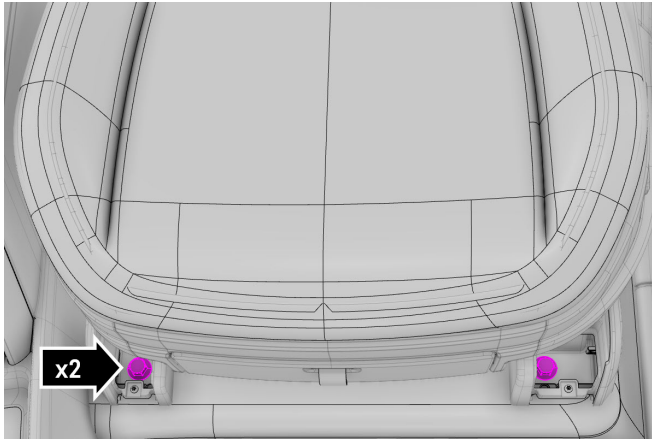
4.

**CAUTION:** Potentially non-reusable fastener(s).

| Step Number | Torque (Nm) |
|---|---|
| 4 | 93 |

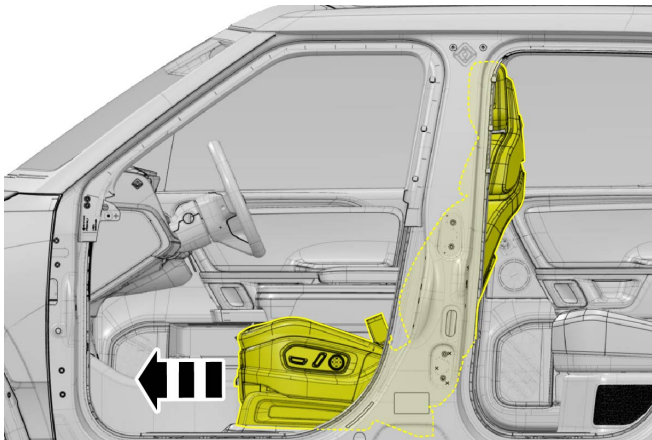
5.

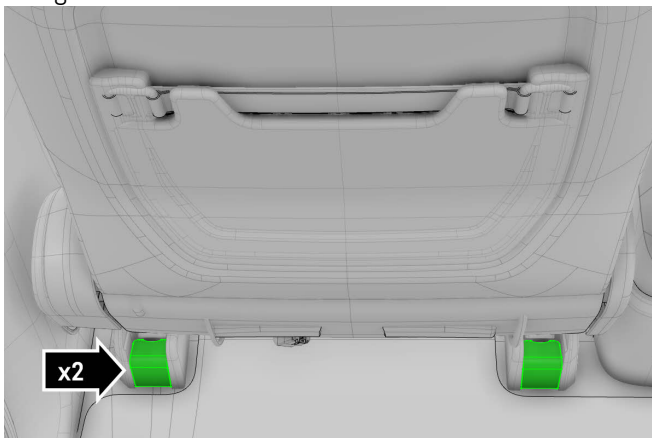
6. Using a trim tool:

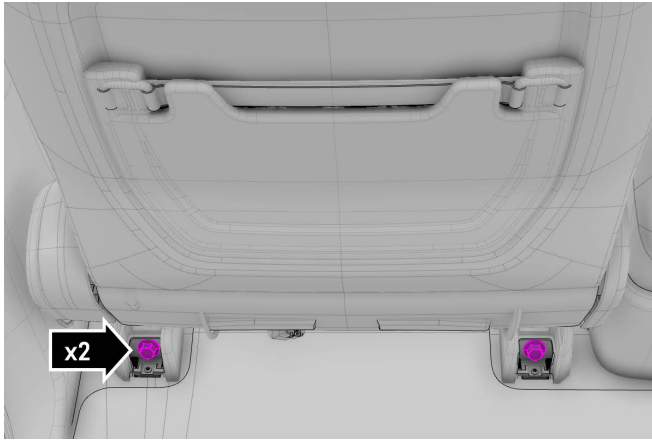
7.

**CAUTION:** Potentially non-reusable fastener(s).

| Step Number | Torque (Nm) |
|---|---|
| 7 | 93 |

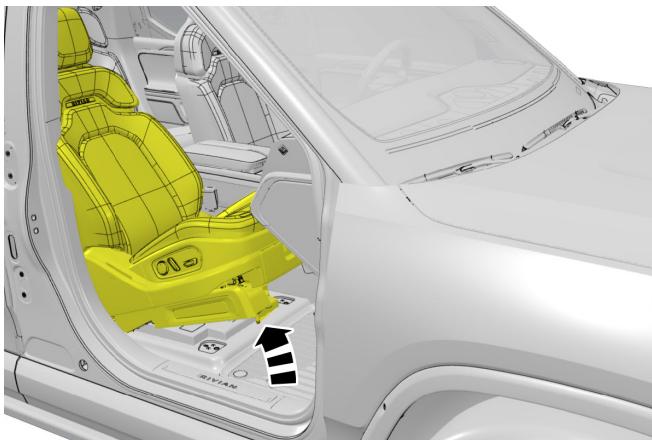
9. Disable 12V power (refer to service manual procedure 780010017).

**Note:** Model year 2025 vehicles: When accessing the negative cable:

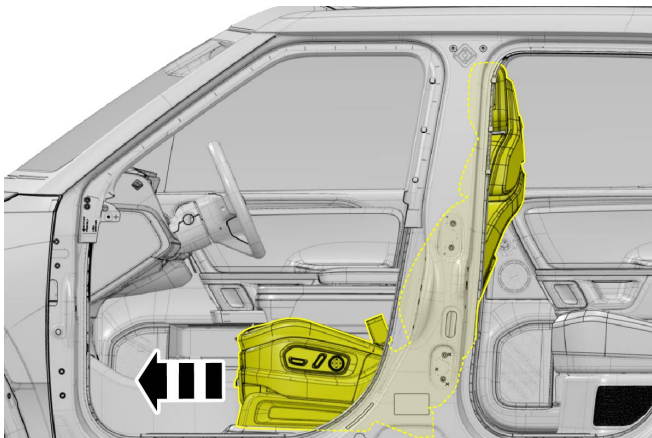
10.

**DANGER:** After disabling 12V power, wait at least 1 minute for airbag system electrical circuits to discharge before disconnecting or handling the component.

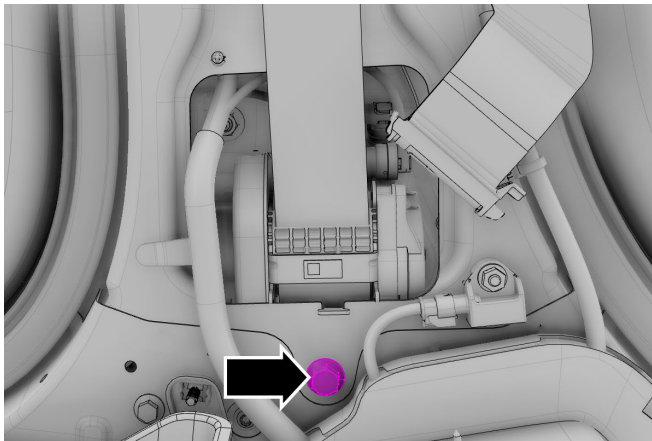
12.

**CAUTION:** Non-reusable fastener(s).

| Step Number | Torque (Nm) |
|---|---|
| 12 | 35 |

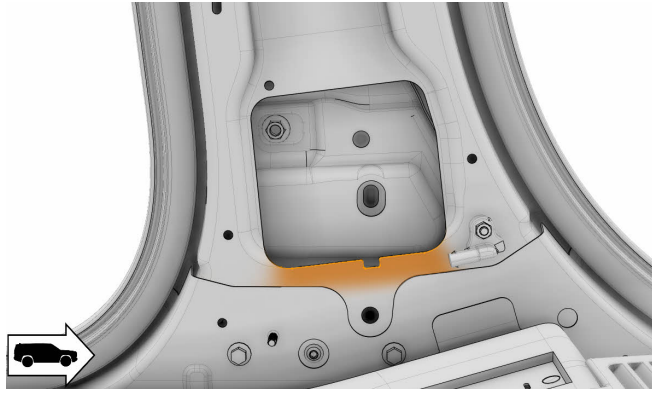
14. Clean the highlighted areas. Use alcohol wipes or rubbing alcohol on a clean cloth.

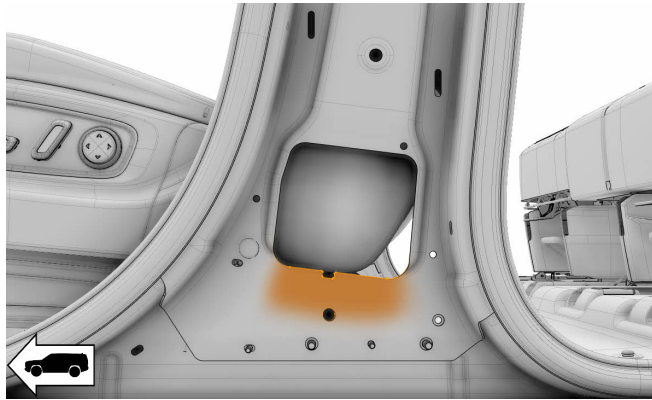
• On the inside:

**Note:** Shown with components removed for clarity.

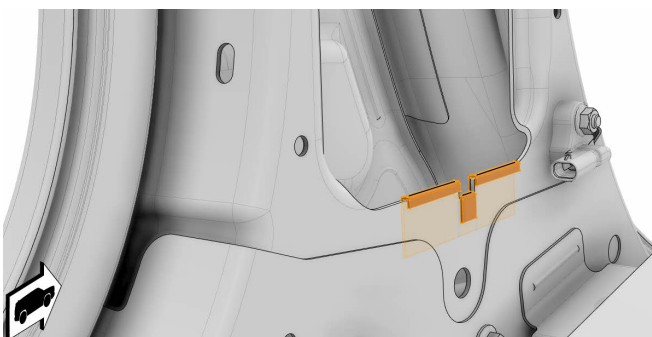
15. Position the component(s) as shown.

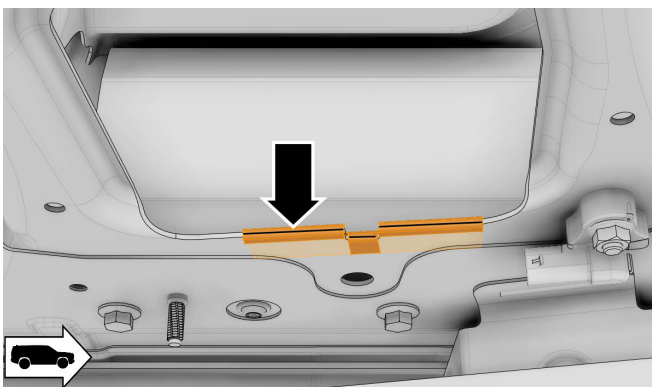
- Lines on the tape pieces face up

16. Reinstall all components that were removed for access and replace all non-reusable components. Refer to the service manual procedures referenced in this document for additional component reusability information and torque specifications.
