## Technical Service Bulletin

**GROUP****CAMPAIGN****NUMBER****26-01-064G****DATE****JULY 2026****MODEL(S)****G70 (IK),  
G80 (RG3)****SUBJECT:****WATER-FLOWING/GURGLING NOISE - ENGINE COOLANT AIR  
BLEEDING (LIMITED COVERAGE CAMPAIGN L18G)****\* IMPORTANT**

WATER-FLOWING/GURGLING NOISE - ENGINE COOLANT AIR BLEEDING  
(LIMITED COVERAGE CAMPAIGN L18G)

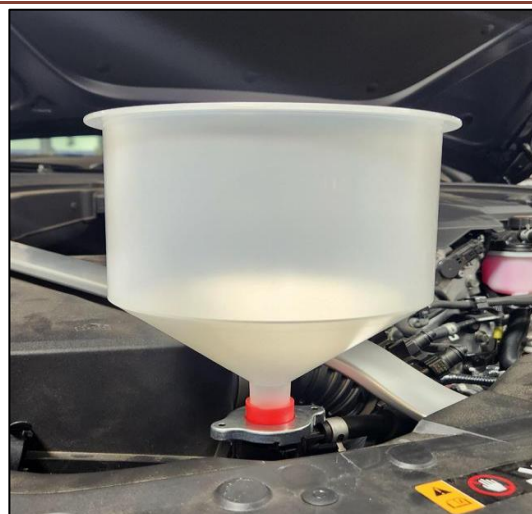
Open the radiator cap and install a no-spill coolant funnel as shown in the figure.

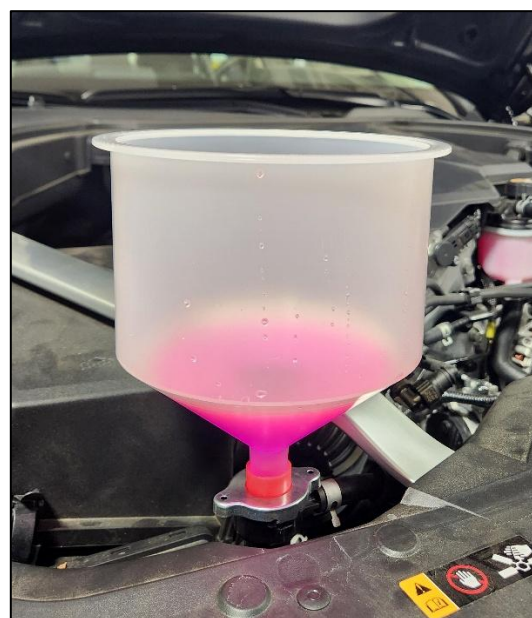
2. Fill the no-spill coolant funnel with **500 mL** of pink coolant, mixed at a **50/50** concentration with distilled water.

Press the upper and lower radiator hoses several times to aid in purging air from the cooling system.

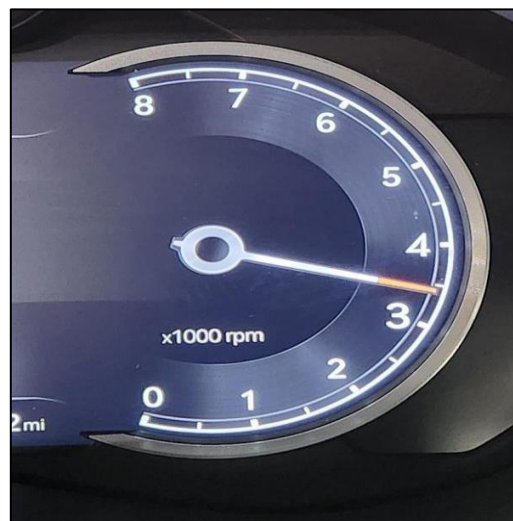
3. With the engine ON and the transmission in P (Park), maintain engine speed between **2,000–5,000 rpm** until the cooling fan operates.

From a cold condition to the initial cooling fan operation, it takes approximately **5 to 10 minutes**.

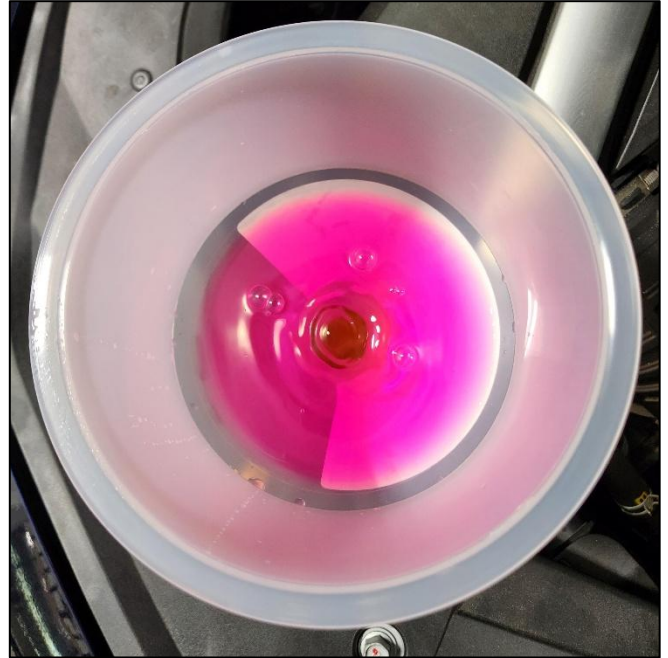
4. After confirming that the cooling fan is operating, verify that air bubbles are being released.

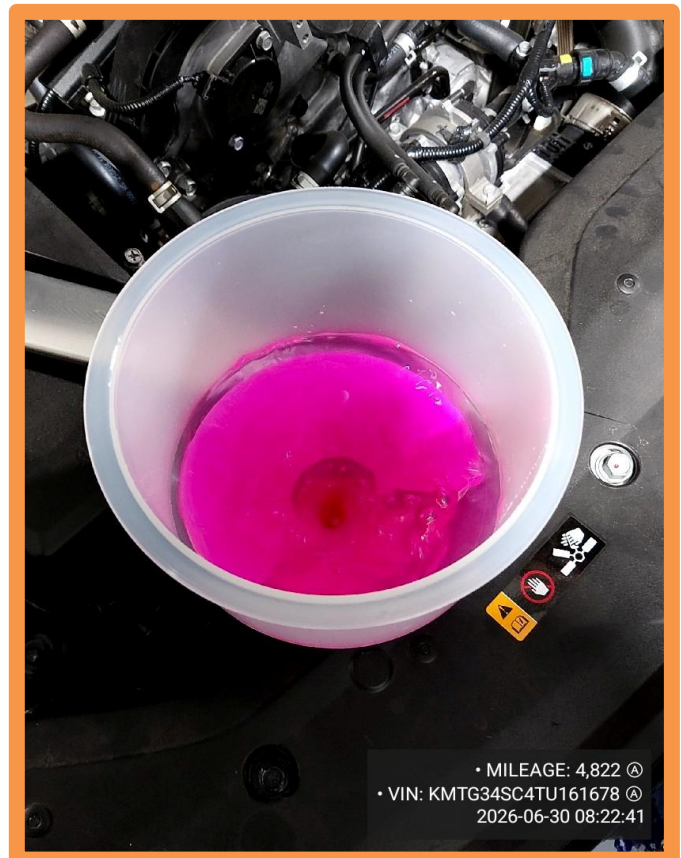
Using the STUI camera function, take a photo of the coolant funnel with coolant present in it while the system is being bled.

**NOTE:** If the STUI camera function is **NOT** used, write the last 6 digits of the VIN and date of repair on a piece of paper to include in the photo.

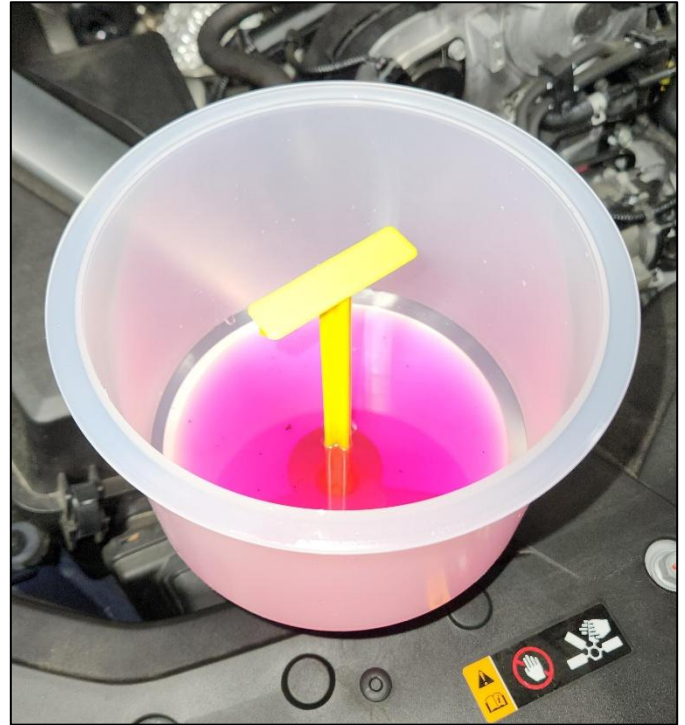
7. Turn the engine OFF.
8. Install the plunger supplied with the coolant funnel kit to seal the intake opening and prevent coolant loss, then remove the funnel.

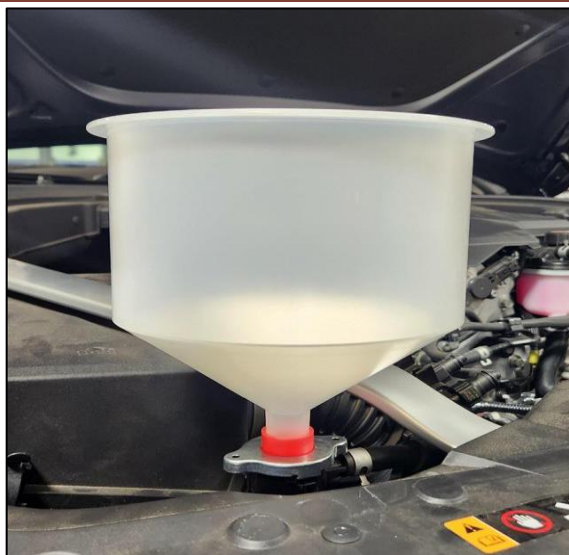
Open the radiator cap and install a no-spill coolant funnel as shown in the figure.

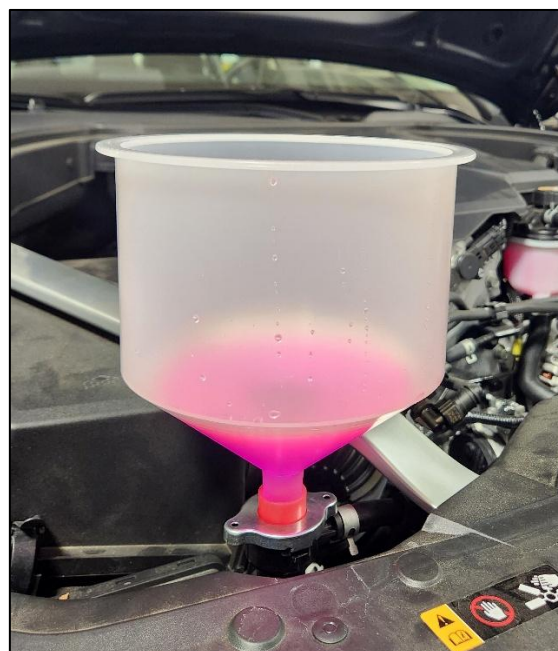
Press the upper / lower hoses on the radiator so that the air can get out easily.

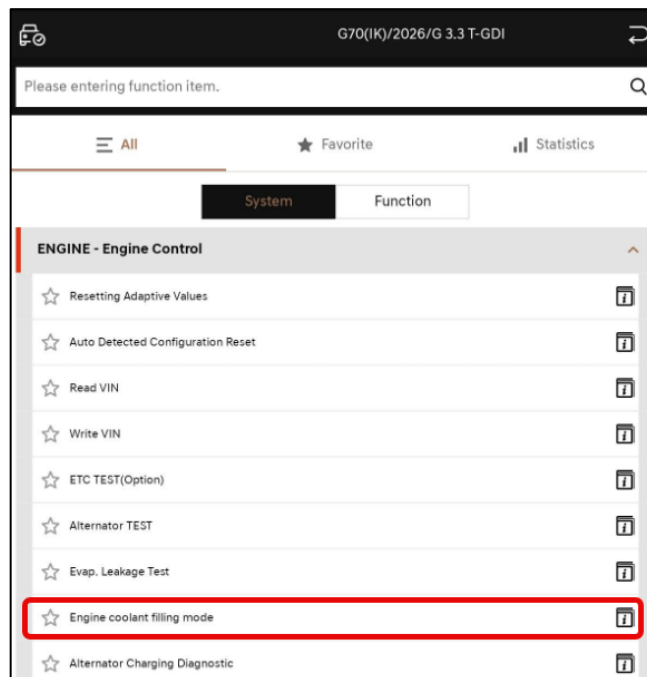
3. Connect the GDS and VCI to the vehicle and start the engine.

4. Use GDS to activate **Engine Coolant Filling Mode**.

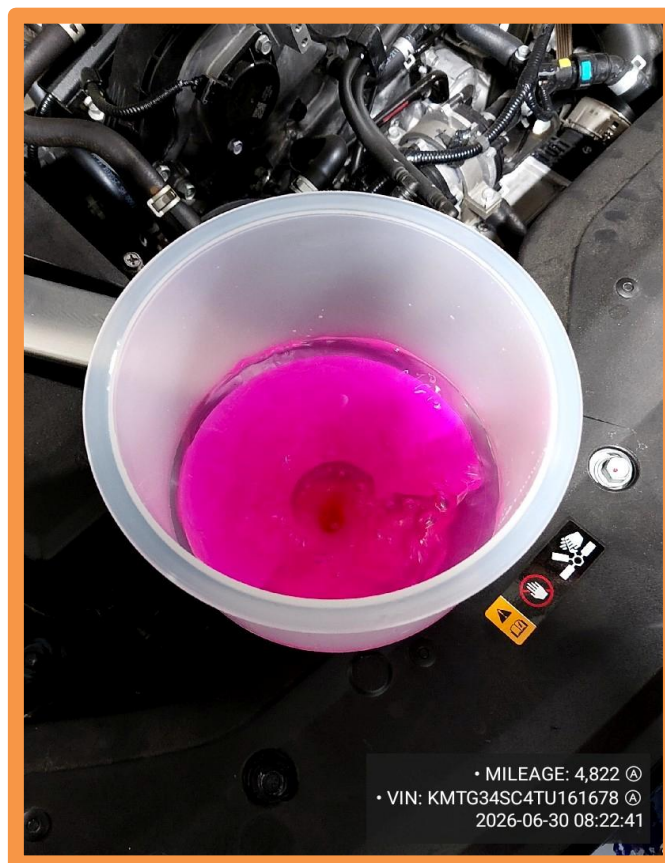
Using the STUI camera function, take a photo of the coolant funnel with coolant present in it while the system is being bled.

**NOTE:** If the STUI camera function is **NOT** used, write the last 6 digits of the VIN and date of repair on a piece of paper to include in the photo.

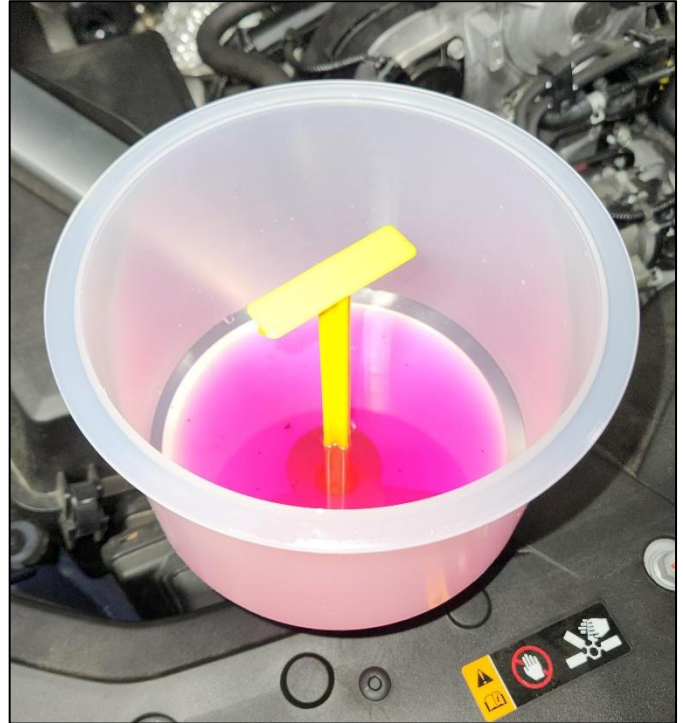
7. Install the plunger supplied with the coolant funnel kit to seal the intake opening and prevent coolant loss, then remove the funnel.
