**HYUNDAI**  
**Technical Service Bulletin**

| GROUP<br><b>CAMPAIGN</b> | NUMBER<br><b>26-01-060H</b> |

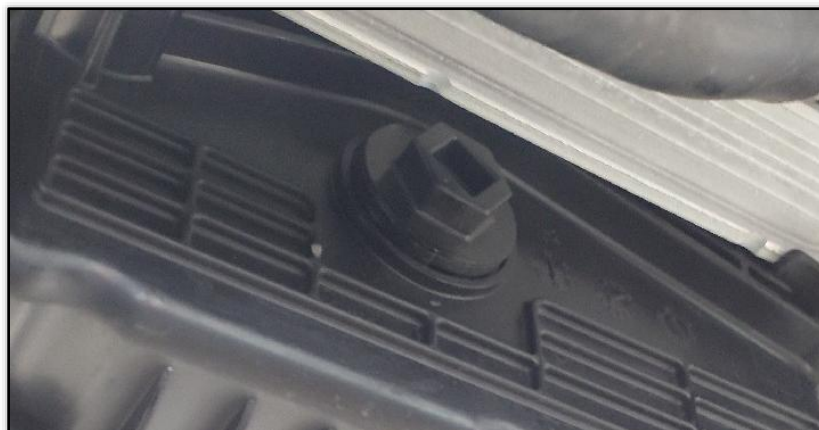
**Applicable Vehicles (Certain):**

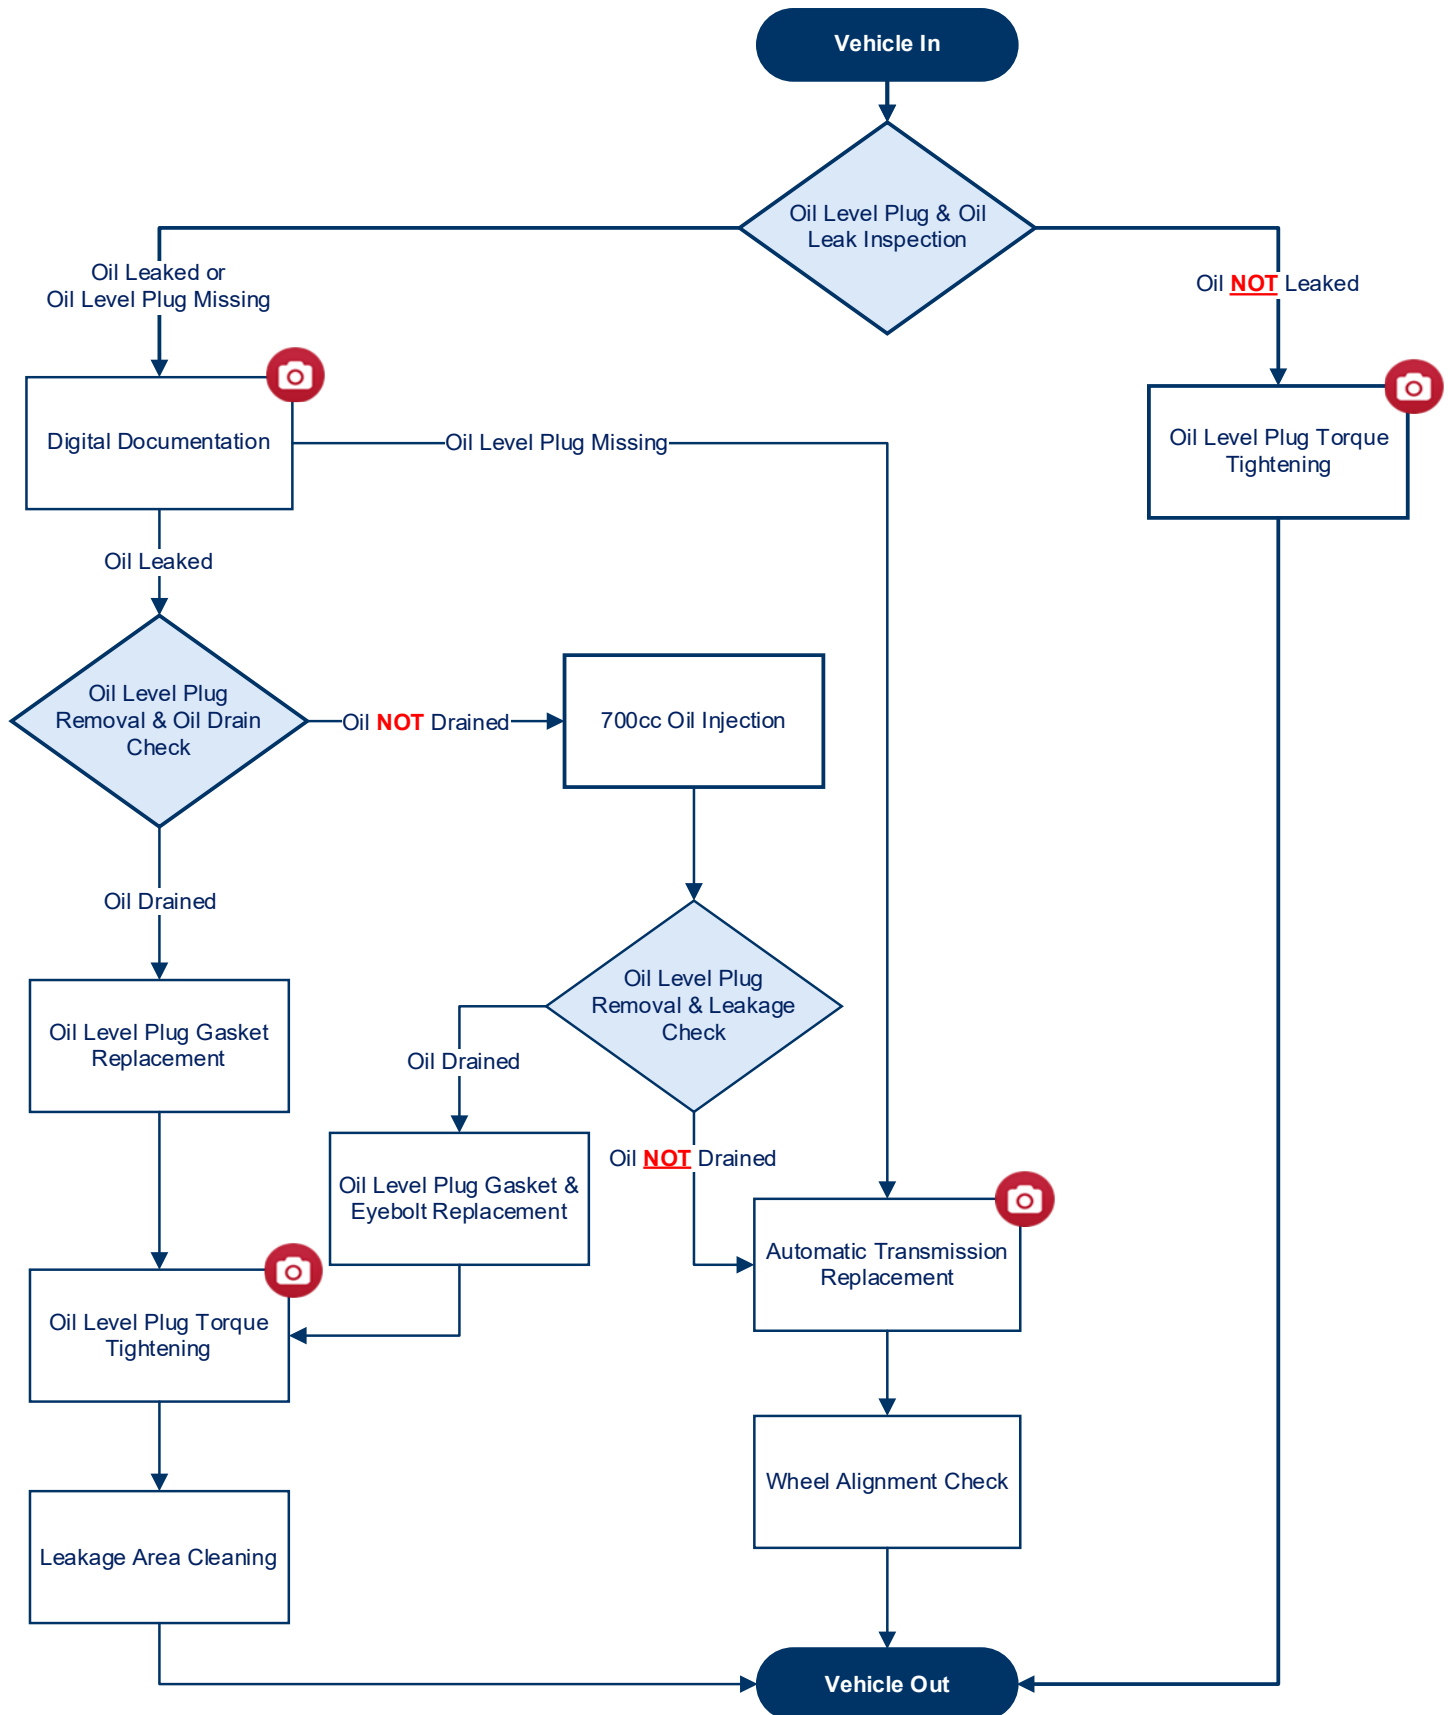
**SUBJECT:****LOOSE TRANSMISSION OIL LEVEL PLUG – AUTOMATIC TRANSMISSION  
REPLACEMENT (LIMITED COVERAGE CAMPAIGN LA15)****Oil Level Plug Check**

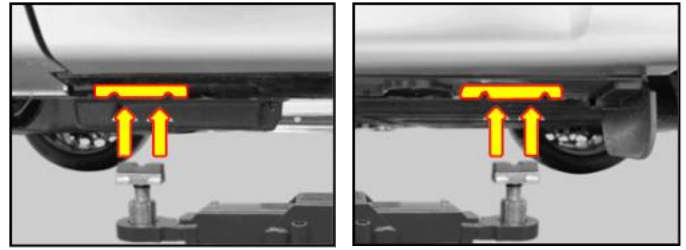
Refer to the shop manual:

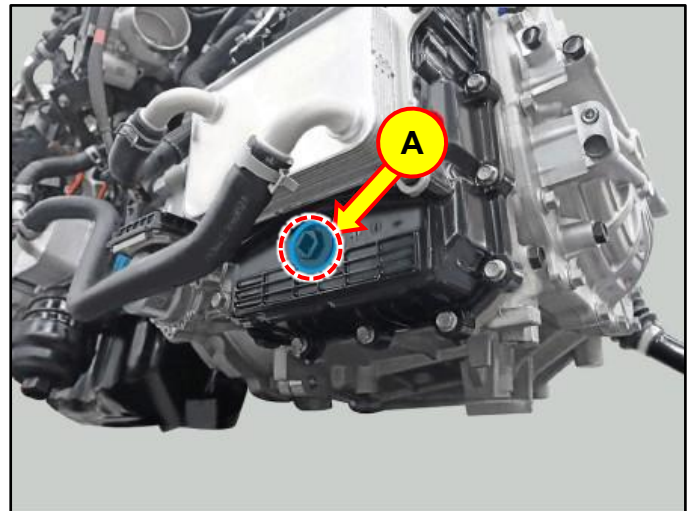
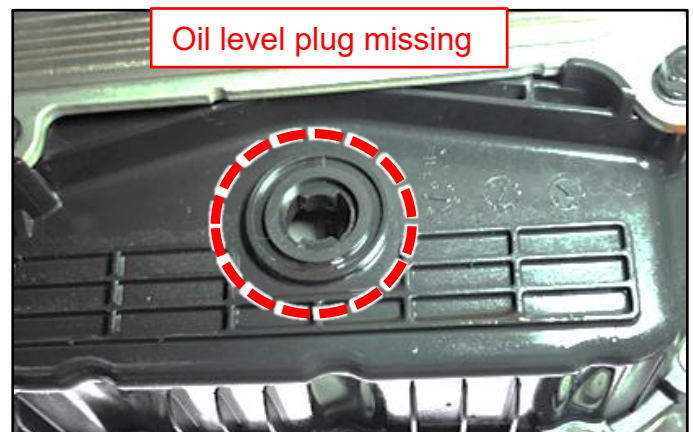
**SUBJECT:****LOOSE TRANSMISSION OIL LEVEL PLUG – AUTOMATIC TRANSMISSION  
REPLACEMENT (LIMITED COVERAGE CAMPAIGN LA15)**

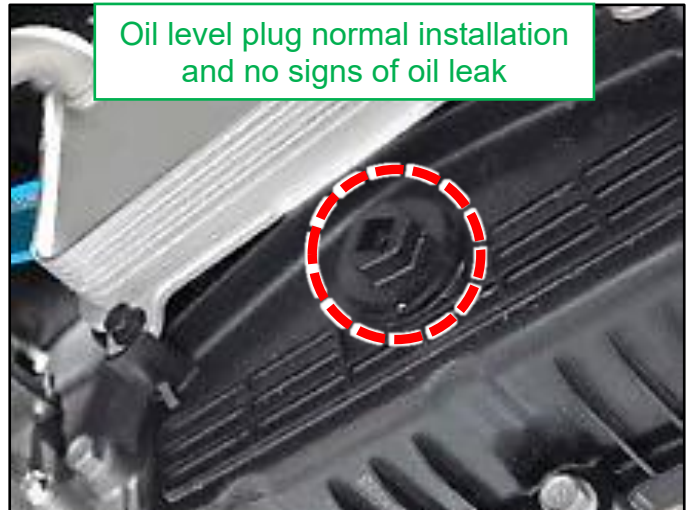
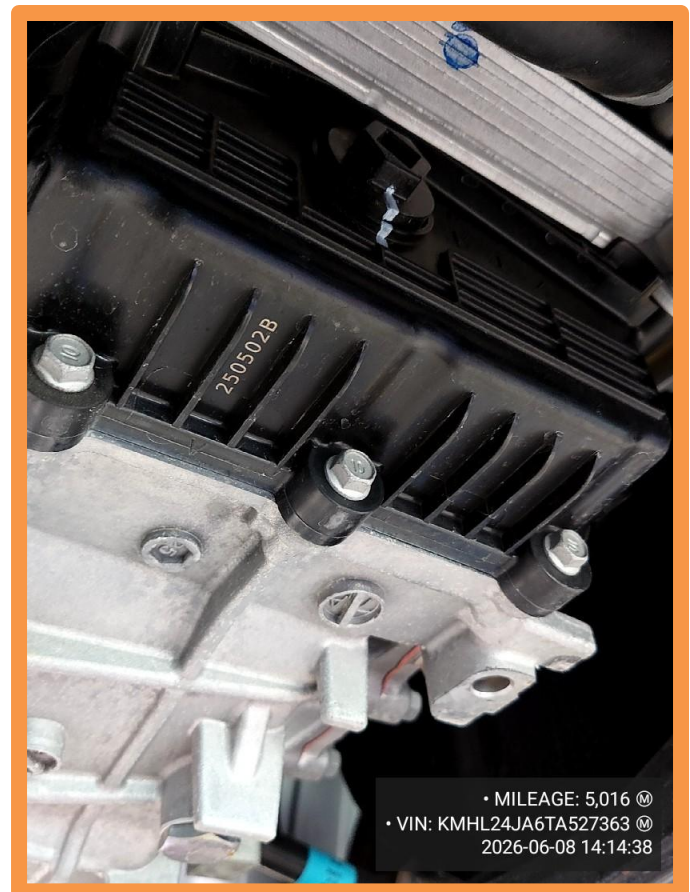
Oil level plug normal installation  
and no signs of oil leak

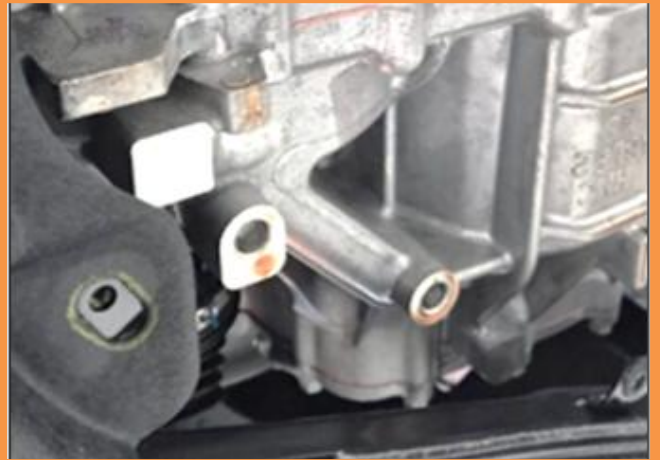
6. Lower the vehicle.

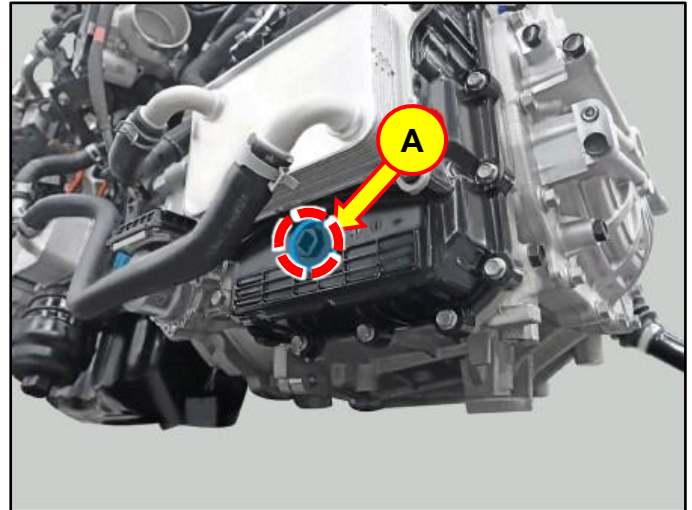
11. If the oil drains in a thin, steady stream, replace the oil level plug gasket.

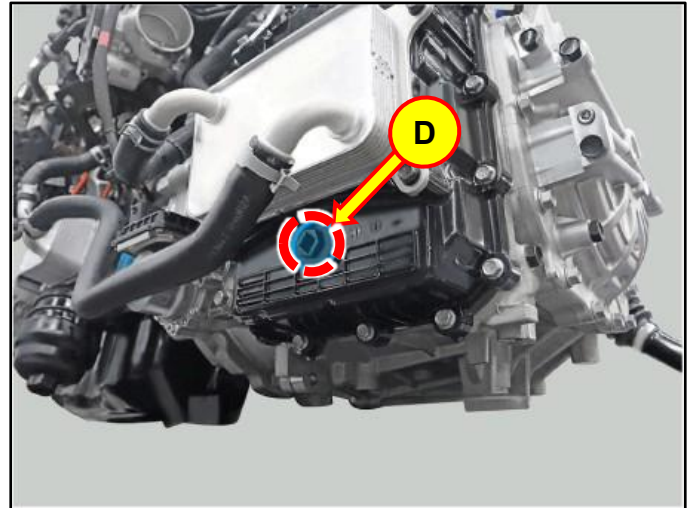
**SUBJECT:****LOOSE TRANSMISSION OIL LEVEL PLUG – AUTOMATIC TRANSMISSION  
REPLACEMENT (LIMITED COVERAGE CAMPAIGN LA15)**

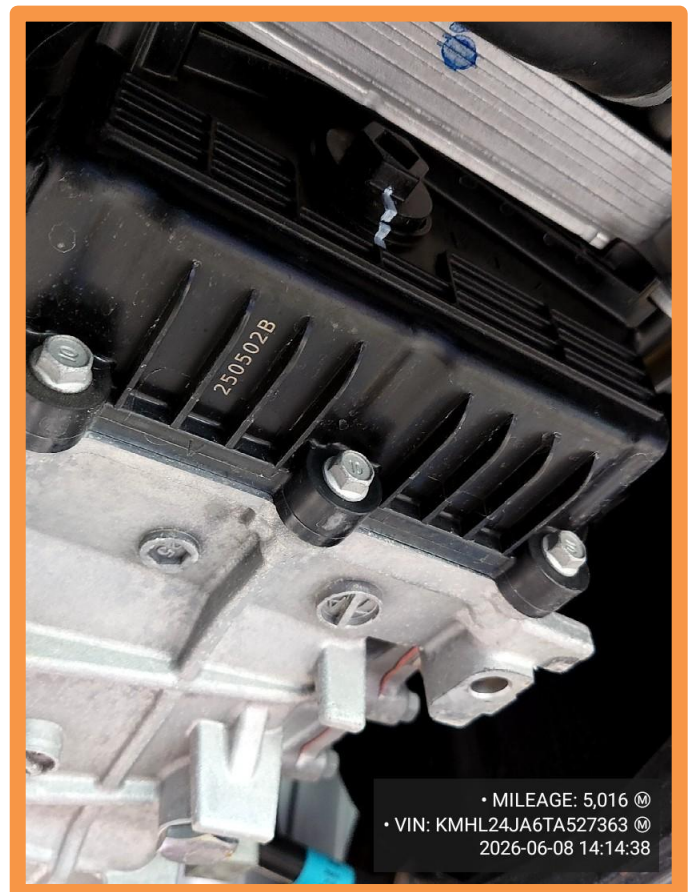
**SUBJECT:****LOOSE TRANSMISSION OIL LEVEL PLUG – AUTOMATIC TRANSMISSION  
REPLACEMENT (LIMITED COVERAGE CAMPAIGN LA15)**

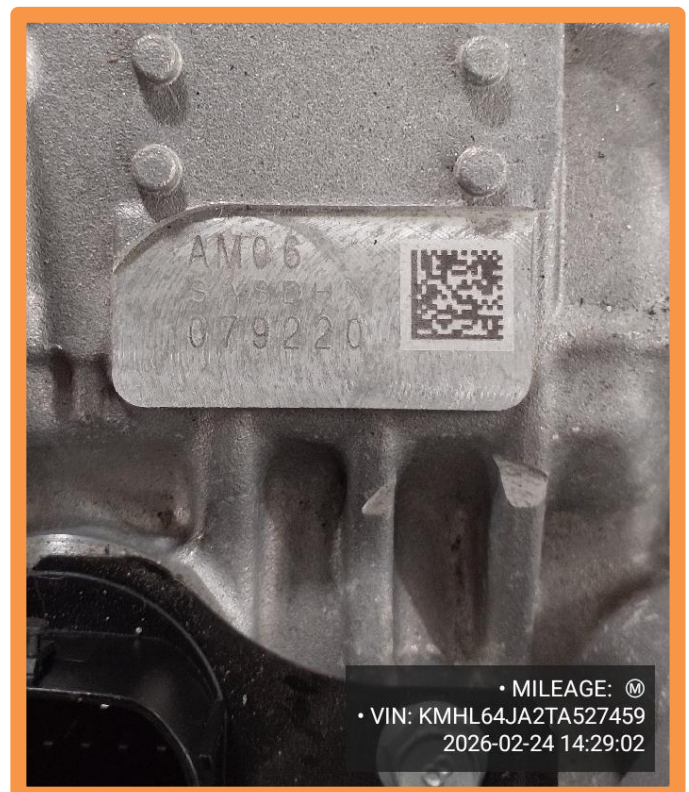
**SUBJECT:****LOOSE TRANSMISSION OIL LEVEL PLUG – AUTOMATIC TRANSMISSION  
REPLACEMENT (LIMITED COVERAGE CAMPAIGN LA15)**
