| Technical Journal Title<br><b>FLL Repair Instructions</b> | | Ref. No.<br><b>TJ 37625.3.0</b> | |
| Function Description<br><b>Autonomous drive lidar</b> | | Page<br><b>Page 1 of 25</b> | |

If FLL needs to be exchanged according to fault tracing, follow the VIDA instruction if a spare part exists; otherwise, follow the advice under “Service” below.

| <b>Title</b> | Forward-Looking Lidar (FLL) | <b>Page</b> | 1 ( 23 ) |

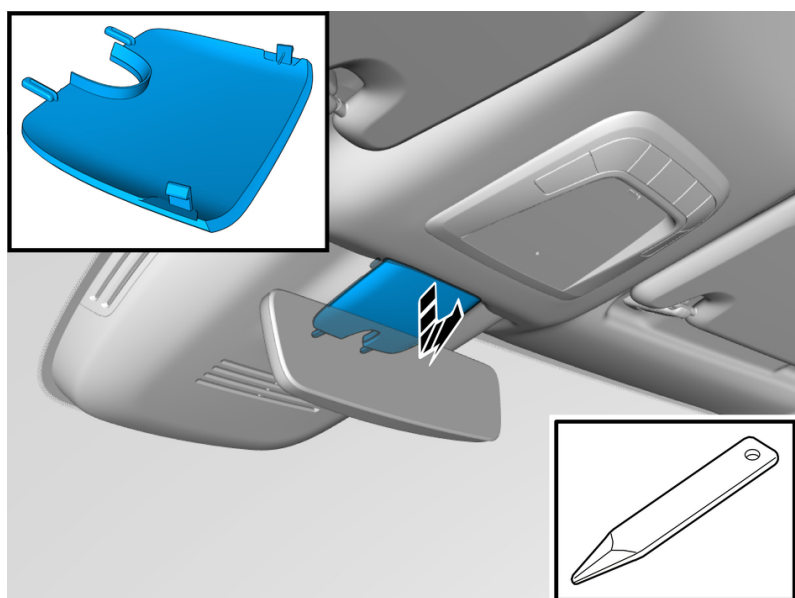
Remove the marked part.

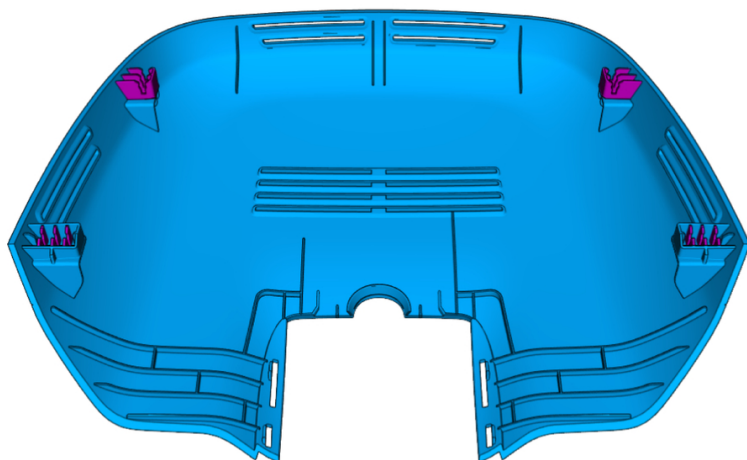
**Note!** The graphic shows the back of the component before removal.

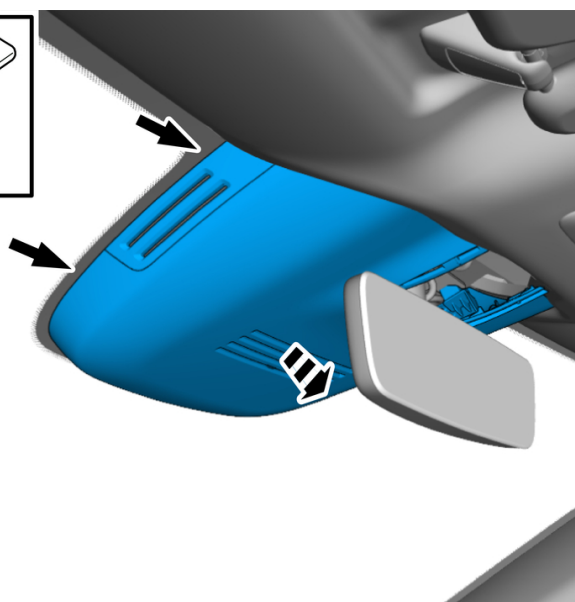
Release the catches.  
Repeat on the other side.  
Remove the marked part.

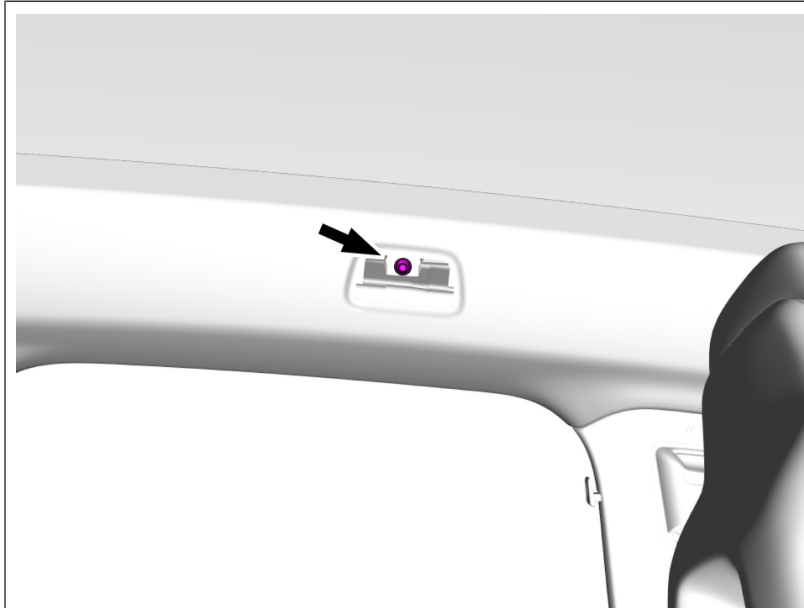
Remove the screw.  
Repeat on the other side.

M5 , 5 Nm

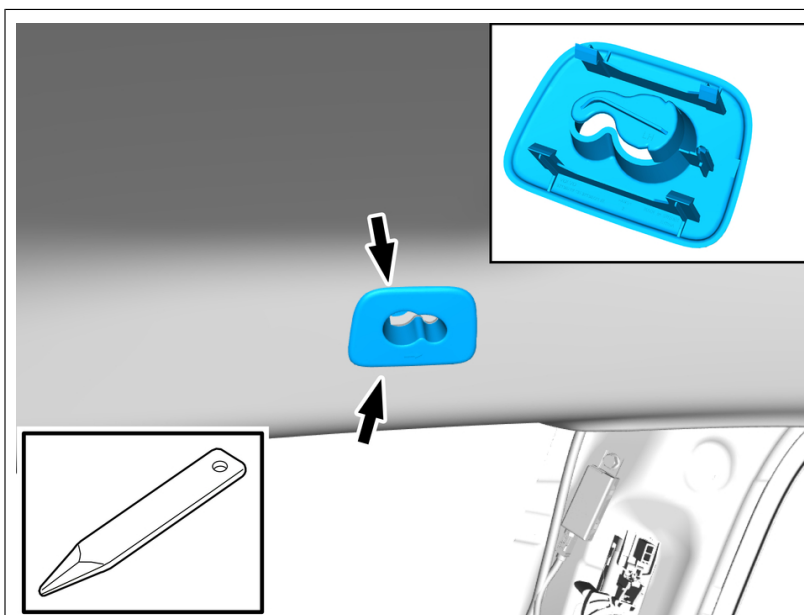
Remove the marked part.  
Repeat on the other side.

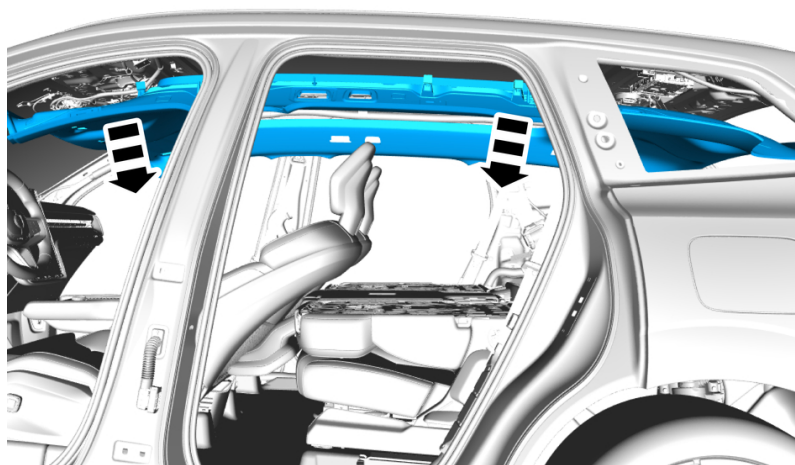
**Caution! Take extra care not to crease the headliner.**

Lower the component somewhat.

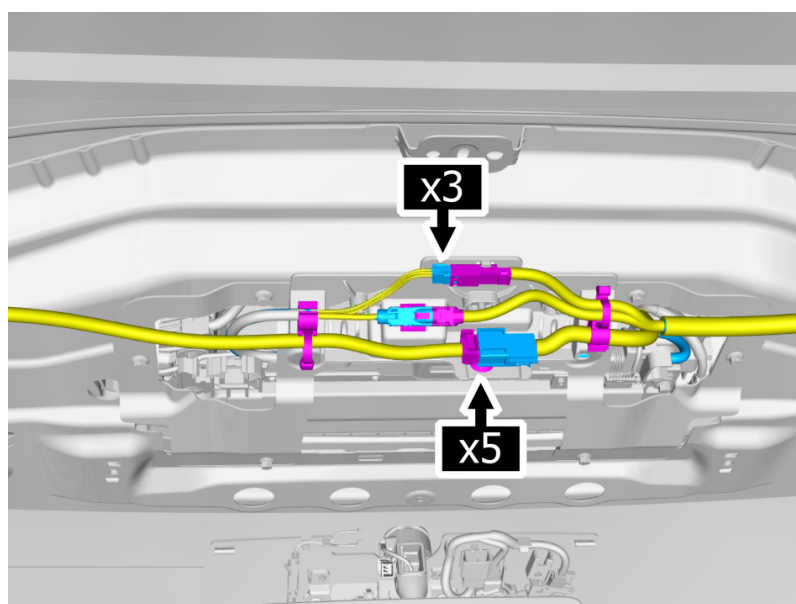
Disconnect the connectors.  
Remove the clips.

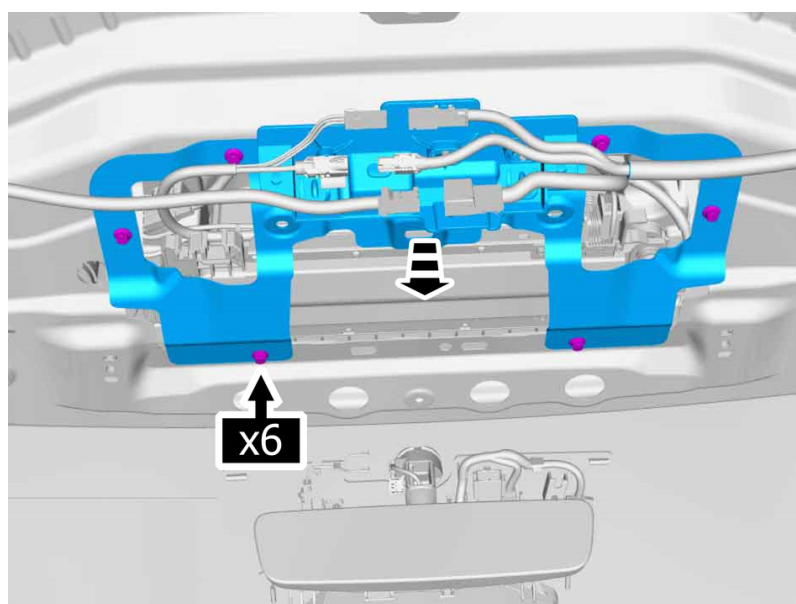
Remove the screws.  
Remove the marked part.

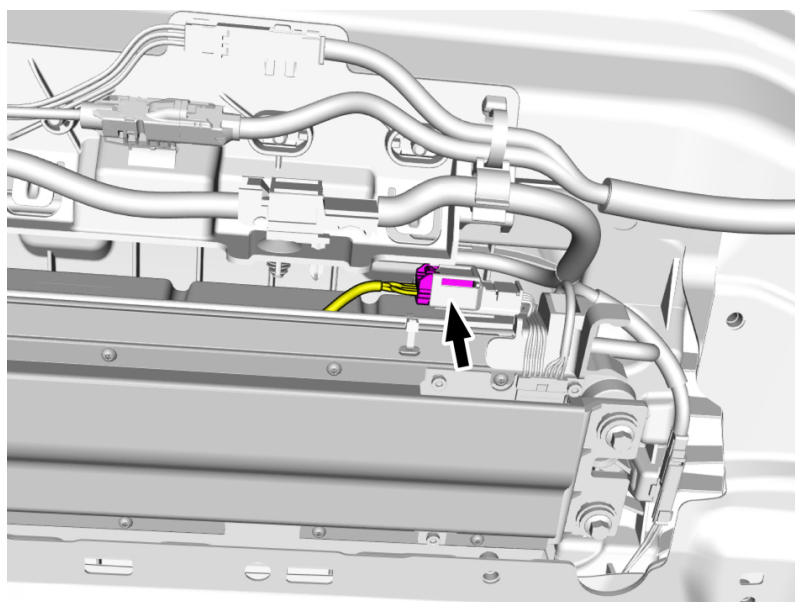
Disconnect the connector.

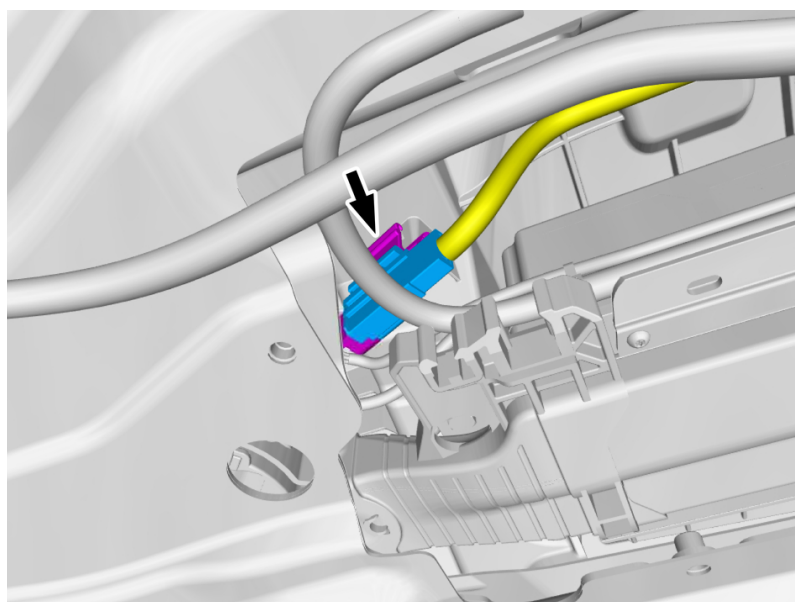
Loosen the clip.  
Disconnect the connector.

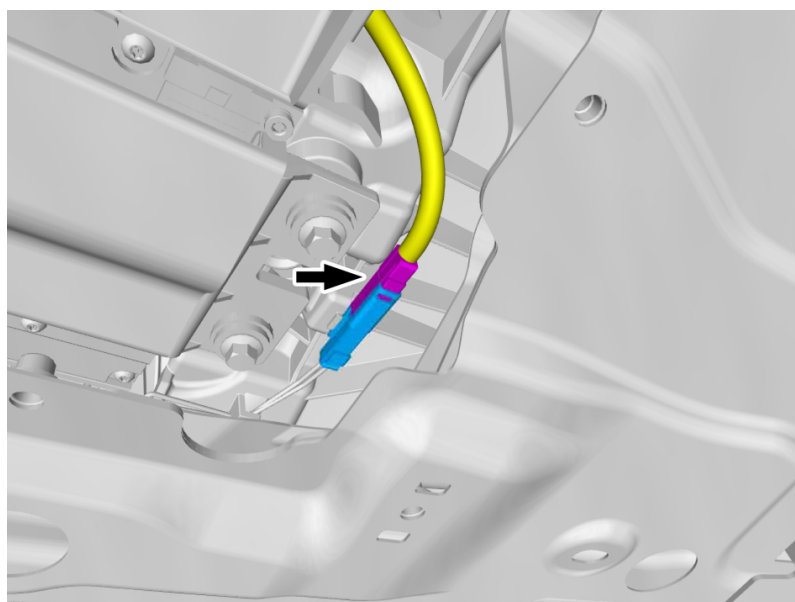
Remove the clip.  
Disconnect the connector.

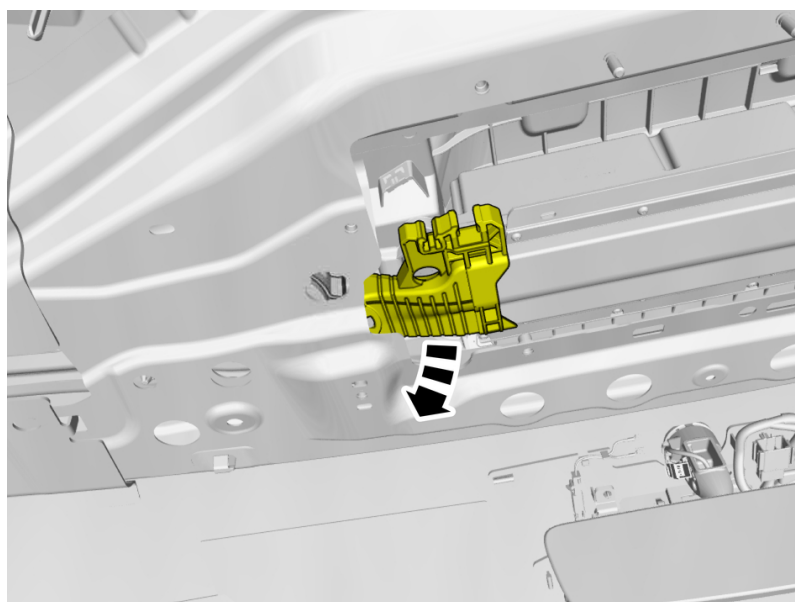
Fold marked part aside.

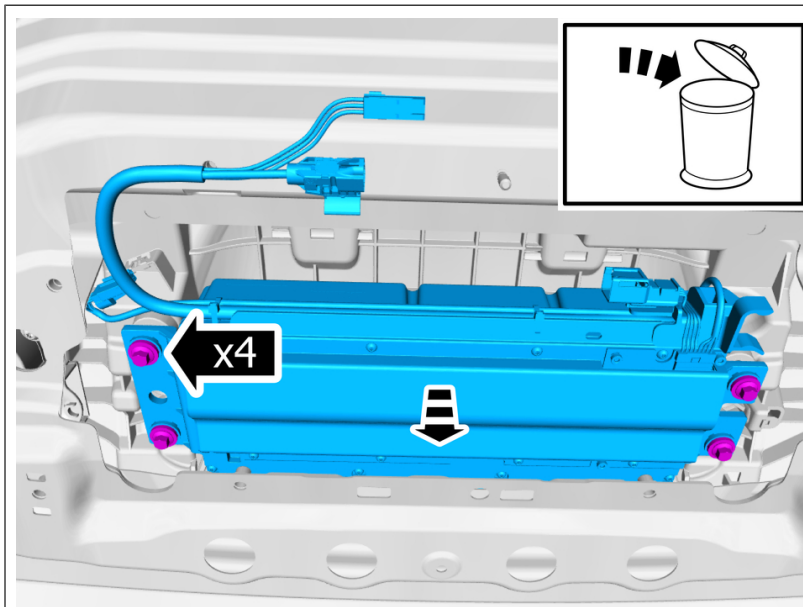
Remove the screws.  
Remove the marked part.  
The parts are not to be reused.

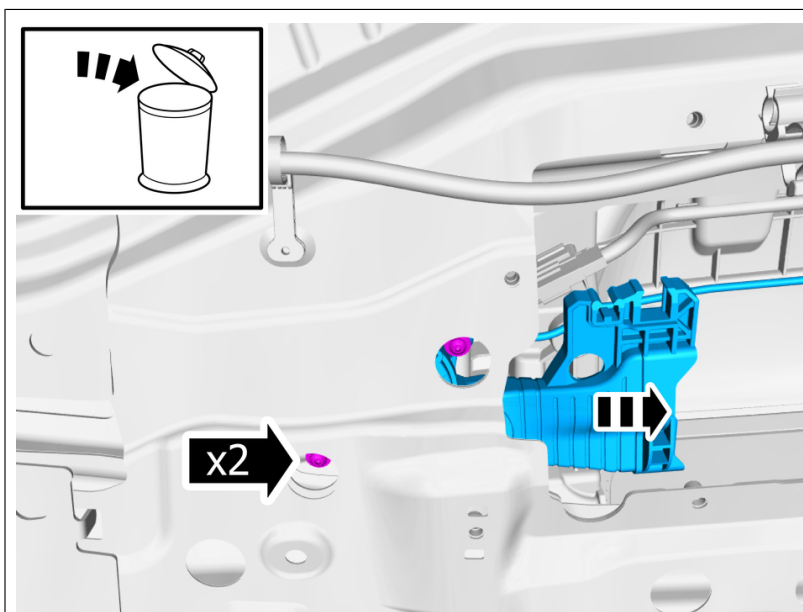
Remove the screws.  
Remove the marked part.  
The part is not to be reused.

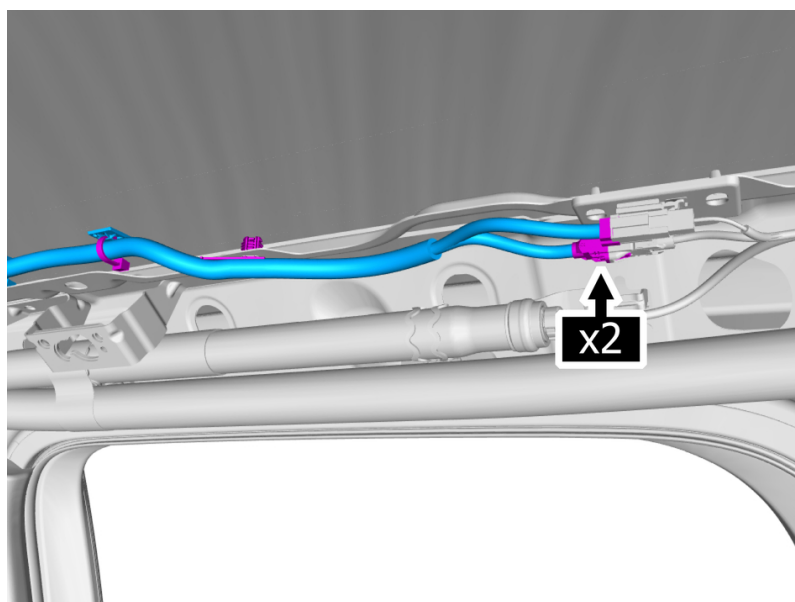
Disconnect the connectors.  
Loosen the clip.  
Remove the cable tie(s).

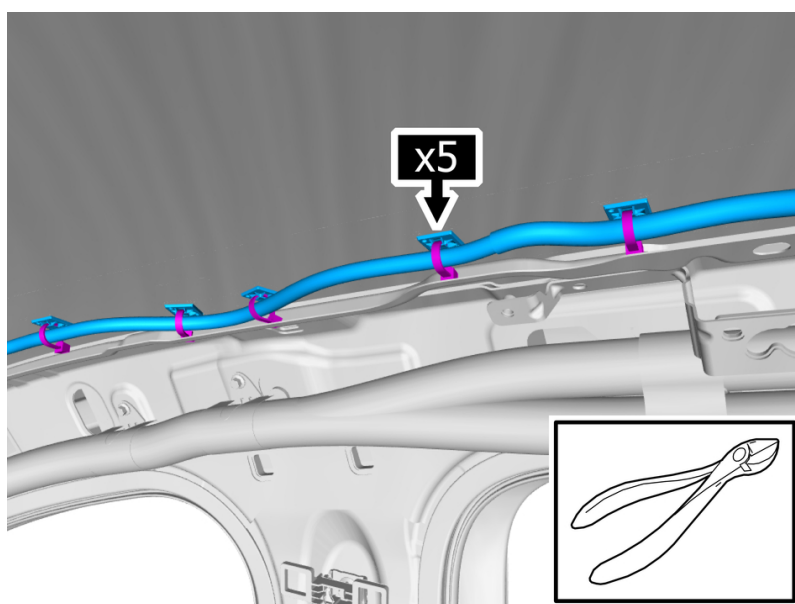
Remove the cable tie(s).

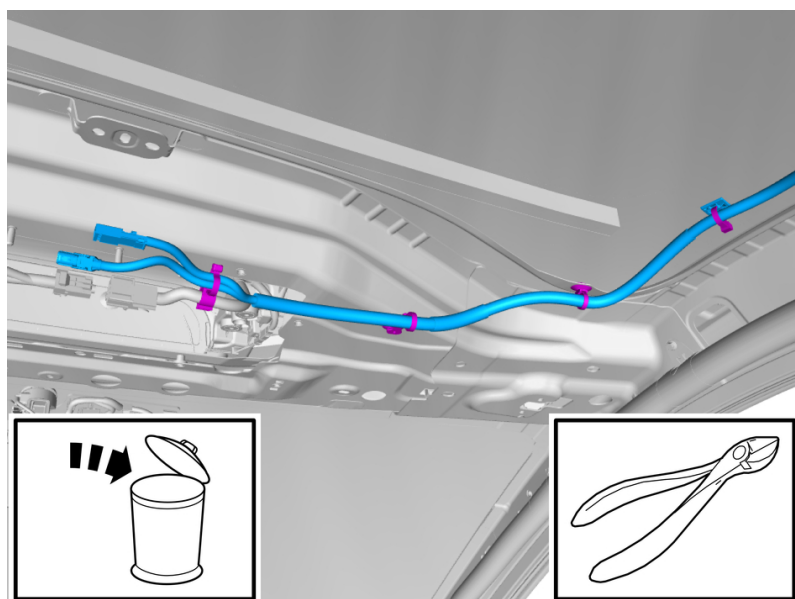
Remove the cable tie(s).  
Remove the clips.  
Remove the marked part.  
The parts are not to be reused.

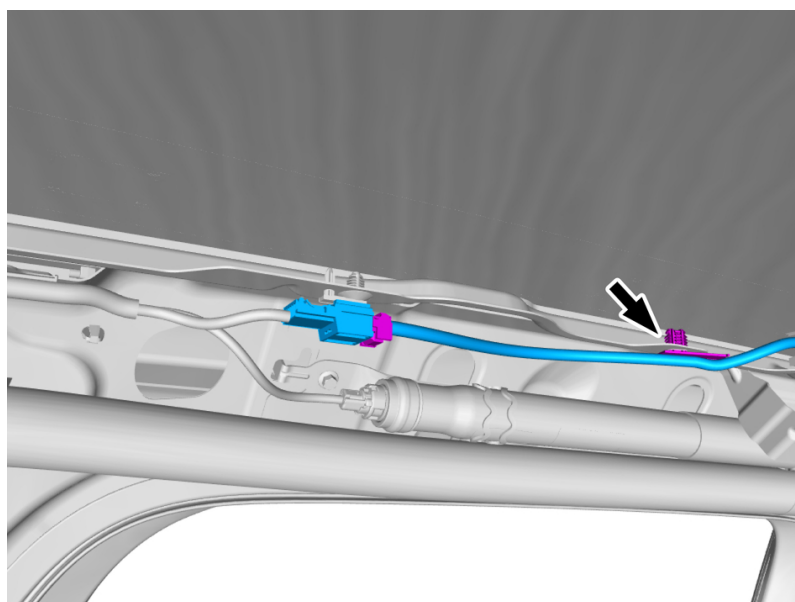
Disconnect the connector.  
Loosen the clip.

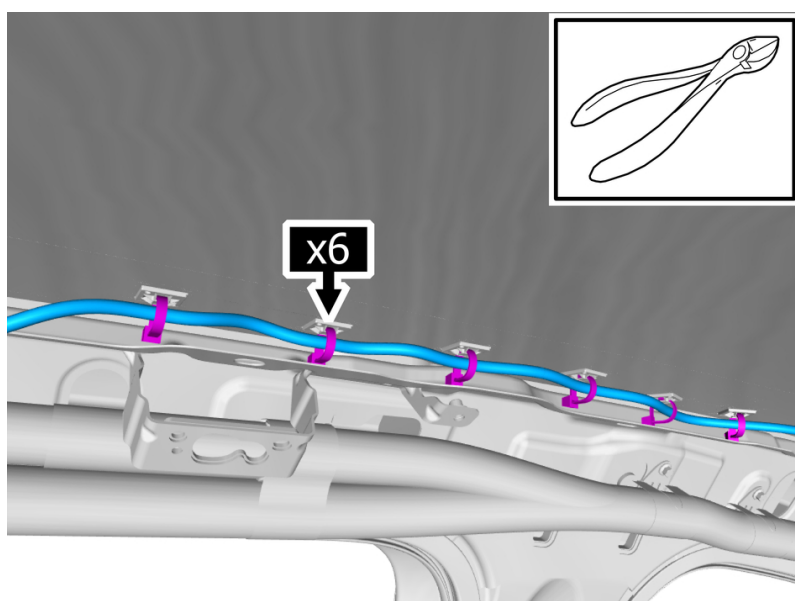
Remove the cable tie(s).

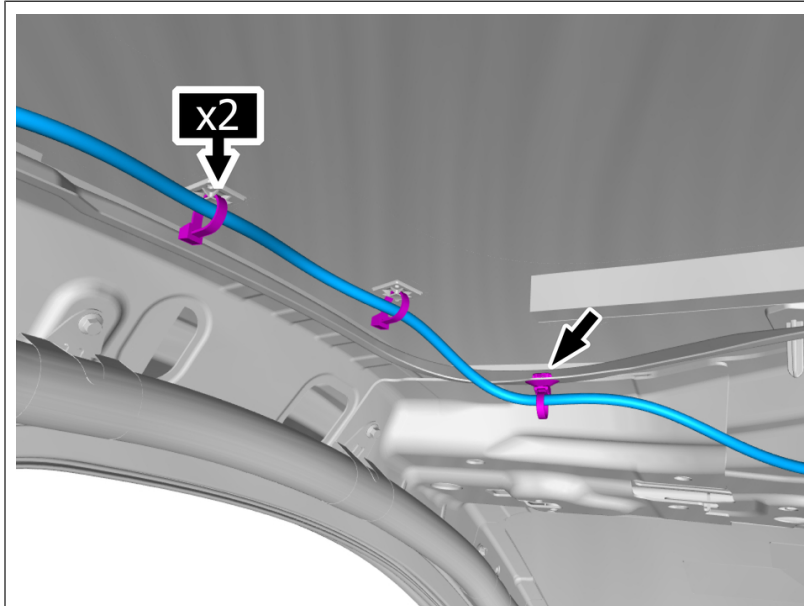
Remove the cable tie(s).  
Loosen the clip.

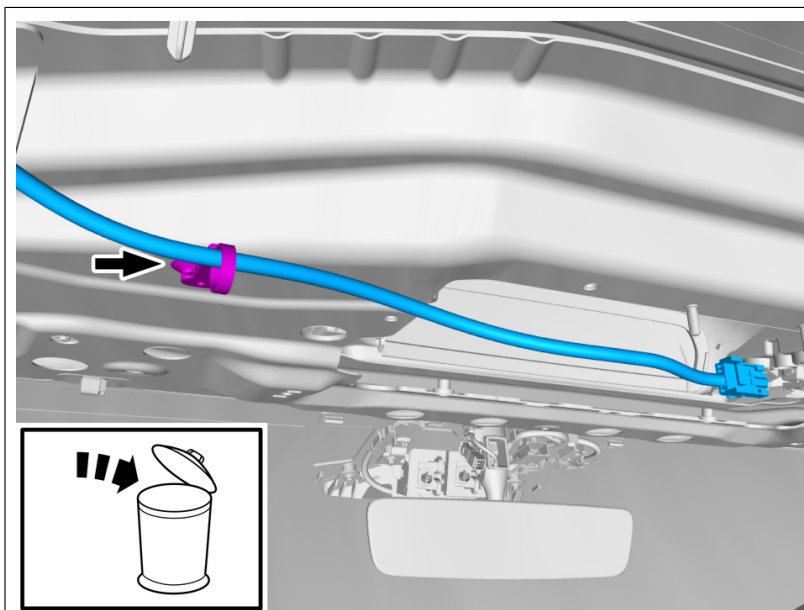
Loosen the clip.  
Remove the marked part.  
The part is not to be reused.

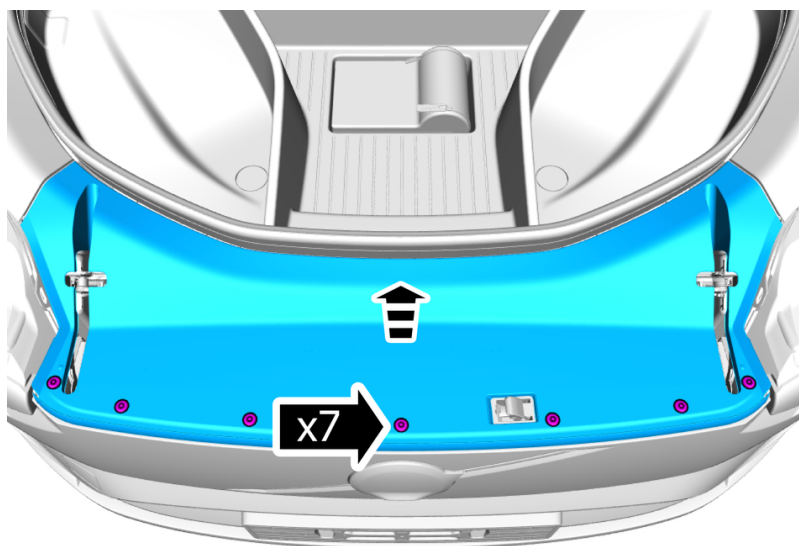
Remove the clips.  
Remove the marked part.

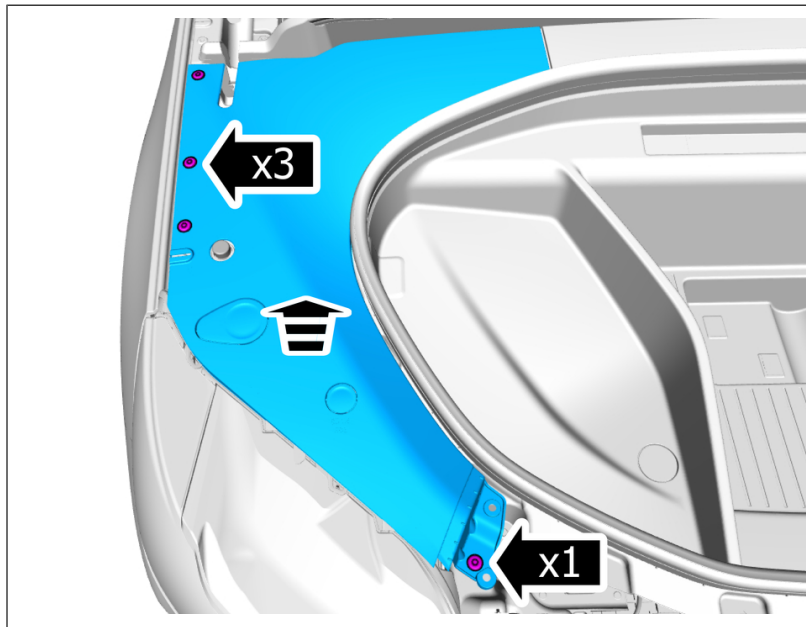
Remove the clips.  
Remove the marked part.  
On both sides.

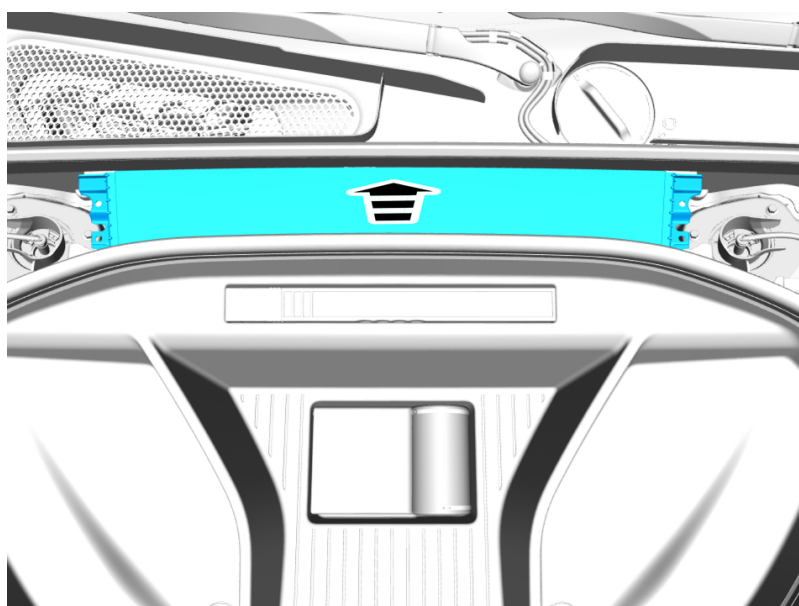
Remove the marked part.

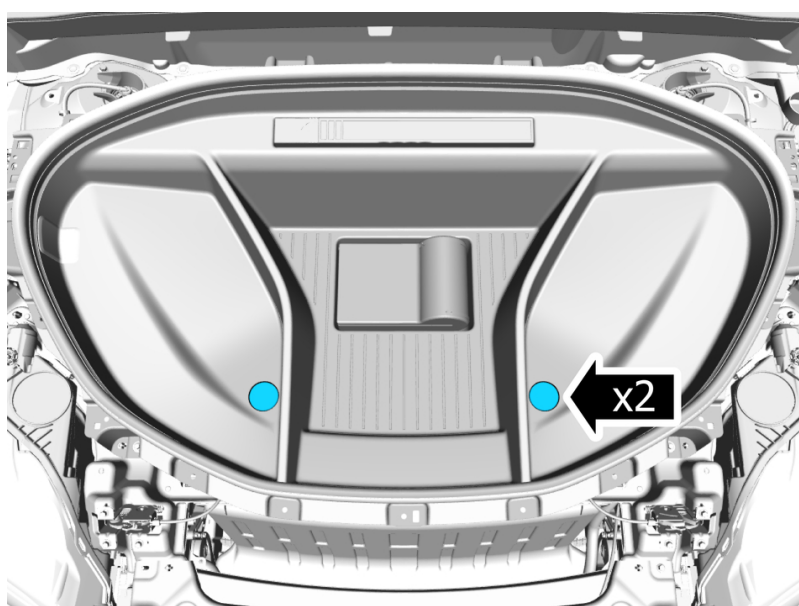
Remove the marked parts.

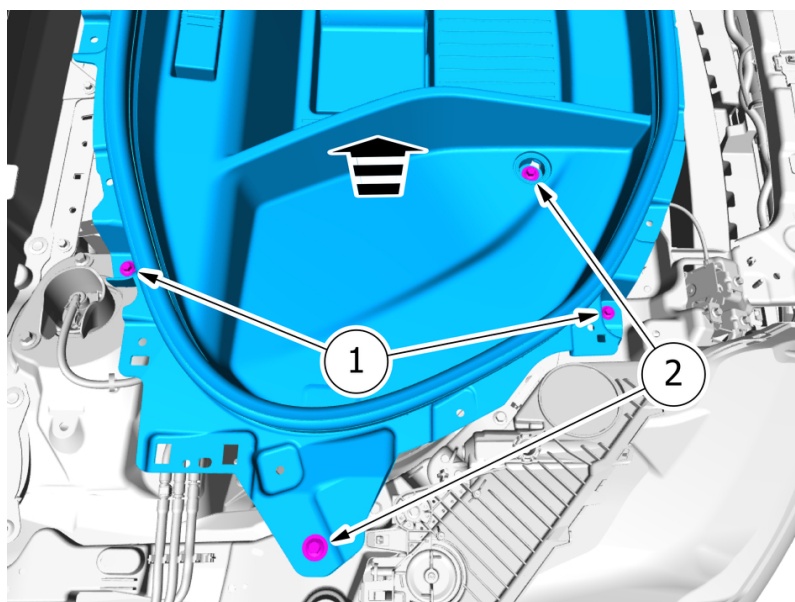
Remove the screws.  
On both sides.  
Remove the marked part.

- 1 . **Torque:**  
M6 , 10 Nm
- 2 . **Torque:**  
Luggage compartment, front, to bracket ,  
10 Nm

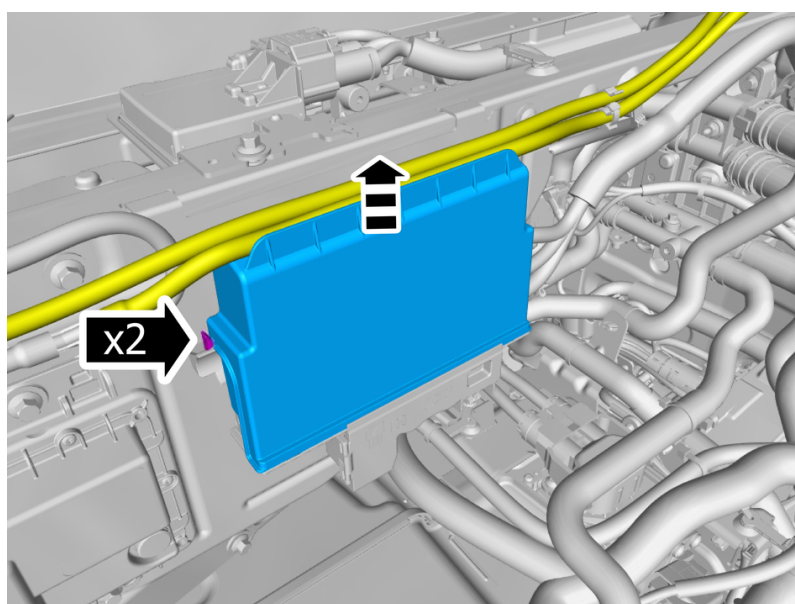
Release the catches.  
Remove the marked part.

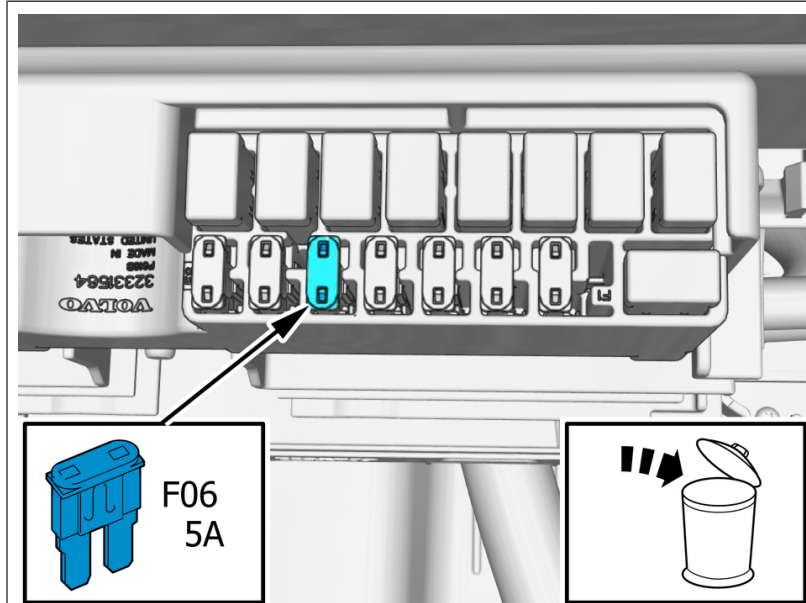
Remove the marked part.  
The part is not to be reused.
