SIB 77 01 26

SERVICE SOLUTION: R 1300 RT Case Release Jammed

R 1300 RT models with BMW cases.

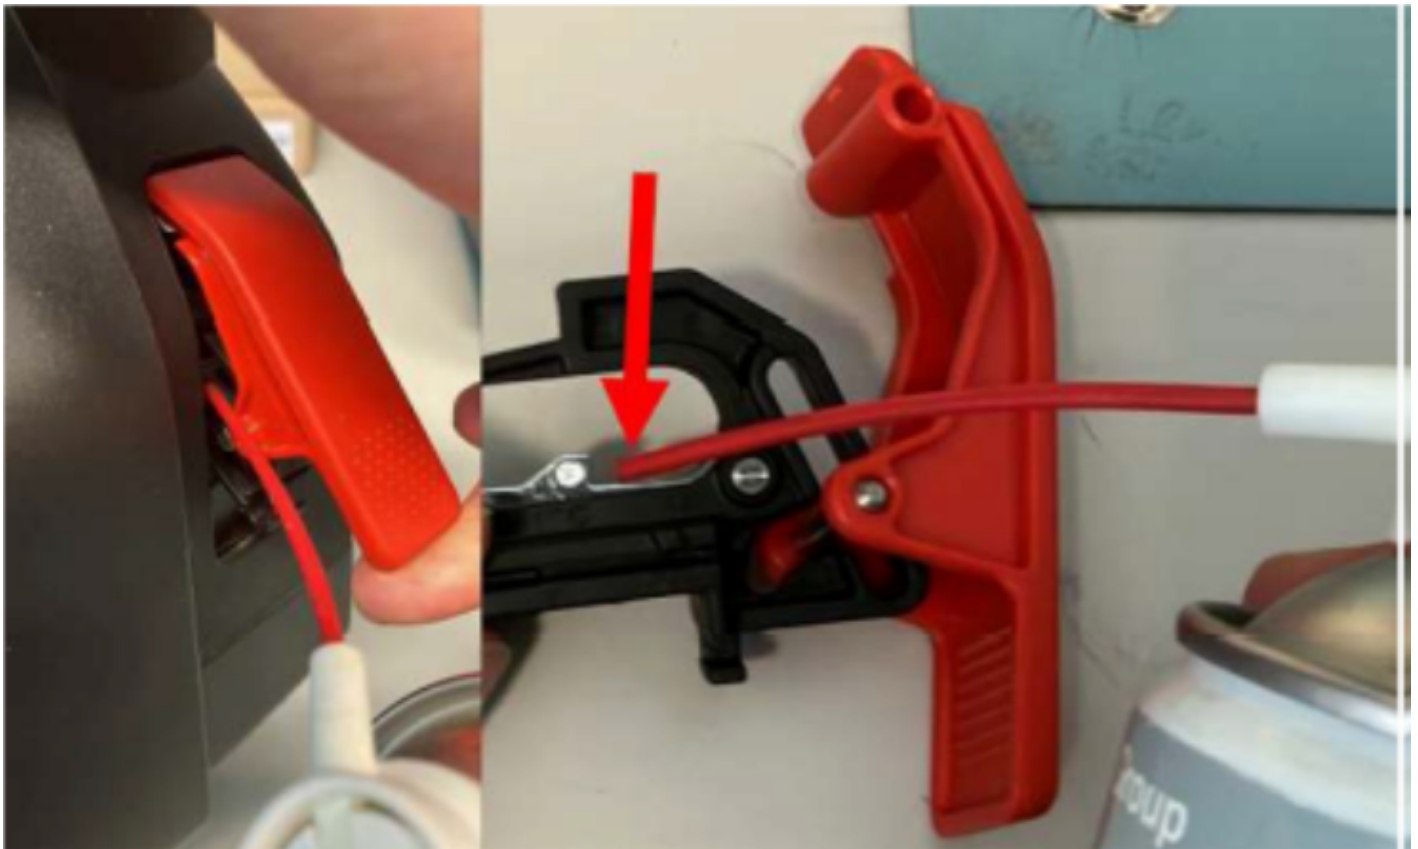
The mechanism of the release lever is jammed.

When trying to open the case, the release lever does not open after the lock barrel has been pressed.

The following figure shows how and where to lubricate.

**NOTE: DO NOT REMOVE THE LATCH!** The Below is only removed for reference.

The assembly can operate as designed again using a suitable Adhesive lubricant. Often called High-Adhesion Lubricant. This is a high tack, long lasting aerosolized lubricant.

When the release lever is slightly lifted (possibly with the aid of a non-marring pry tool), the lubricant can be applied to the metal assembly inside. (See location in below figure)
