# KEYSTONE

## RECREATIONAL VEHICLE CUSTOMER SATISFACTION

CSC-260814

### CUSTOMER SATISFACTION CAMPAIGN

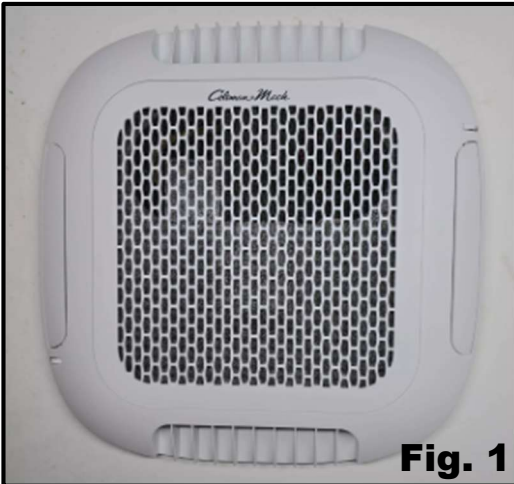
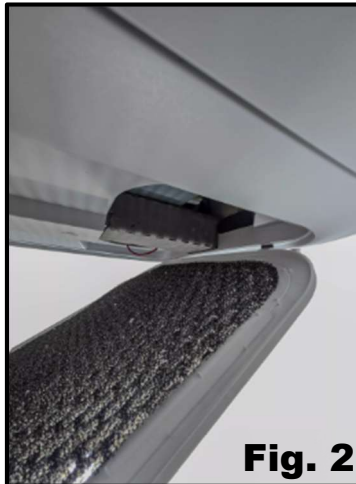
- 1.) Remove the Coleman-Mach A/C ceiling shroud vent by pushing upward on the vent to release the retaining latch. Once released, pull the vent downward at an angle to remove it from the ceiling shroud. See Fig. 1 – Fig. 2
- 2.) Use a screwdriver to remove the four screws securing the A/C shroud to the ceiling mounting frame. See Fig. 3

- 4.) Reinstall the Coleman Mach A/C ceiling shroud to the ceiling mounting frame using the four screws previously removed and then reinsert the ceiling shroud vent as shown in Fig.1.
