| <br><b>HARBINGER</b> | <h1>Technical Service Bulletin</h1> |
| Bulletin Number: TSB-02-00007 | |
| Subject: AC Connector Removal | |
| Applicability: All 2025/2026 MY Stripped Chassis | |

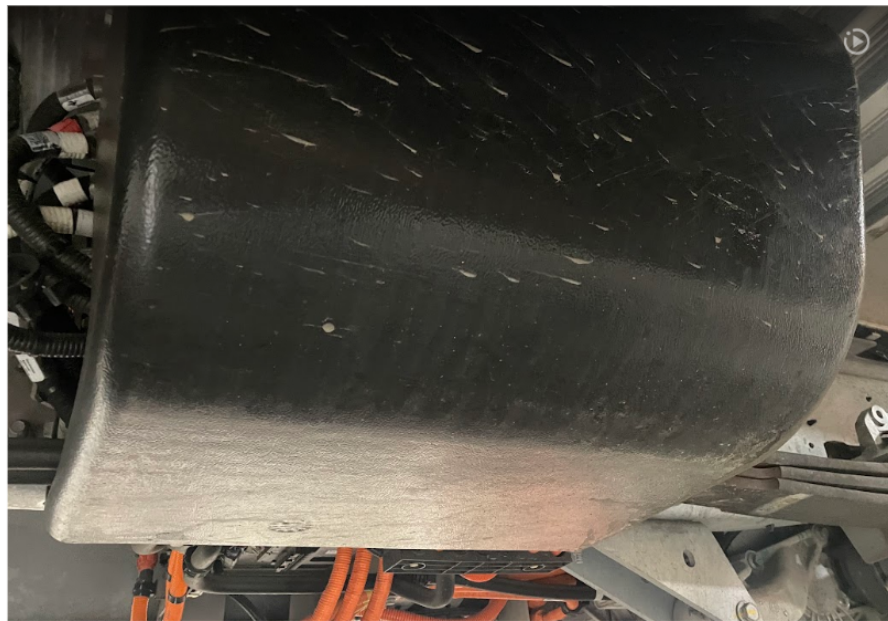
## Remove the PCU cover

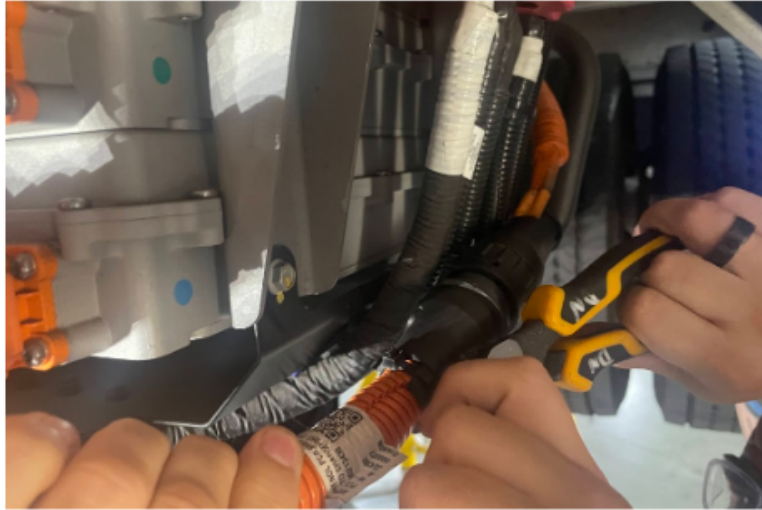
## Cut and remove the zip ties holding the wire loom in place

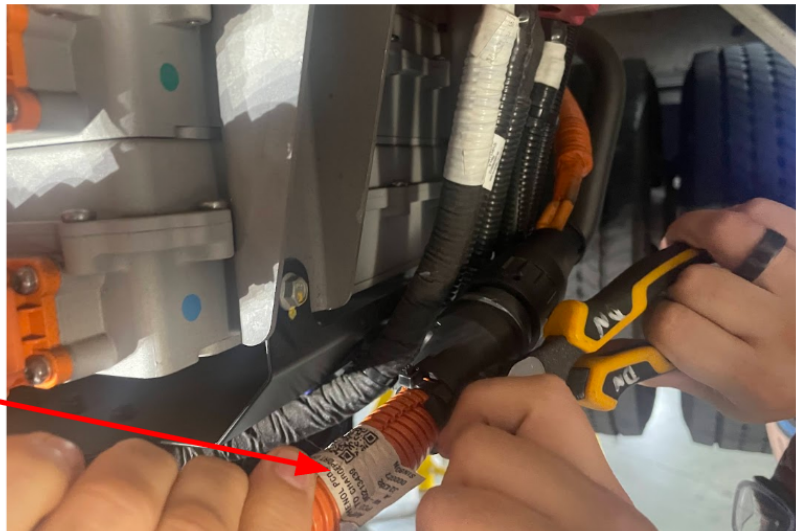
Please note or photograph the serial number from the PCU harness label and the charge port harness label for the case, and link that info to the removed connector for RMA (Return Material Authorization)

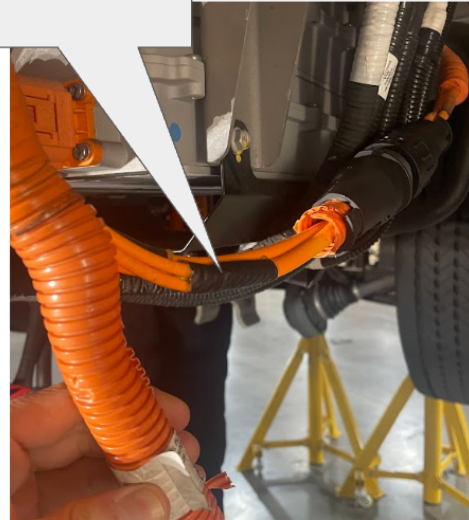
Y- Splice

Pull back the split loom to expose the wires

If there is visible thermal damage to the wires, identify how far back you need to cut to leave only clean good condition wire remaining

Do not cut further back than ½” before the Y splices

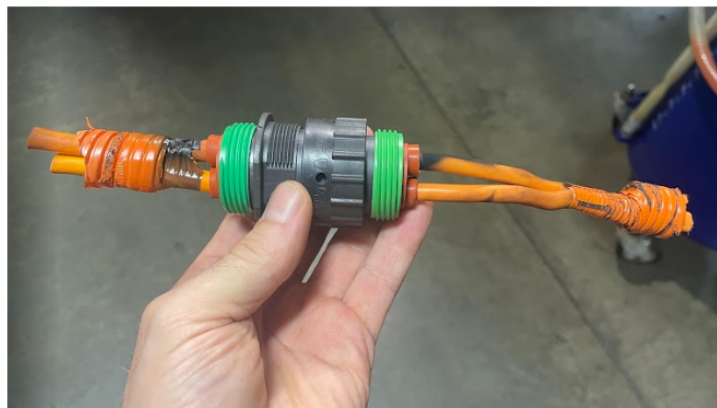
Cut out the connector including any thermally damaged length of wire

Save it for the RMA and tag with the Case number or RMA number

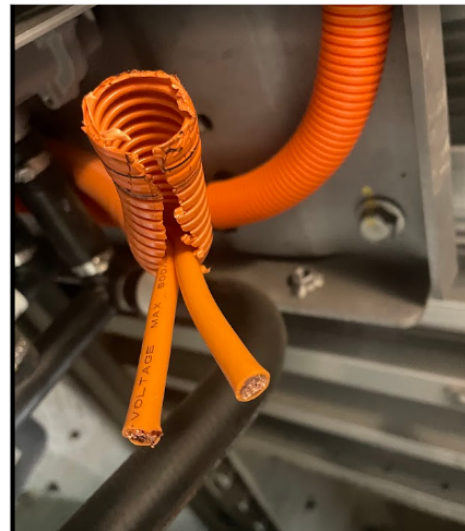
Pull back the split loom to expose the wires on the other side

If there is visible thermal damage to the wires, identify how far back you need to cut to leave only clean good condition wire remaining

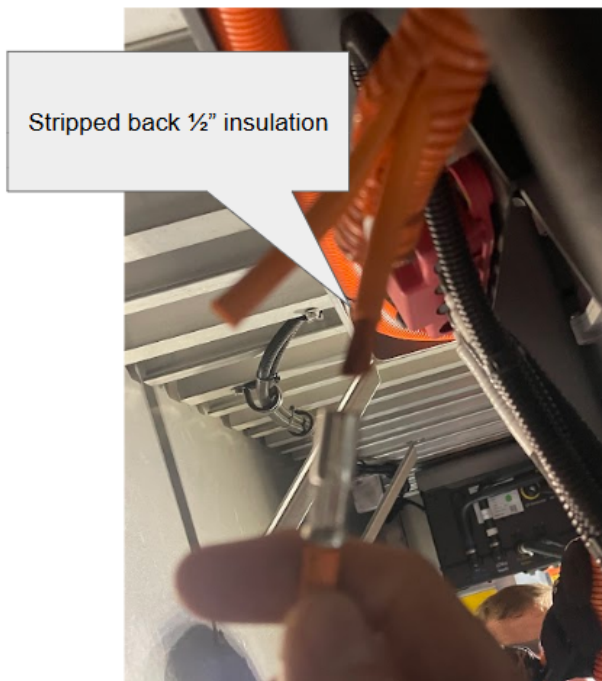
Strip back ½ inch of insulation on all 4 wires while being careful not to cut any of the wire strands

Twist and organize the conductor strands so they can **ALL** fit inside the crimp connector, then crimp

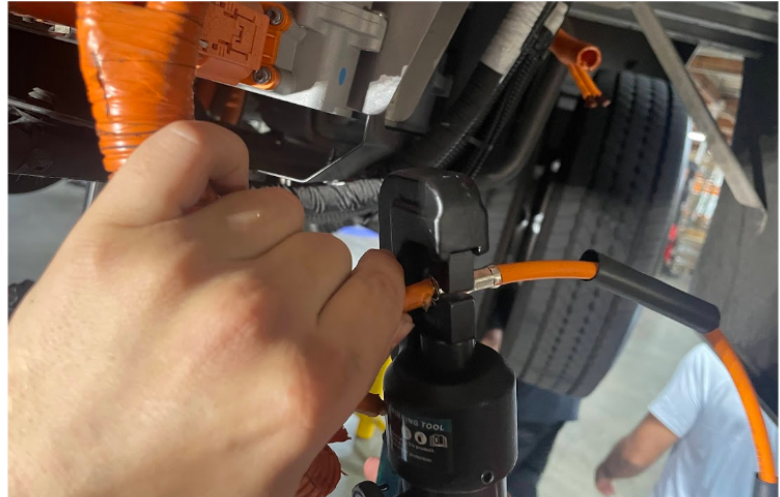
Crimp using the 2awg jaws from the [HF hydraulic crimp tool](#)

Be sure the shrink wrap pieces are in place before doing both ends as they cannot be slipped into place after

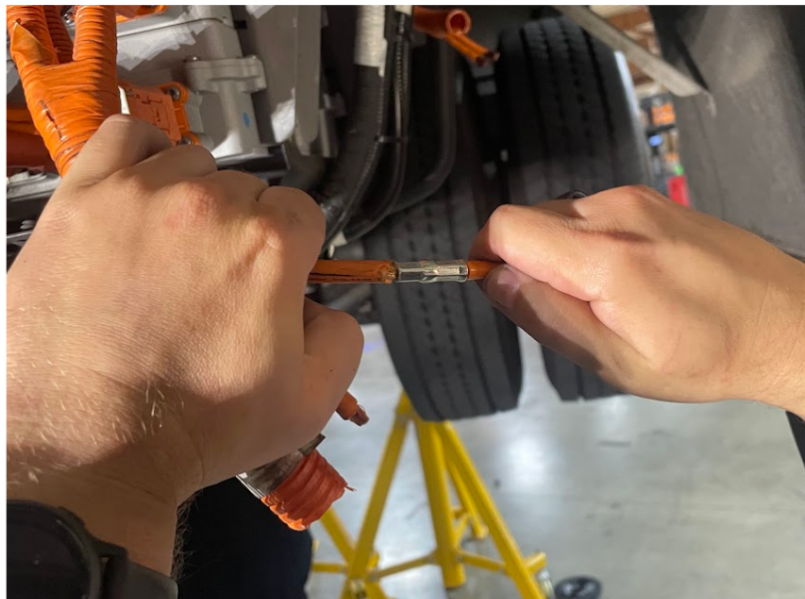
Once all 4 crimps are done do a pull test to be sure they are secure

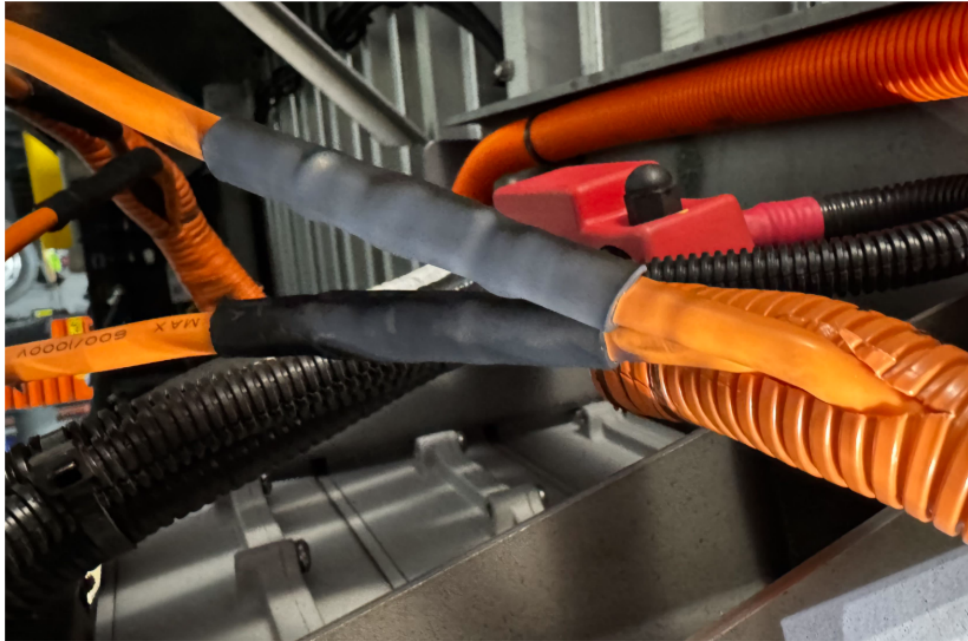
Then heat the shrink wrap to shrink it

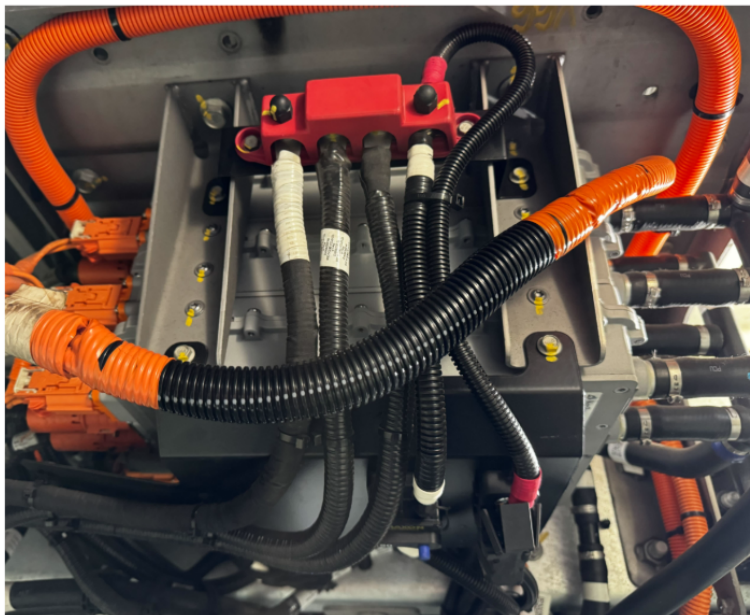
Install New Split loom  
over the wire

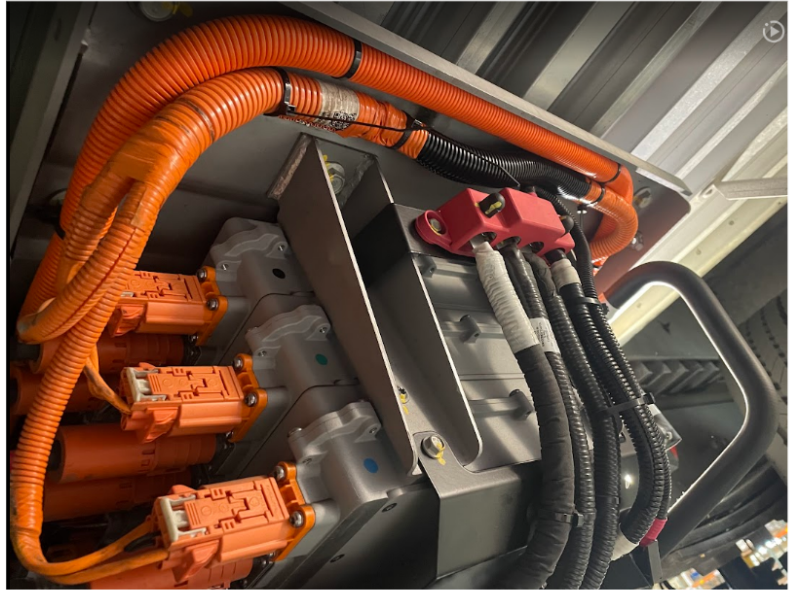
Put the anchors back in place and secure the assembly

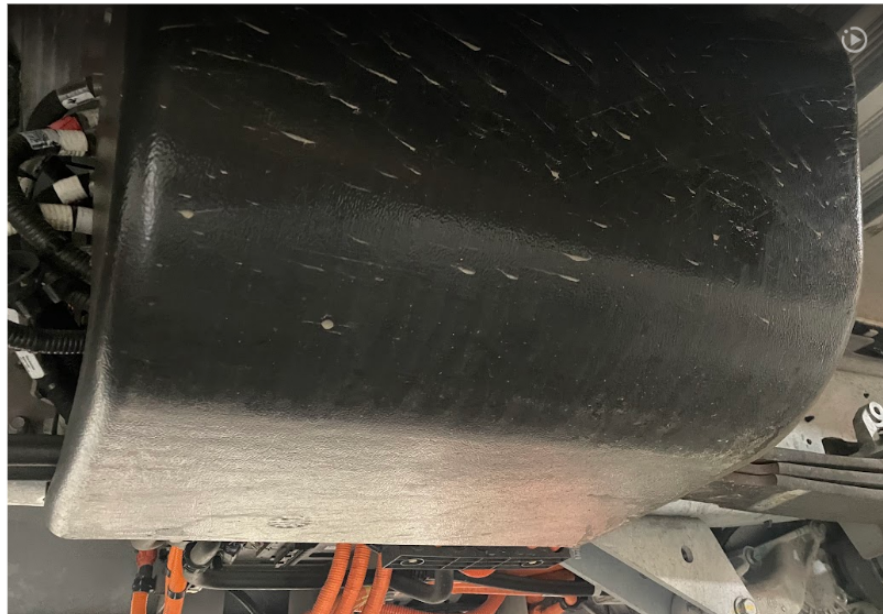
Reinstall the PCU cover and test the AC charging system

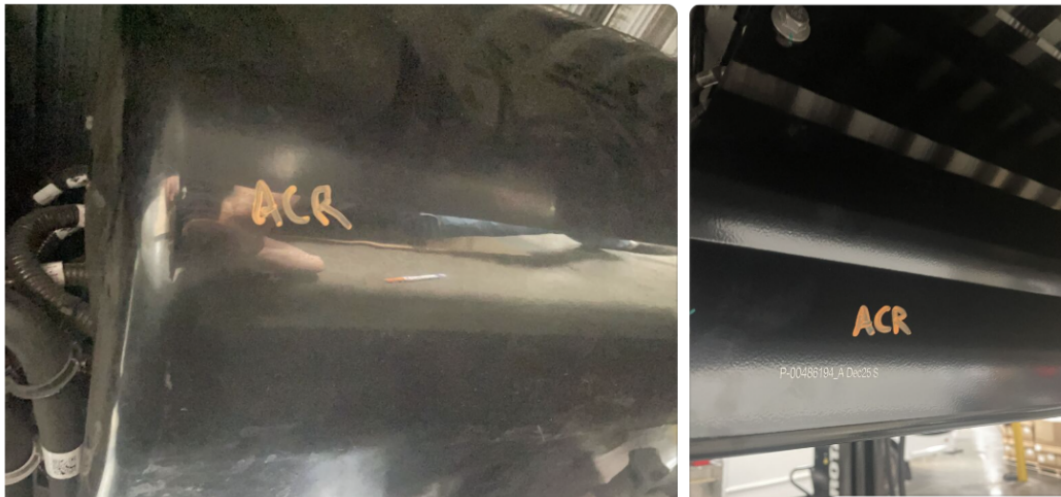
Use a permanent paint pen and mark the PCU cover or HPS cover if equipped with “ACR”
