## Thor Motor Coach Technical Service Bulletin

| TSB # | <b>TSB 26-06</b> | | |
| Description/Title: | DC/DC Charger setting | | |
| Affected Product Line(s): | Certain model year 2026-2027<br>Eddie Bauer Van, Palladium, Sanctuary, Talavera, Tranquility | | |

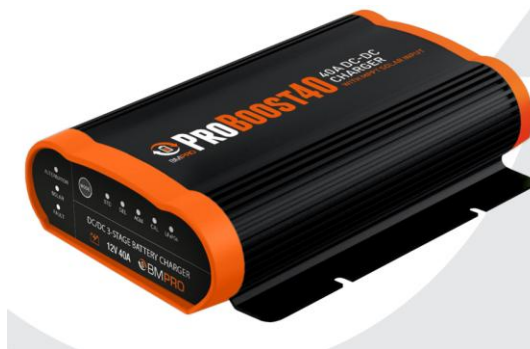
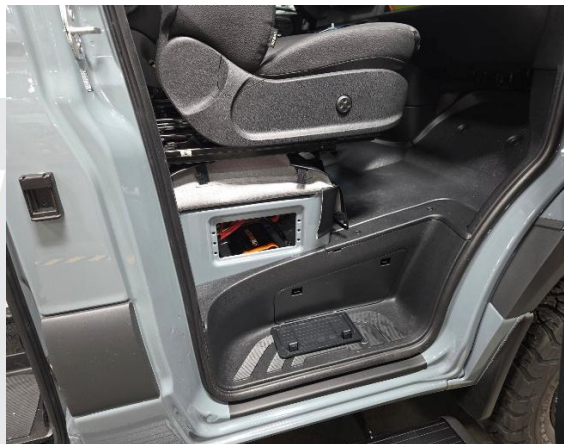
1. Locate the DC/DC Charger under the passenger seat using the access door on the side of the pedestal.

It has been discovered the DC/DC Charger may not have the correct (LiFePO4) type of house batteries selected. Constant exposure to improper charging will result in incomplete charging and/or premature battery aging.

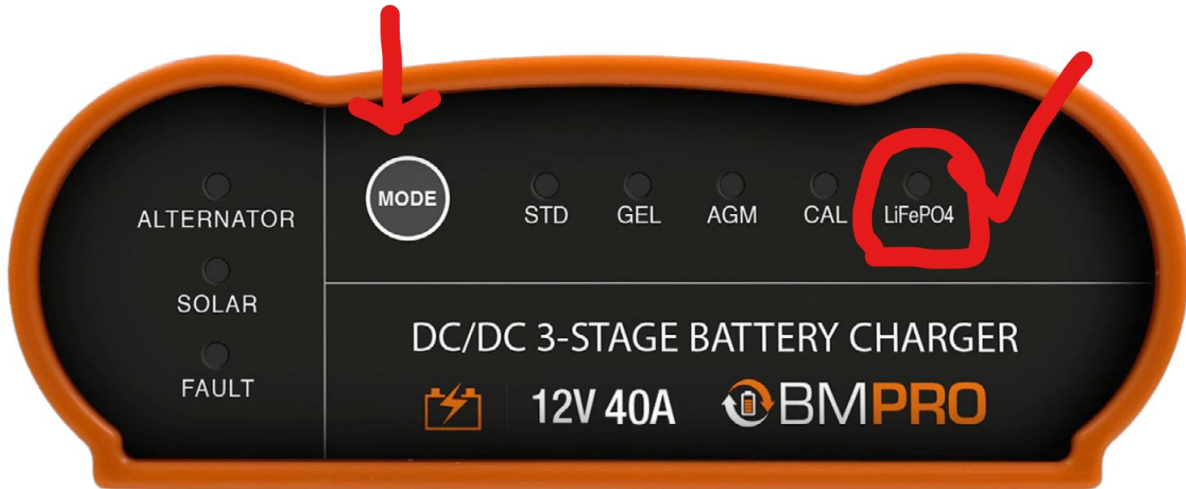
2. Ensure the MODE setting is on LiFePO<sub>4</sub>.

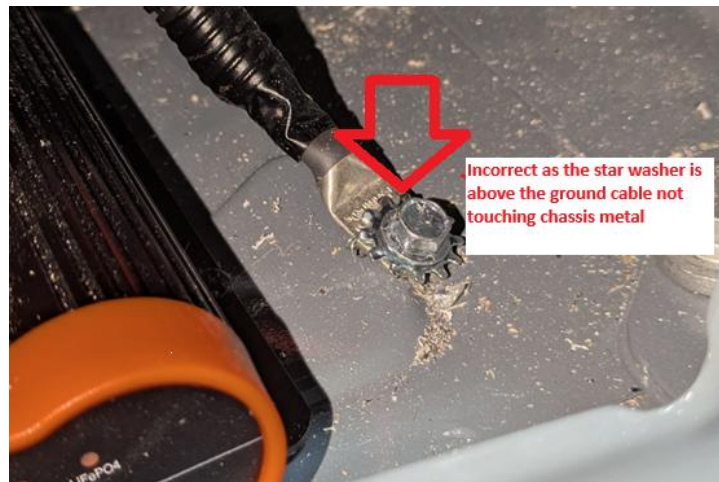
**As a precautionary measure**, ensure the grounding cable & stud under the passenger cockpit chair is secure and tight with the star washer touching the chassis metal and not on top of the ground cable with no contact to chassis metal.
