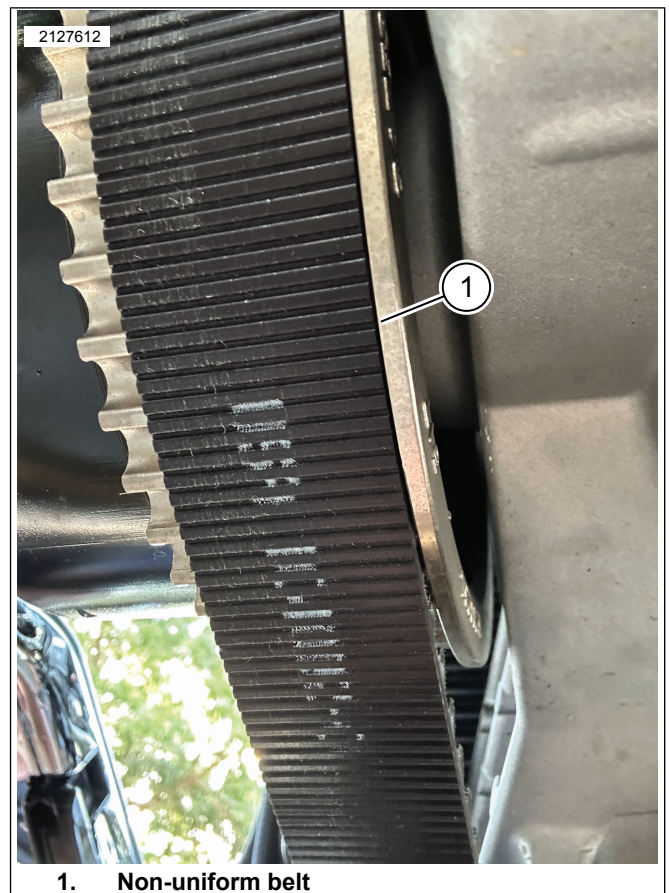
Figure 7. Non-Uniform Belt

*See Figure 7 and Figure 8. Belt surface should appear uniform when material has been removed.*

1. Non-uniform belt
