Title: PSI 8.8L Engine Oil Pan Gasket Leaks

Applies To: All PSI 8.8L LPG and Gasoline Engines MY2015, MY2016, MY2017, MY2018, MY2019, MY2020, MY2021, MY2022, MY2023, MY2024.

The purpose of this article is to provide updated repair guidelines for the engine oil pan leak on all 8.8L gasoline and LPG engines. Engine oil can leak from the rear of the engine oil pan due to an excessive gap in the sealing area between the engine oil pan and the engine block.

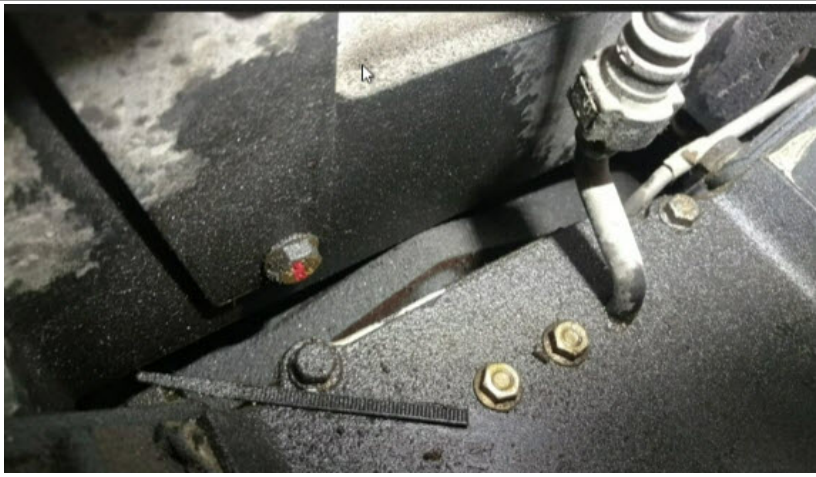
**Figure 1**

| Step | Action | Decision |
|---|---|---|
| 2 | <b>DIAGNOSTIC:</b><br>Perform a visual inspection of the intake valley plate and confirm it is not leaking, causing a false engine oil pan leak. See Figure 1 for an example of an intake valley plate leak.<br><br><b>**NOTE**</b> The intake manifold <b><u>DOES NOT</u></b> need to be removed to inspect the engine valley plate for an oil leak.<br><br><b>YES/NO QUESTION?</b><br><br>Is the engine valley plate leaking engine oil? | <b>Yes:</b> Repair the engine oil leak at the valley plate. Clean the engine and retest for engine oil leaks. |

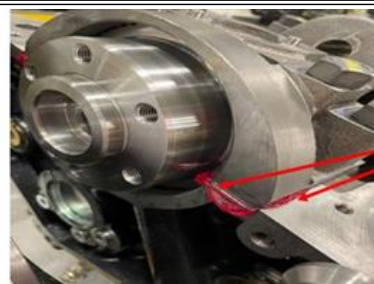
- Oil pan gasket leaks on PSI Engines
  - Some may be reported as rear or front crank seal leaks

- Two different sealants are being used in the assembly, RTV and Anaerobic sealer
- Two different sealers do not adhere onto each other causing leaks

Anaerobic Sealant used at the main cap to block joint

| Step | Action | Decision |
|---|---|---|
| 7 | <b>DIAGNOSTIC:</b><br><br>Confirm that anaerobic sealant was not used when the original oil pan was installed. Please see attached Figure 2 below. | <b>Yes:</b> Remove the rear main cap and reseal with RTV. Please see Figure 2A for RTV application instructions. |

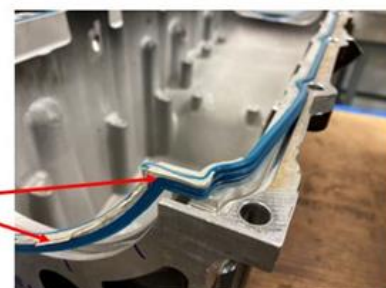
RTV sealant used on oil pan seal

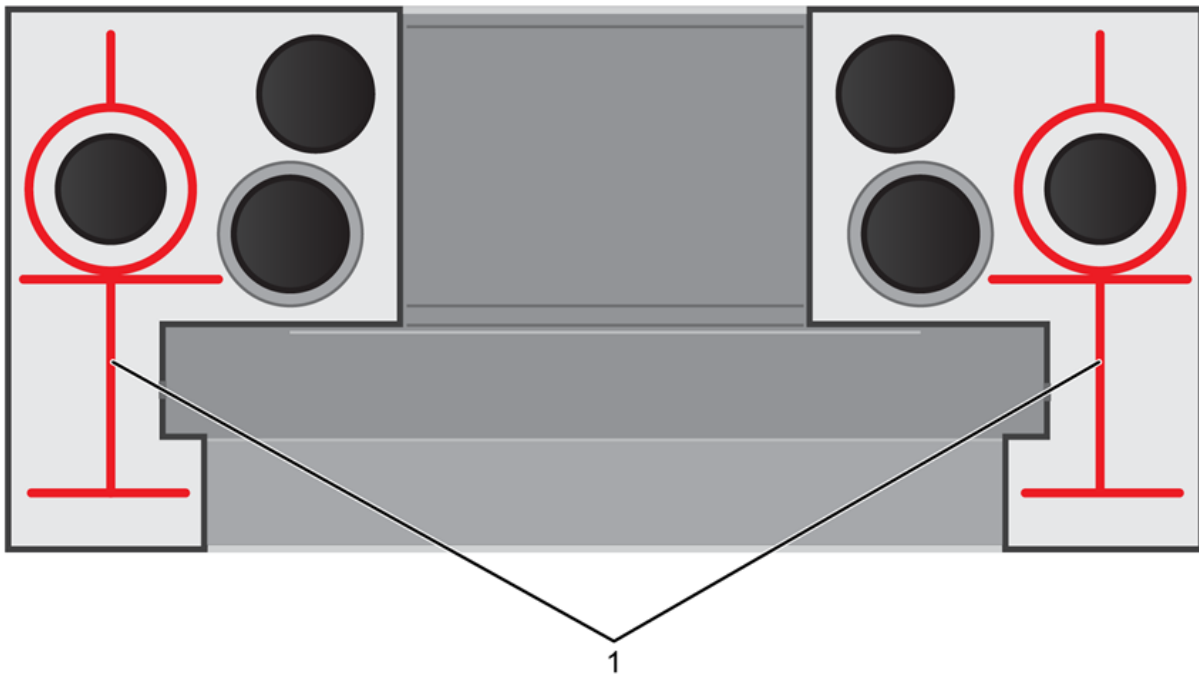
Figure 2A RTV Application Instructions

#### RTV Application Instructions:

1. It is imperative that the engine block and rear main cap mating surfaces are completely free of oil and debris. Verify that no anaerobic sealant or RTV is present within any rear main cap bolt holes.
2. Apply a continuous 1/8-inch bead of RTV, ensuring the bead does not exceed 3/16 inch. Excessive RTV may damage the rear main bearing. Apply sealant as specified in Figure 2A, Callout 1 (highlighted in red).
3. Allow the RTV to skin over prior to assembly. Wait a minimum of five minutes and no more than 10 minutes before installing the rear main cap. The sealant must be tacky at the time of installation and not fully cured.

Excessive squeeze-out indicates over-application of RTV. A minimal, uniform bead should be visible at the mating surfaces once the rear main cap is installed.

4. Torque the rear main cap to specification per the service manual. Remove any excess RTV from the rear main seal sealing surface to prevent contamination or sealing issues.

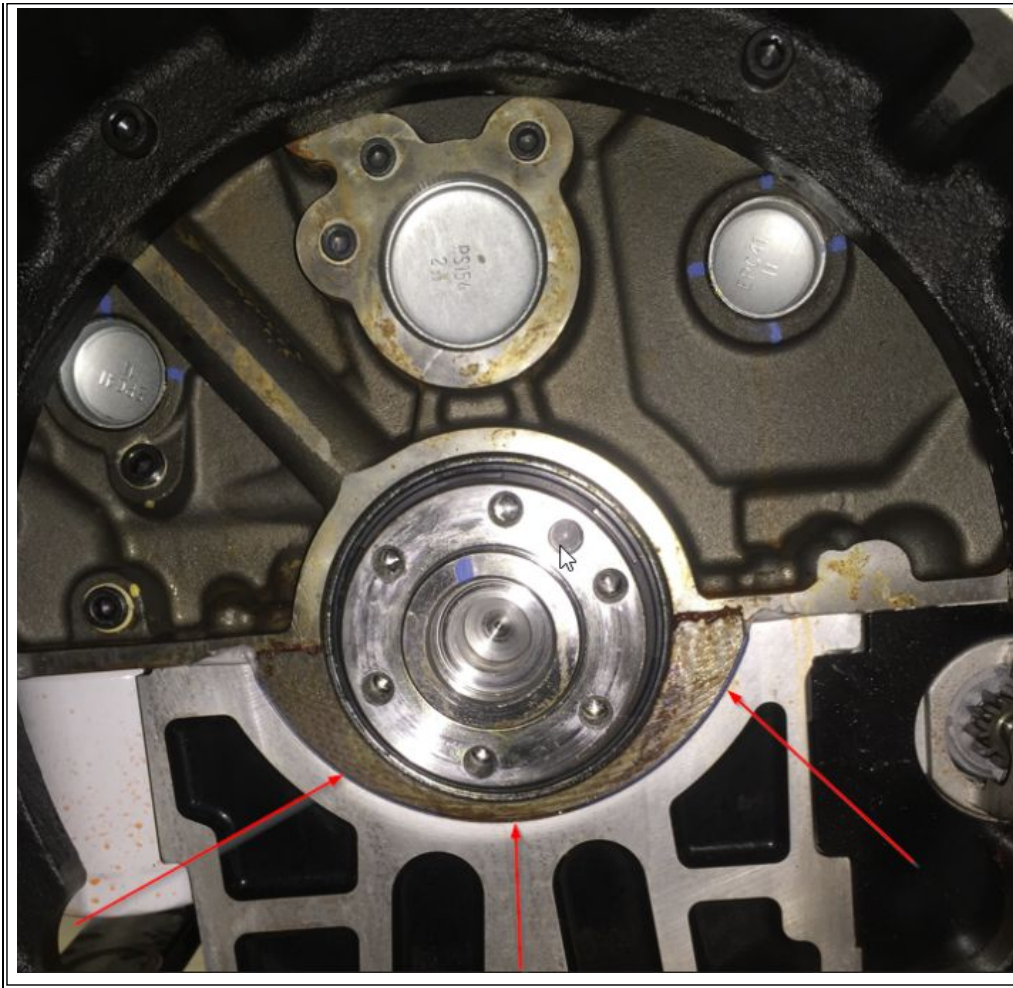
Figure 3

1. Using feeler gauges, measure the gap between the oil pan gasket and the rear main bearing cap. (**Figure 3**)
    1. **\*\*NOTE\*\*** If no gap is present, do not install any additional cork gasket. Proceed with installing the oil pan per the service manual.

1. Allow RTV to become slightly tacky before installing the engine oil pan.
8. Apply the RTV-coated cork gasket to the rear main cap (Figure 3)
9. Install and torque the oil pan as described in the PSI 8.8L service manual. (The link to the manual is below)

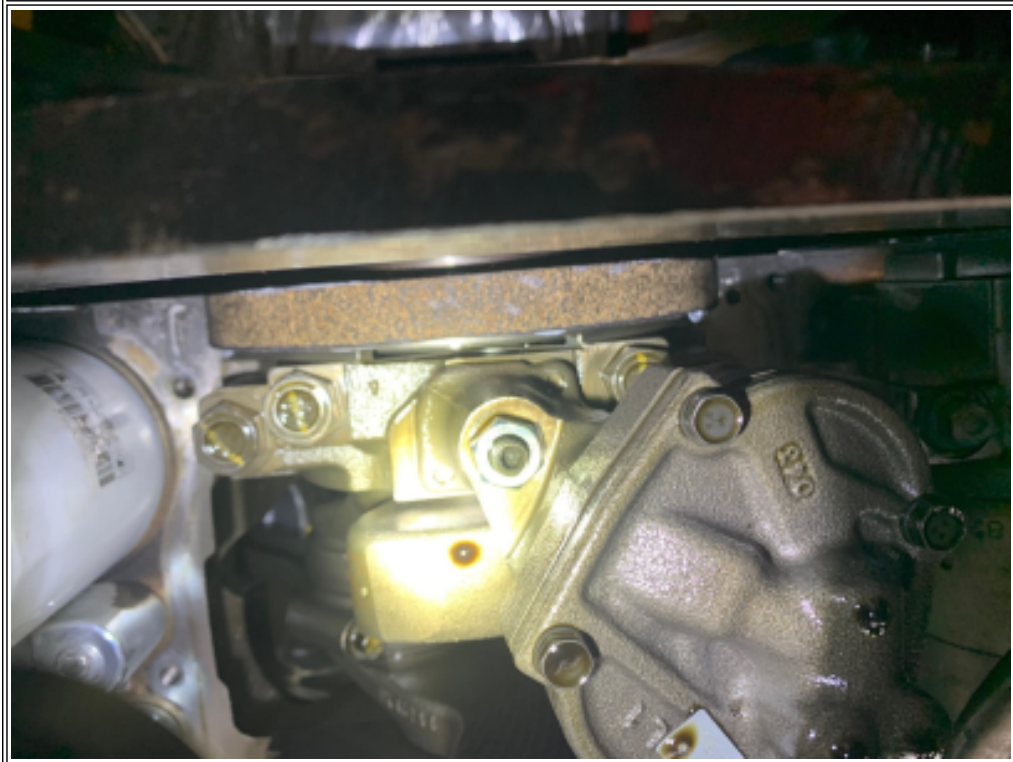
Figure 4: Cork installed with RTV on the rear main bearing cap

5. Remove oil pan.
6. Using the measurement from step 4, determine which thickness gasket is needed. (1/8-in or 1/16-in.)
  1. Cut a strip of 1/8in or 1/16in cork gasket that fits along the rear main cap (**Figure 4**)

2. Apply a Navistar-approved RTV to both sides of the cork gasket, then allow the RTV to become slightly tacky before installing it.
7. Apply RTV to the corners of the engine oil pan and rear main cap mating surfaces. (See service manual for application locations.)
