| GROUP | MODEL |
|---|---|
| Voluntary Service Campaign | 2024-2026MY EV6 (CV, CVa) |
| SC373 | August 2026 |

### 3-WAY COOLANT VALVE REPLACEMENT (SC373)

This bulletin provides information to replace the 3-way coolant valve. In addition, inspect the 3-way coolant valve harness connector for corrosion, and if necessary, replace the harness connector on certain 2024-2026MY EV6 (CV, CVa) vehicles produced from August 07, 2023 through June 18, 2026. The 3-way coolant valve in the subject vehicles may become damaged and result in a coolant leak. As a result, corrosion may also be present in the 3-way coolant valve harness connector. An inoperative 3-way coolant valve or corrosion within the harness connector may result in reduced Heating, Ventilation, and Air Conditioning (HVAC) performance and/or in the illumination of the "Check electric vehicle system" or "Refill Coolant" warning messages in the instrument cluster. Follow the procedure outlined in this publication to replace the 3-way coolant valve with a new one. In addition, inspect the 3-way coolant valve harness connector for corrosion and, if necessary, replace the harness connector on the applicable vehicle. Before conductin

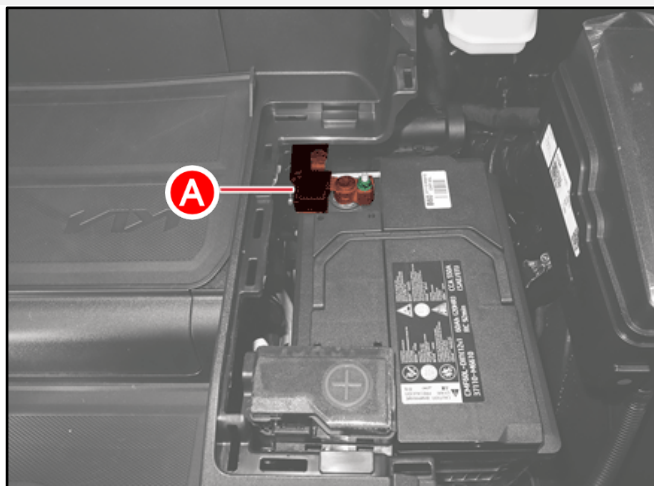
1. Disconnect the auxiliary 12V battery negative (-) terminal (A).

**Tightening torque for nut (A):**  
5.8 - 7.2 lb.ft (7.8 - 9.8 N.m)

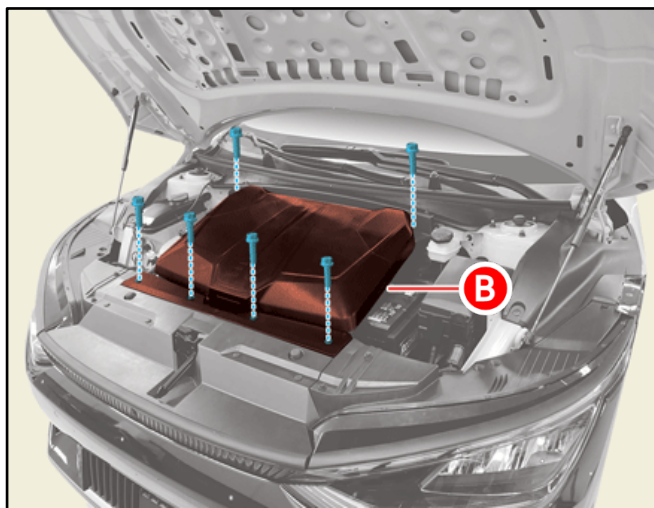
2. Remove the front trunk (B) by referring to "Body (Interior and Exterior) → Body Side Molding → Front Trunk → Removal and Installation" in the applicable Shop Manual on KGIS.

**Tightening torque for bolts:**  
3.5 - 5.3 lb.ft (4.8 - 7.2 N.m)

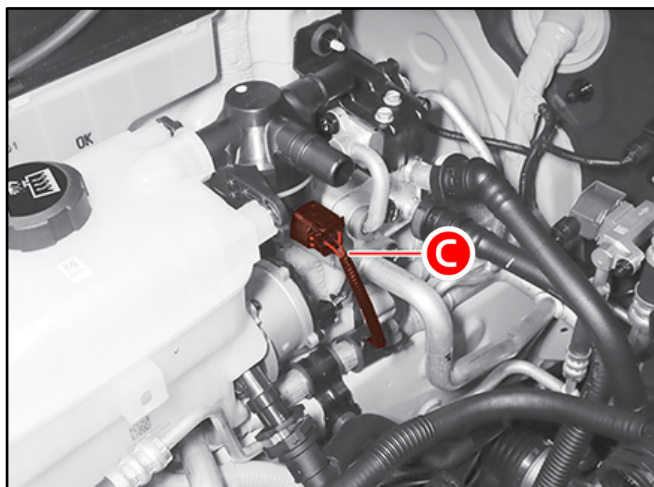
- 3a. Locate and disconnect the 3-way coolant valve connector (C).

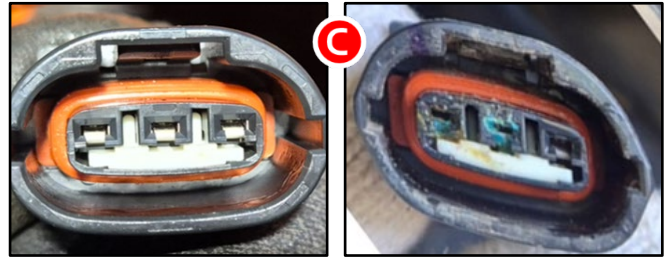
3b. Inspect the 3-way coolant valve connector (C) for corrosion.

OK

NG

- **Corrosion is NOT present (OK)**, then proceed to the 'Replacement Procedure: (3-Way Coolant Valve)' on page 7.
- **Corrosion IS present (NG)**, using KDS Tablet **Warranty Claim Attachment Tab**, take a photo of the NG condition then proceed to step 4a.
