# Transmission Oil Cooler Lines Rubbing

- GEN 5 Cascadia WST 47x 49x

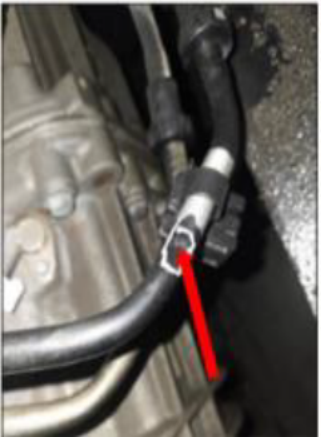
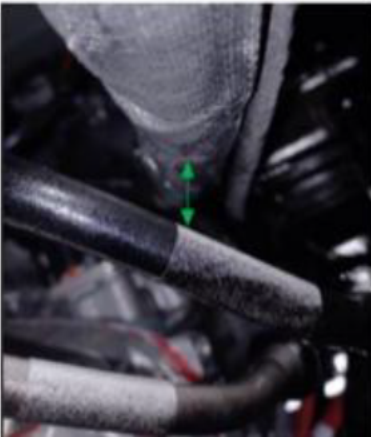
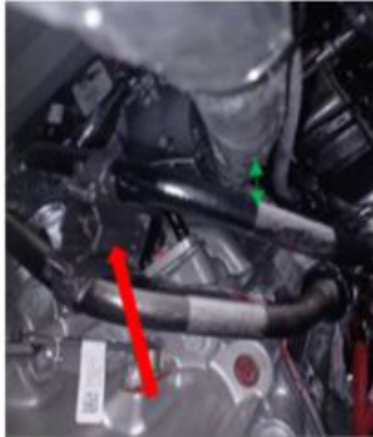
## VISUALIZATION:

- Nylon Transmission oil cooler lines if not festooned correct can rub & chafe & eventually leak at low mileage. If caught early, lines are replaced. If not caught quickly the entire transmission often must be replaced.

- Plant work instruction was updated to address the routing requirements, Stating not to deviate or add any extra ties or clamps.
- Re-Training at the plants per the updated work instruction implemented & on going.

- LTCA Production - Plant Updates – Add Transmission Cooler lines to Standard Routing and Clipping Guidelines
- Verification 30/60/90 Day process audits to be complete by 8/15/26
