# Service Bulletin

Bulletin No.: PIT6533B

**Subject: False / Ghost Left or Right Side Object Detection Alerts**

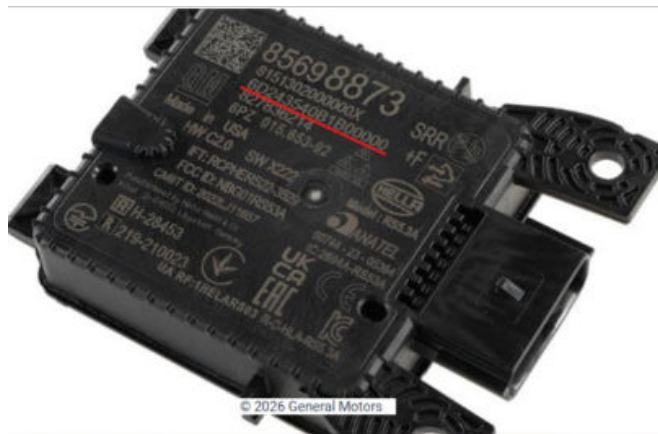
7190398

Create a TAC case and provide the Trace Data Identifier (shown below) or add a picture of the Short Range Radar to the case so TAC can verify if the Short Range Radar the dealer suspects is causing the concern is affected by this software anomaly.

At this time, Service Stock is also affected so it is suggested to provide the replacement Short Range Radar Trace Data Identifier to TAC to confirm the replacement part is not an affected part prior to installing and programming the radar.

If TAC confirms the Short Range Radar is one of the affected parts, the Short Range Radar will need to be replaced using latest part number listed in GM Parts Connect.

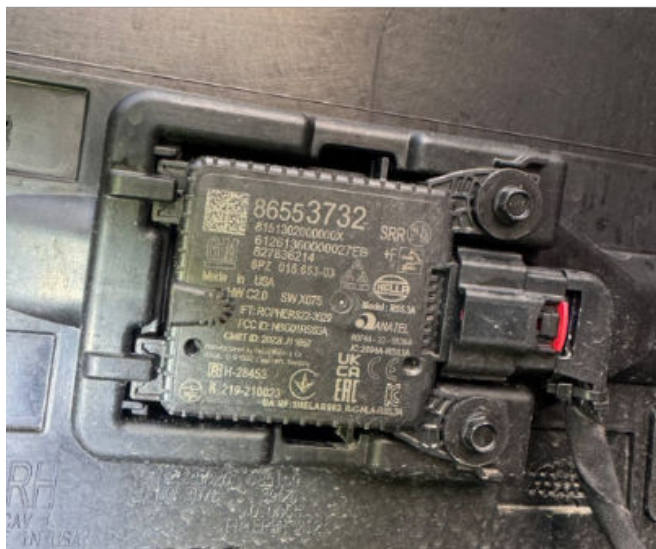
7206295

Ensure the Short Range Radar is installed in the correct orientation. Each radar contains an emitting side and a non-emitting side. The emitting side is free of any part number labels or identification stickers and should be facing outward from the vehicle. When properly installed, the non-emitting side, which contains the Part Number and Trace ID information, should be visible without removing the radar from the fascia (faces inward towards the vehicle,) as illustrated below.

**Note:** Prior to replacing a Short Range Radar, confirm that the radar installed in each location matches the specified part number for that position. The radars are visually identical but are assigned different part numbers and may have been swapped during a previous repair.
