## Technical Service Bulletin

### 00-26-01 - Differences Between Fluid Leakage and Seepage

Determining fluid leakage versus seepage.

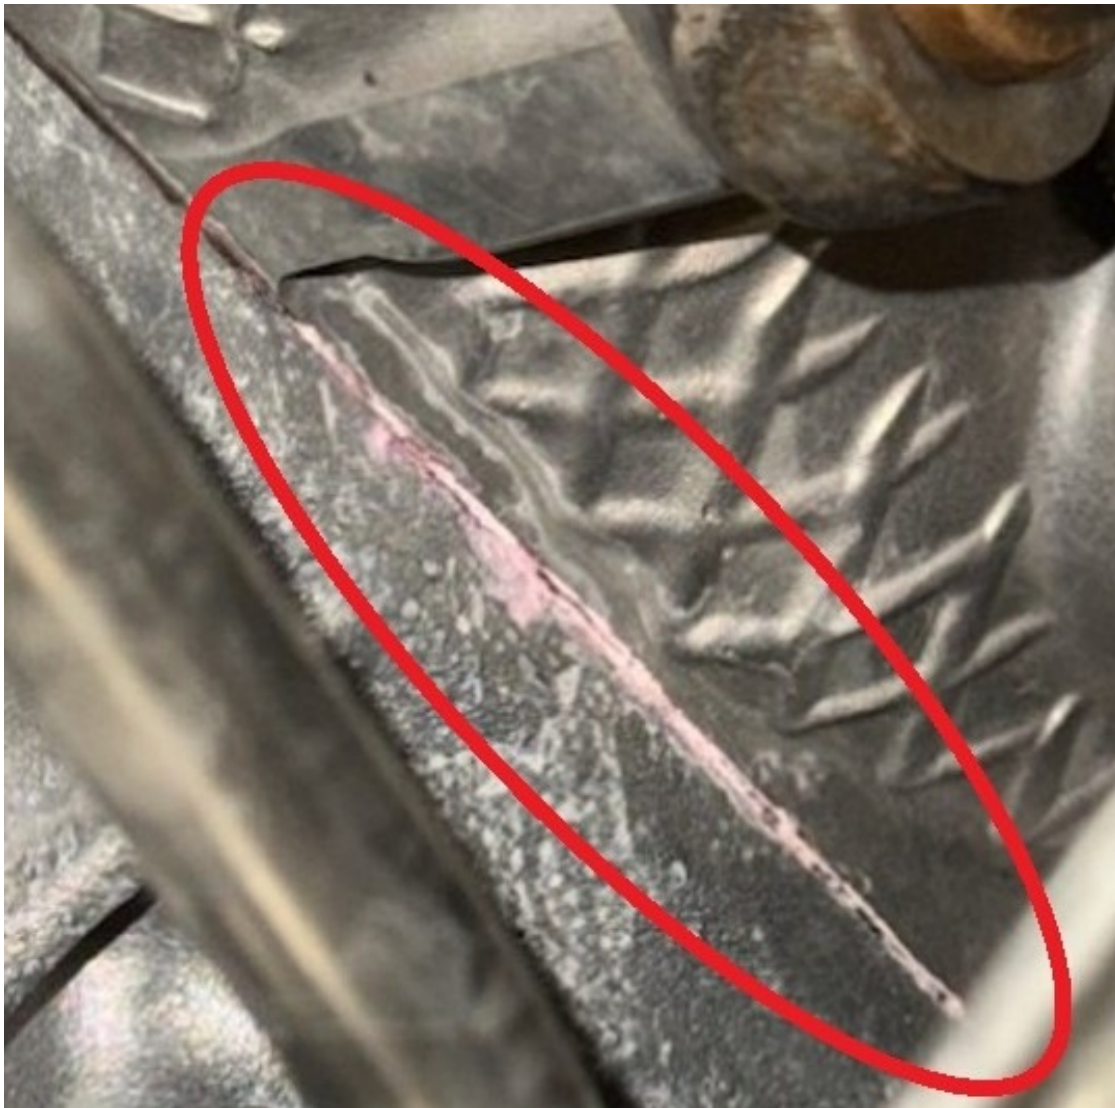
**Figure 1:**

**Seepage** is the minor migration of fluid through assembled components or sealing interfaces that results in surface wetness or light discoloration, but does not produce fluid droplets, does not drip, and does not lead to measurable fluid loss over time. The area often has a darker or damp appearance compared to the rest of the part and may attract dust or dirt over time.

**Seepage - Figures 1-7:**

- If fluid seepage is observed, document the condition and reinspect at the next scheduled service interval. Seepage is a normal condition, and no repair is required unless active leakage is present.

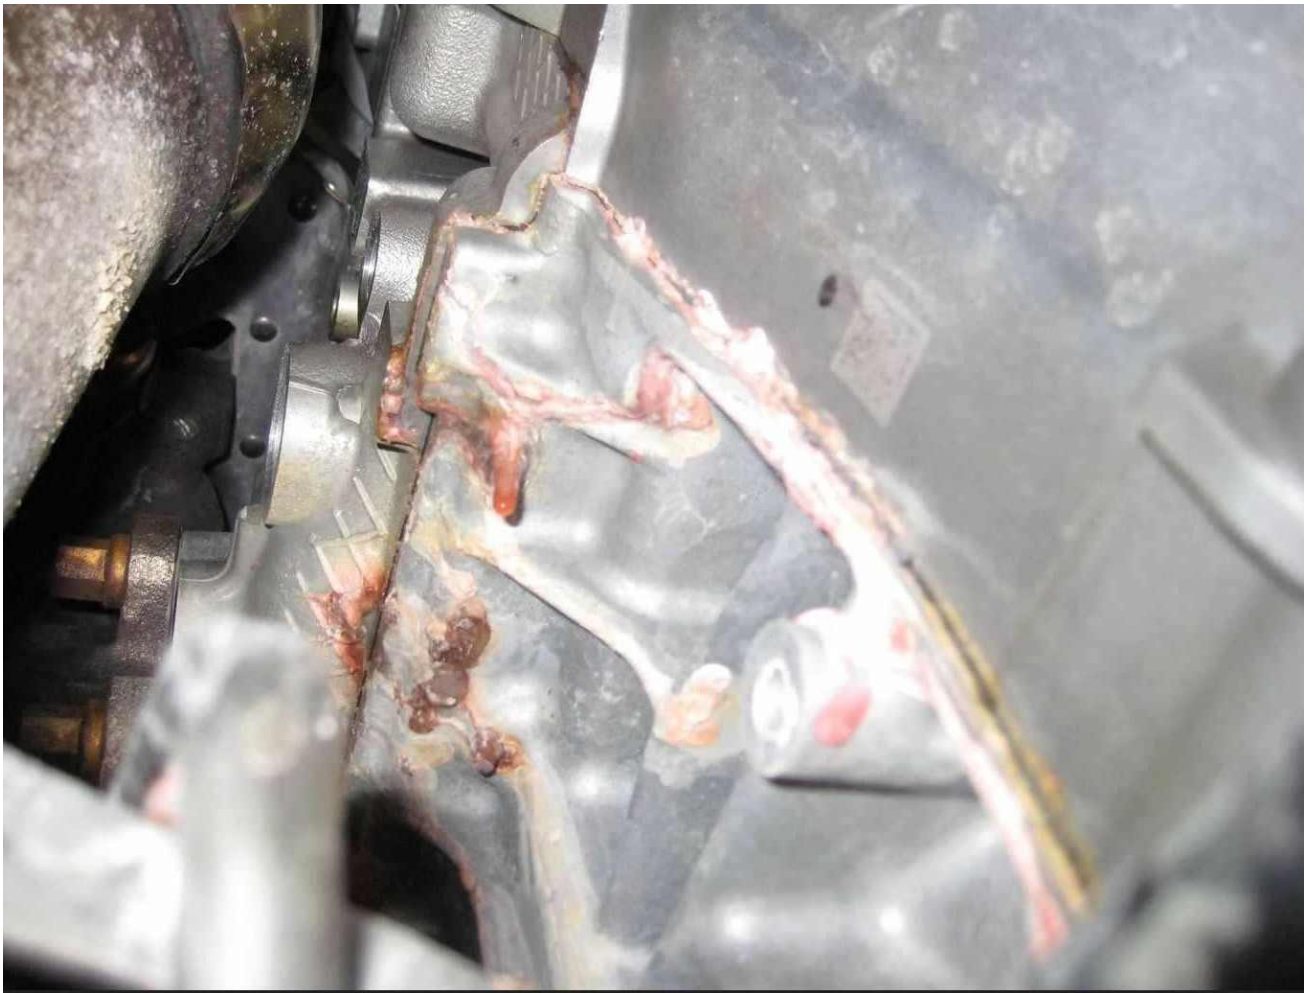
Figure 8:

**Leakage** is the unintended release of fluid from a component or system that results in droplet formation, dripping, or active fluid flow, and may cause measurable fluid loss, contamination of adjacent components, or functional concerns.

Leakage - Figures 8-12:

- If fluid leakage is observed (active dripping, droplet formation, or puddling), diagnose the source and perform the necessary repair according to repair manual procedures. Verify repair effectiveness after completion.
