## Technical Service Bulletin

Transaction No.: 2070207/15

48-23-01 - Travel Assist Currently Not Available

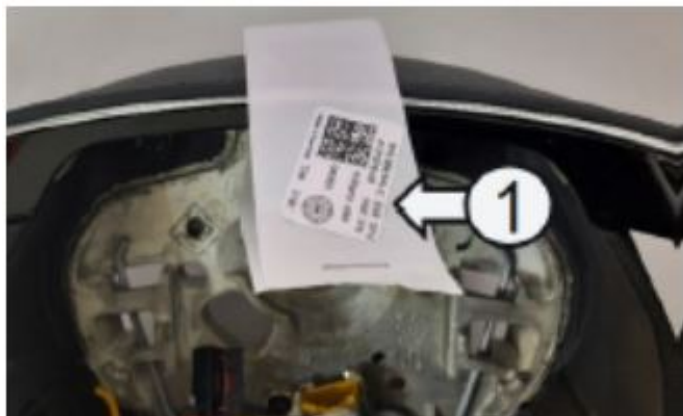
**Figure1:** New Label/Sticker

- Remove the steering wheel according to the repair manual. See Repair Group 48 in Elsa.
- Remove multifunction button set and transfer to new steering wheel according to the repair manual.
- The new steering wheel will have the supplied label/sticker (see figure 1) that will need to be applied to the trim panel on multifunction button set, (see figure 2).

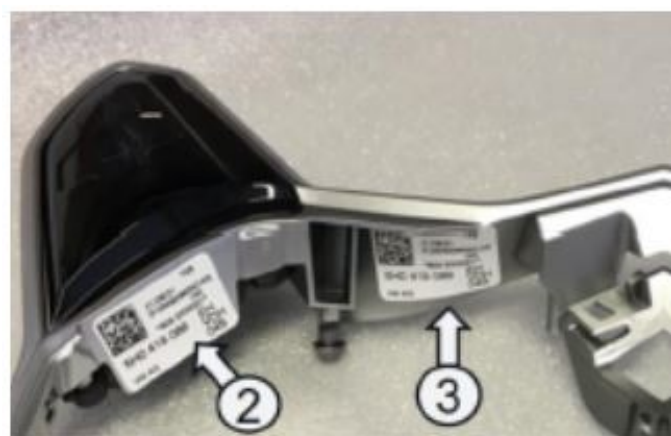
**Figure 2.**

The old label (see Figure 2) must not be covered up.

Position of old (2) new (3) label on trim panel.
