## Technical Service Bulletin

Transaction No.: **2068629/3**

46 Suspension/Brake System : Rattling/grinding noises from front end/front brake system

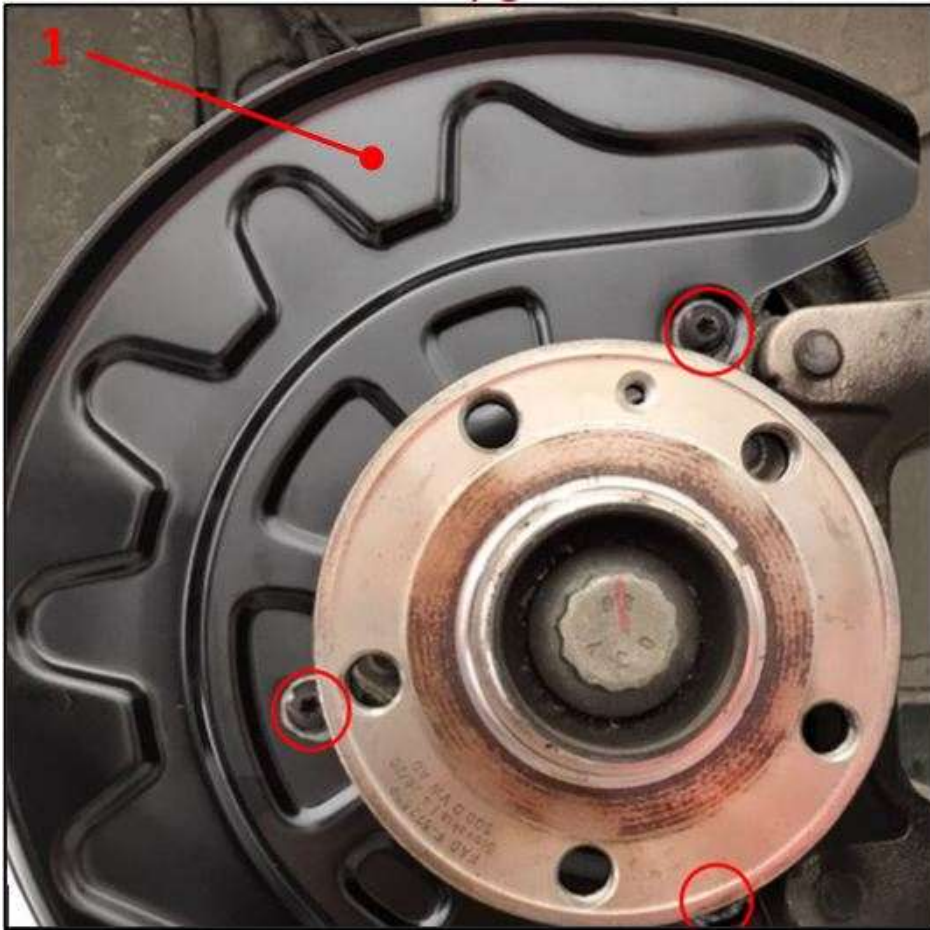
**Figure 1.** *Splash plate for brake disc with contact surfaces of securing bolts.*

1. Remove both front wheels.
2. Remove front brake calipers/brake carriers/brake discs.
3. Check both brake shields for front brake discs (Figure 1, number 1). Brake shields should be secured and seated correctly.
4. If necessary: Replace splash plate(s) for brake disc(s).
5. Install front brake calipers/brake carriers/brake discs.
6. Install front wheels.

**To protect the new brake shields for brake discs against corrosion at the mounting points (Figure 1, red circles), wax must be applied all the way around the contact surfaces of the securing bolts (Figure 2) before they are installed.**

Use cavity preservative sealant (part number: D 329 215 M1) for this purpose, applying it in brief sprays.
