Horizontal Stripes in Front Control Panel/Central Display (PCM) (65/26)

Model Line: **911 (992)**  
**Taycan (Y1A/Y1B/Y1C)**  
**Panamera (YAA/YAB)**  
**Cayenne (9YA/9YB)**

Model Year: **2026**

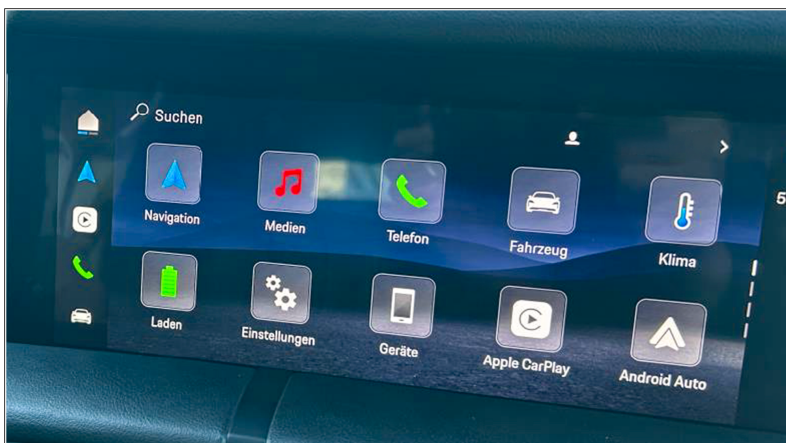
Normal mode

Action: The horizontal stripes -1- are part of the background and differ depending on the selected driving mode (Range, Sport, Sport Plus mode). These are **to be assessed as normal** and do **not constitute a display error**. In the event of customer complaints, the following pictures should provide support as a reference for comparison and for explaining the situation to the customer.
