# RCA-78-26-004-1: Install Front Fascia Camera Hose Check Valve

| Document Type | Customer Satisfaction Campaign Bulletin |
| Affected Model(s) | R1T, R1S |
| Model Year(s) | 2025-2026 |

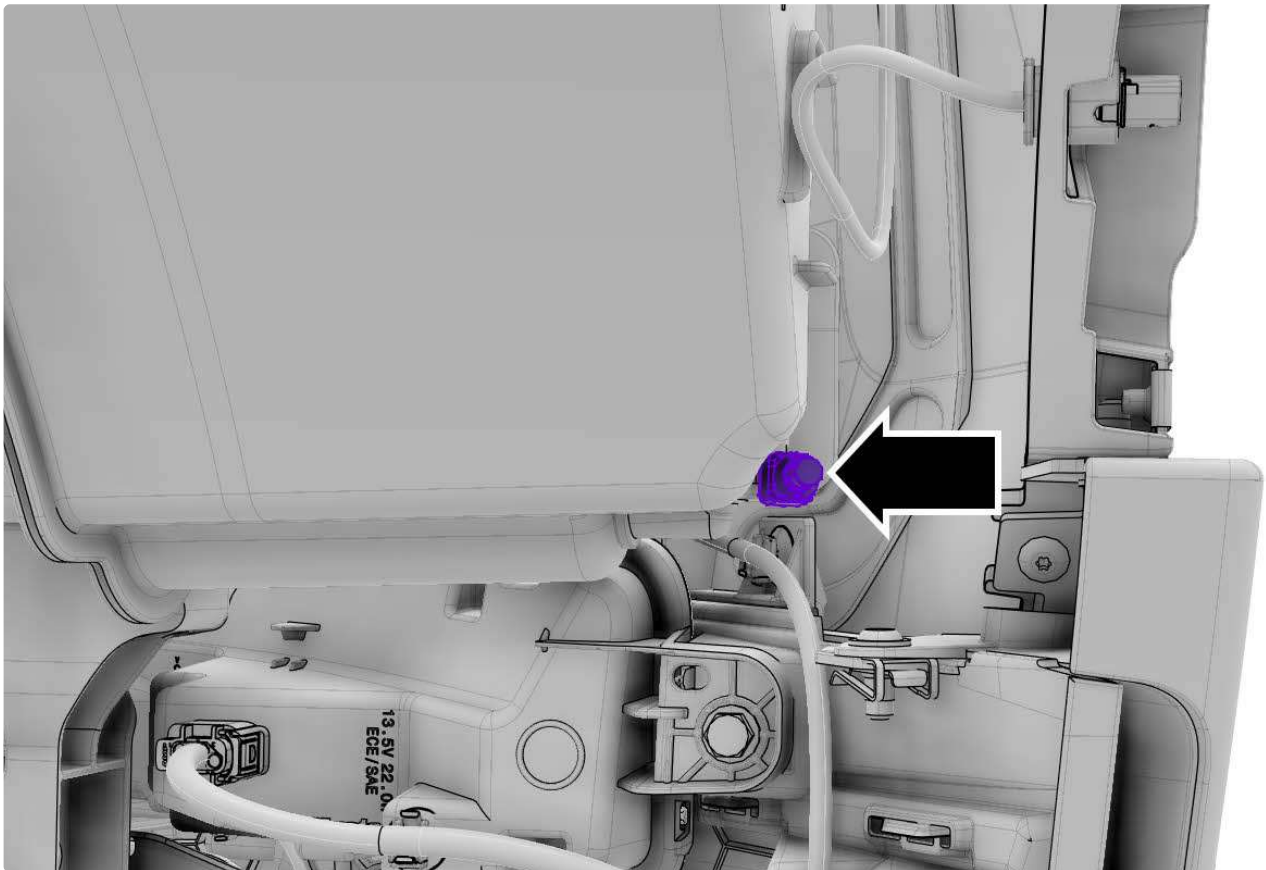
4. Attach the special tool(s).

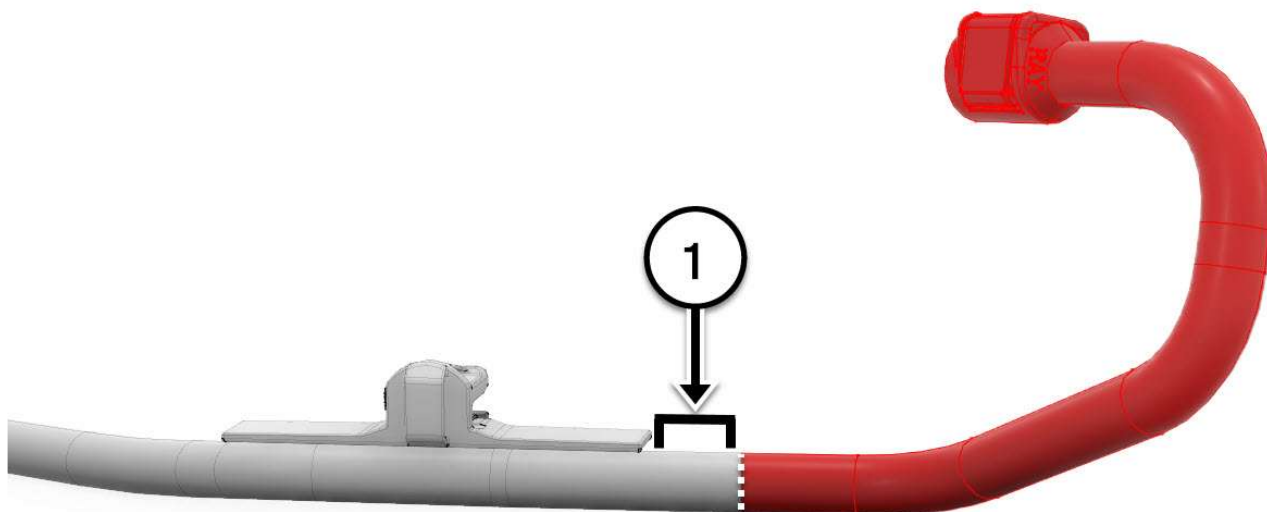
5. Cut in the location(s) shown.

Shown with components removed for clarity.

| 1 | 25 mm |

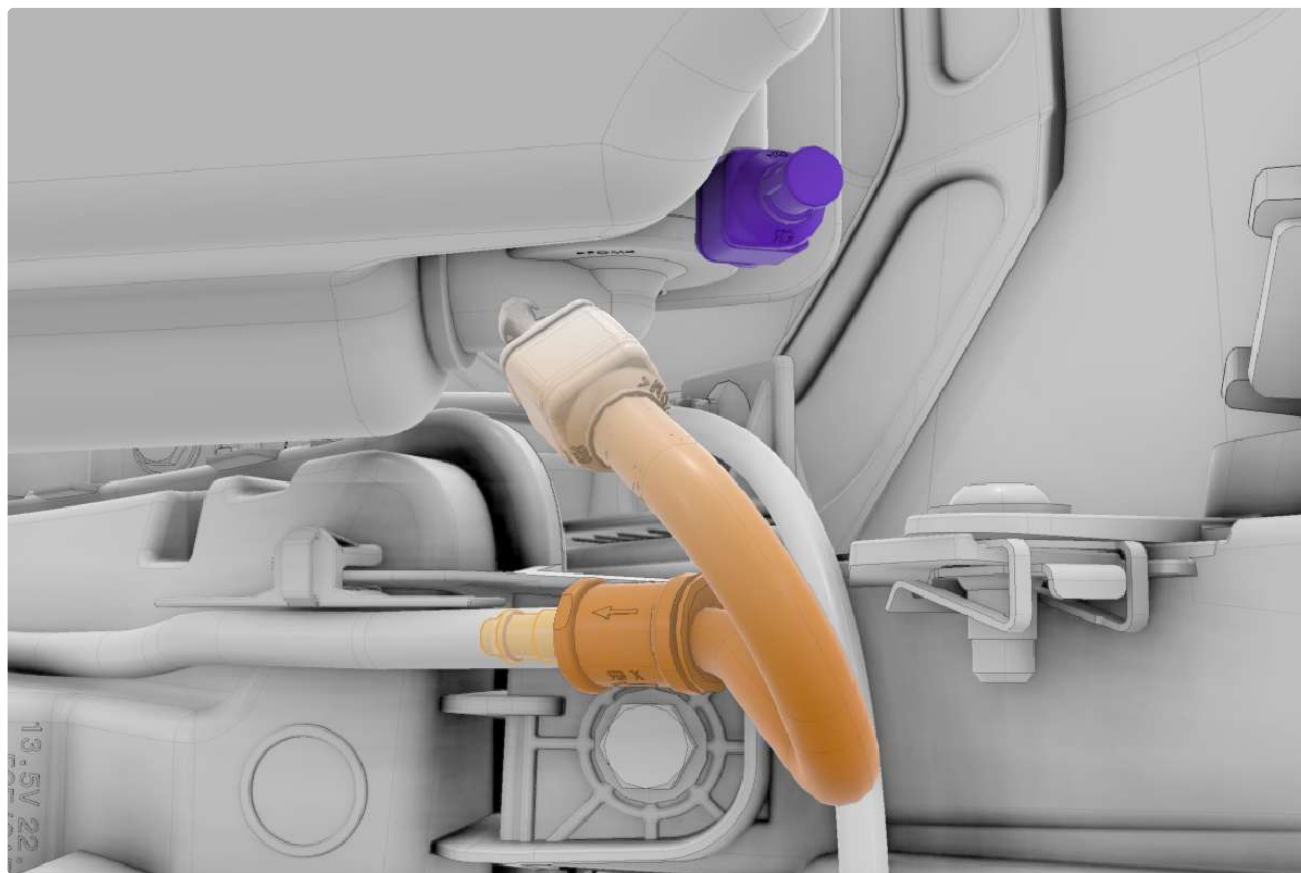
6. Connect:

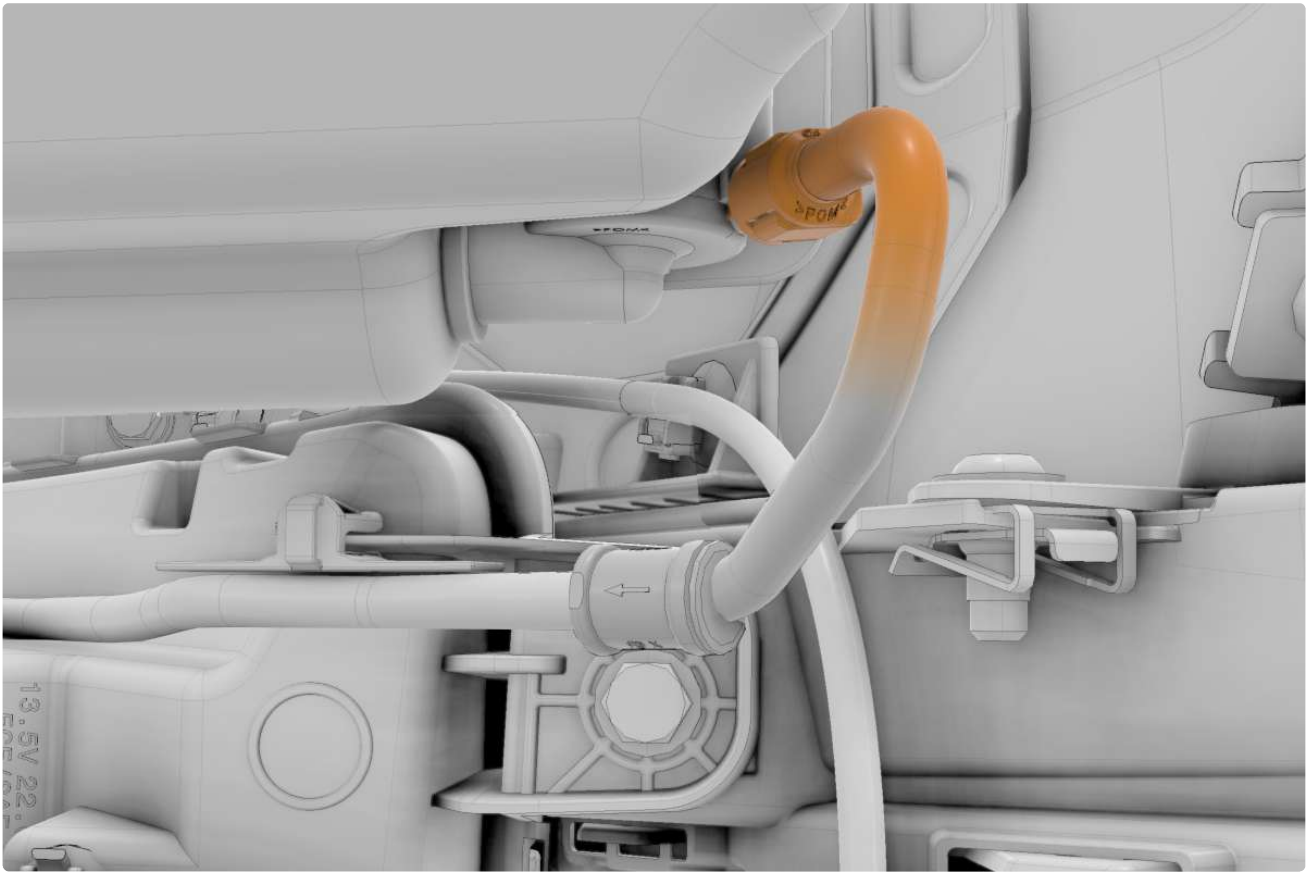
8. Connect:
