### **EMISSION NONCOMPLIANCE RECALL 26TF01**

**Certain 2018 – 2024 Model Year Camry HV and 2019-2022 Avalon HV  
Fuel Cap Negative Pressure Valve & Fuel Filler Dust Intrusion**

### **Replacement of Both Fuel Cap & Fuel Filler Shield**

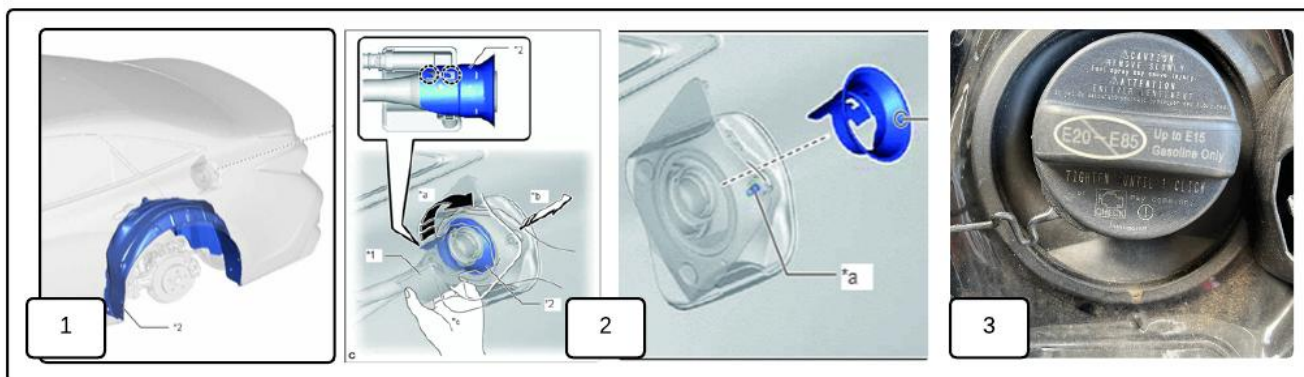
### **VI. COMPONENTS**

| 1 | Rear Wheelhouse Liner |
| 2 | Filler Pipe Protector |
| 3 | Fuel cap Assembly |

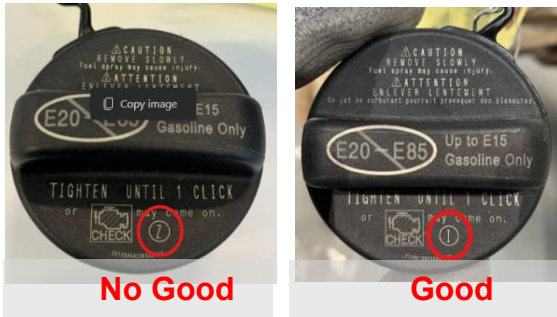
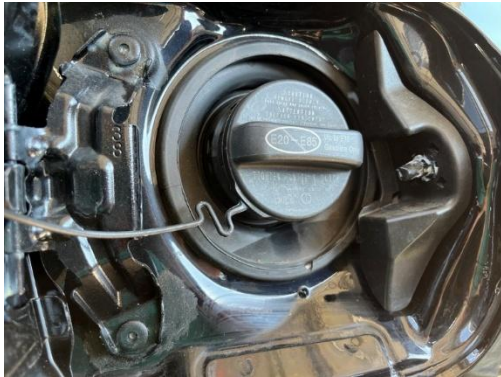
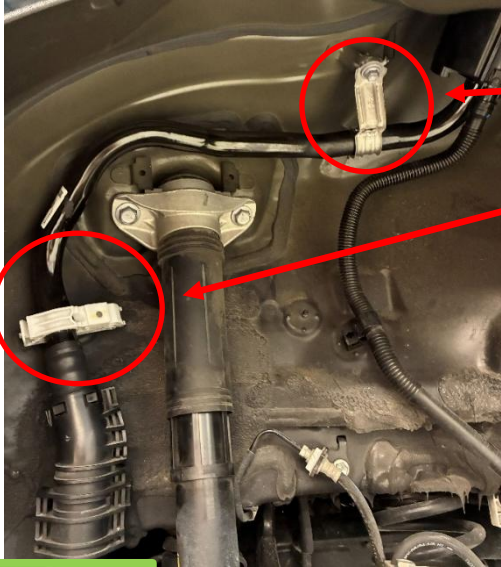
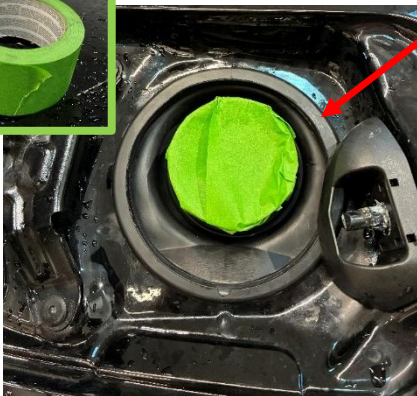
1. Inspect Fuel Cap to confirm good or no good.
  - a. ② = No Good, must be replaced
  - b. ① = Good, do not replace
2. Clean Fuel Cap and Fuel Filler Compartment.
3. Remove Fuel Filler Cap
4. Remove fuel cap tether from fuel door
  - a. Mark removed Fuel Cap to prevent reuse.
5. Remove Rear LH Wheel
6. Remove Rear Wheelhouse Liner LH.
7. Remove 12mm holding bolt on fuel filler pipe
8. Release secure holding clip on Fuel Filler Pipe
9. Cover opening with tape to prevent contamination of fuel line.
  - a. **Note: be careful not to hit or damage the filler pipe retainer surface, as damage may cause fuel cap gasket not to seal properly.**

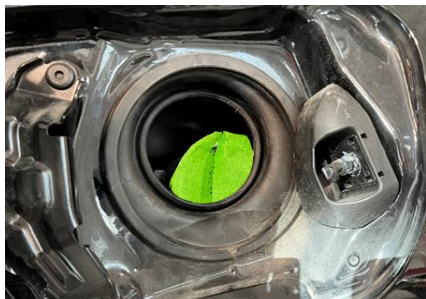
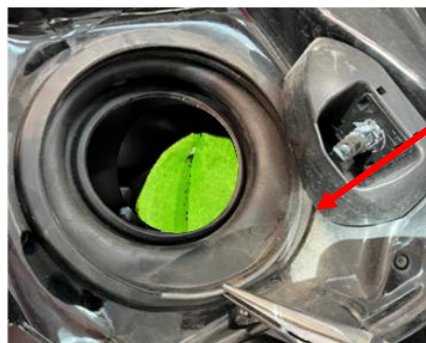
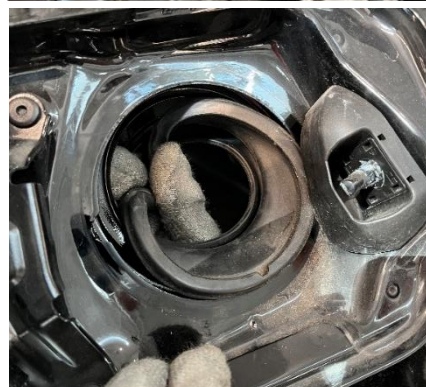
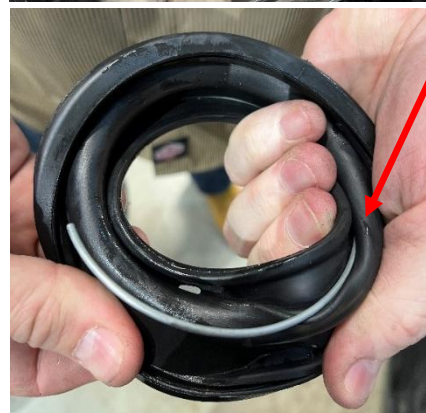
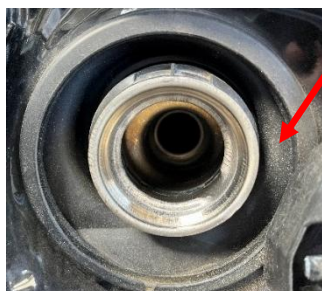
10. Pull Fuel Filler Pipe from behind out of fuel compartment.

11. Remove metal ring from outer section of rubber shield

12. Pull rubber shield from behind to remove from fuel filler compartment

13. Remove metal ring from lower section of rubber shield.

14. Install lower metal ring in new rubber shield

15. Install new rubber shield in fuel filler compartment

16. Install metal ring in outer section of rubber shield

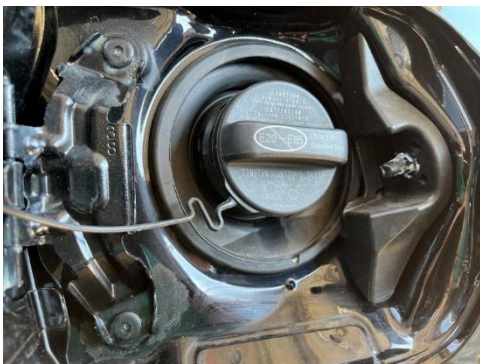
23. Clean the fuel cap area and filler neck seal surface before installing the new cap.
24. Replace fuel cap
  - a. Attach tether to fuel door.
25. Ensure cap is closed properly.
