## Technical Service Bulletin

**GROUP****CAMPAIGN****NUMBER****26-01-073G****DATE****SEPTEMBER 2026****MODEL(S)****G70 (IK)****SUBJECT:****BRAKE DISC SURFACE RUST – BURNISHING & MACHINING  
(LIMITED COVERAGE CAMPAIGN L17G)****\* IMPORTANT**

**Description:** Certain G70 (IK) vehicles may develop brake disc surface rust due to extended storage prior to delivery. This condition may affect braking smoothness or generate minor noise. This bulletin provides instructions to perform brake disc burnishing or machining on the affected front and/or rear brakes as necessary, to restore proper braking performance.

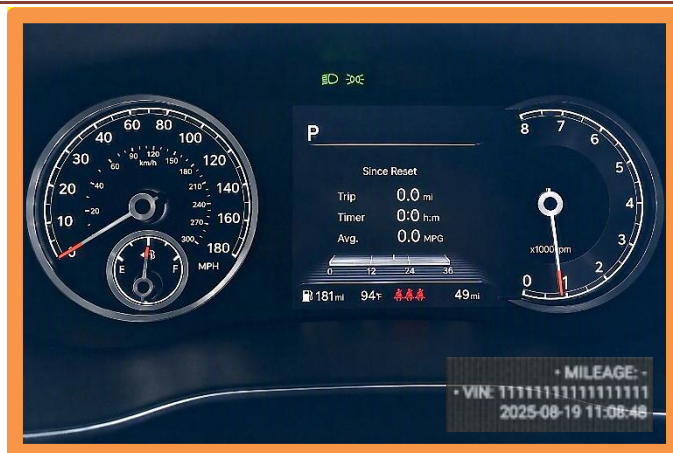
Using the STUI camera function, take a photo of the vehicle mileage as displayed on the instrument cluster.

**NOTE:** If the STUI camera function is **NOT** used, write the last 6 digits of the VIN and date of repair on a piece of paper to include in the photo.

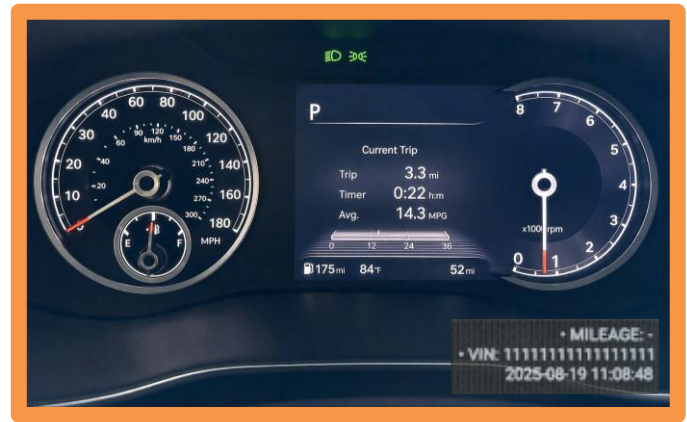
Using the STUI camera function, take a photo of the new vehicle mileage as displayed on the instrument cluster.

**NOTE:** If the STUI camera function is **NOT** used, write the last 6 digits of the VIN and date of repair on a piece of paper to include in the photo.

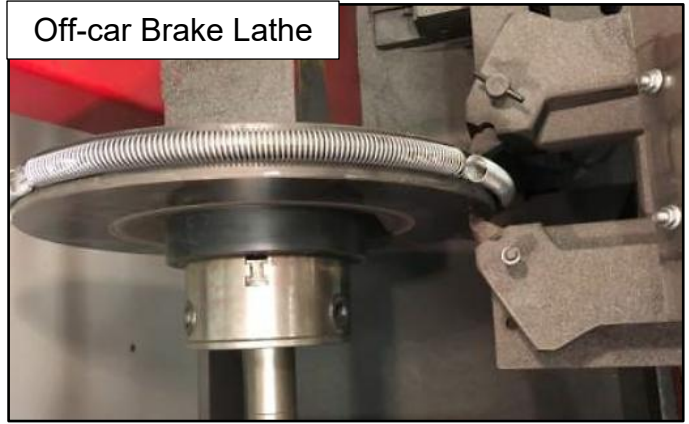
Off-car Brake Lathe

3. Resurface the front and rear brake discs using one of the methods below:
- Remove calipers and brake discs then use the off-car brake lathe
  - Remove calipers then use the on-car brake lathe (recommended)

- Cutting depth: **0.003–0.005 inch (0.08–0.13 mm)** per pass
- Maximum: **2** machining passes per side
- Minimum brake disc thickness:
  - Front: **28.0 mm (1.10 inch)**
  - Rear: **20.0 mm (0.79 inch)**
- If thickness is below specification, replace both brake discs on the affected axle and submit a separate warranty claim.

During a single resurfacing operation, a **MAXIMUM** of **2** cutting passes may be performed per rotor face: one light cut and one finish cut on both the inboard and outboard faces.
