## Technical Journal

| Front bumper - gap | | TJ 37553.1.0 | |

TJ Instruction VCC-522169-4

| <b>Title</b> | Cover bumper, repair | <b>Page</b> | 1 ( 4 ) |

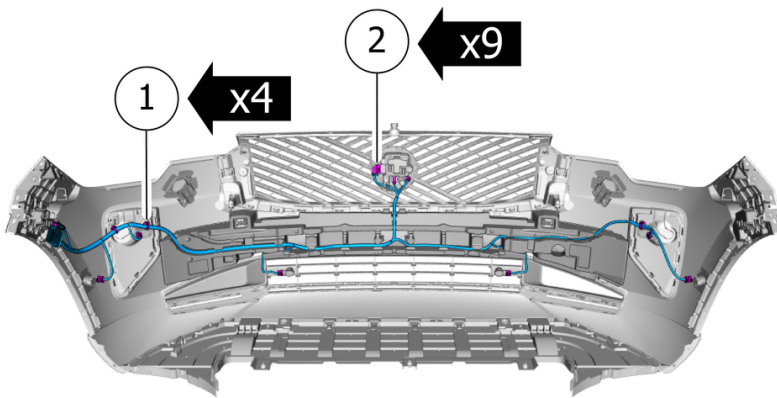
Remove the cable harness.

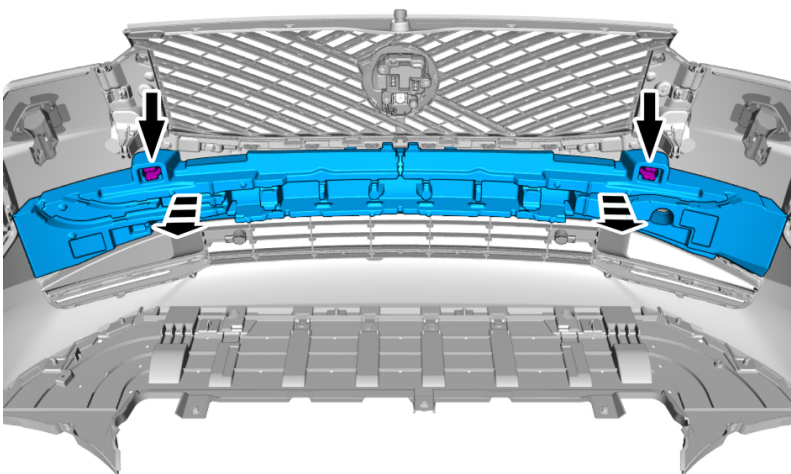
Release the catches.  
Remove the marked part.

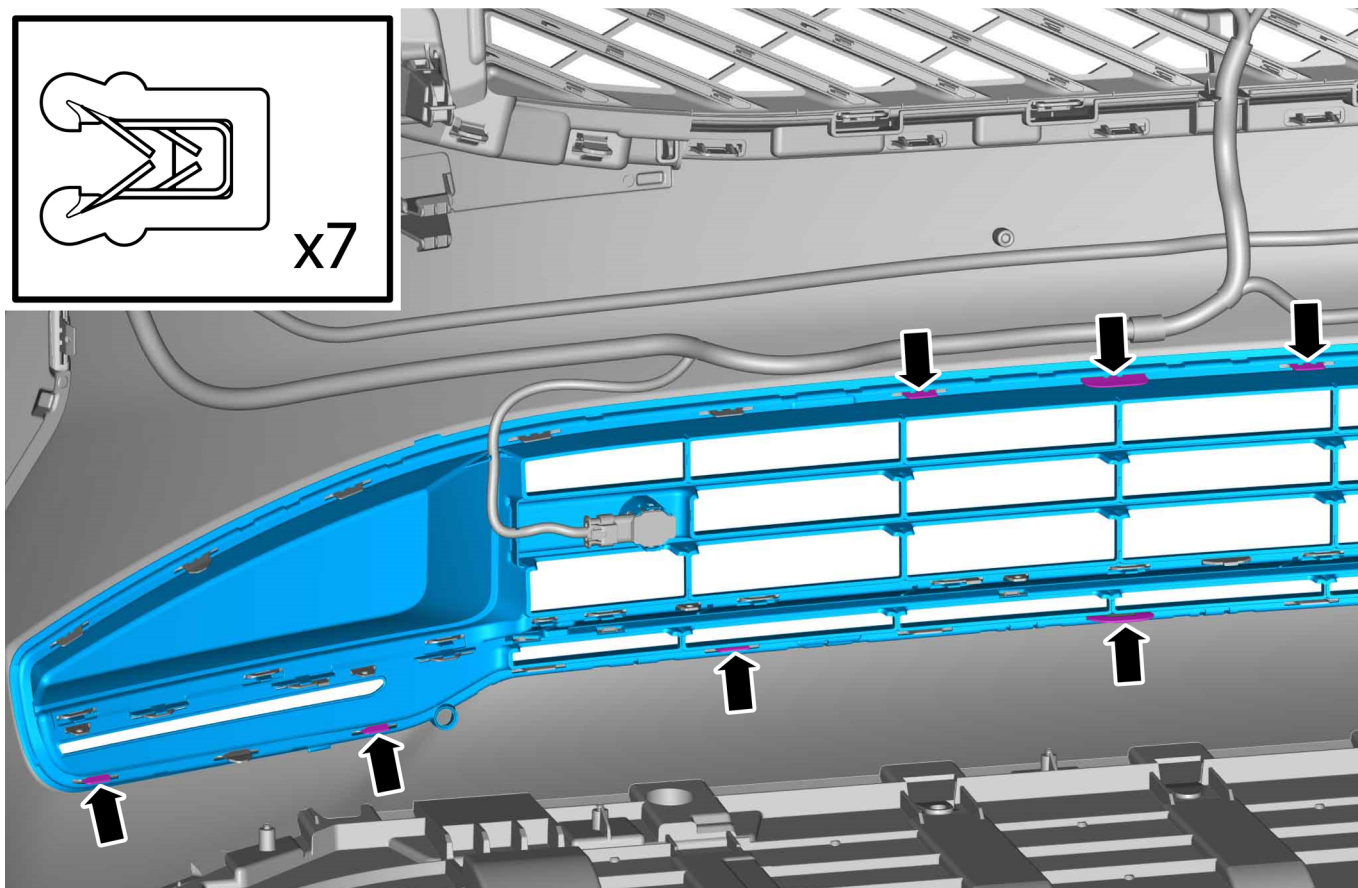
Use new clips.

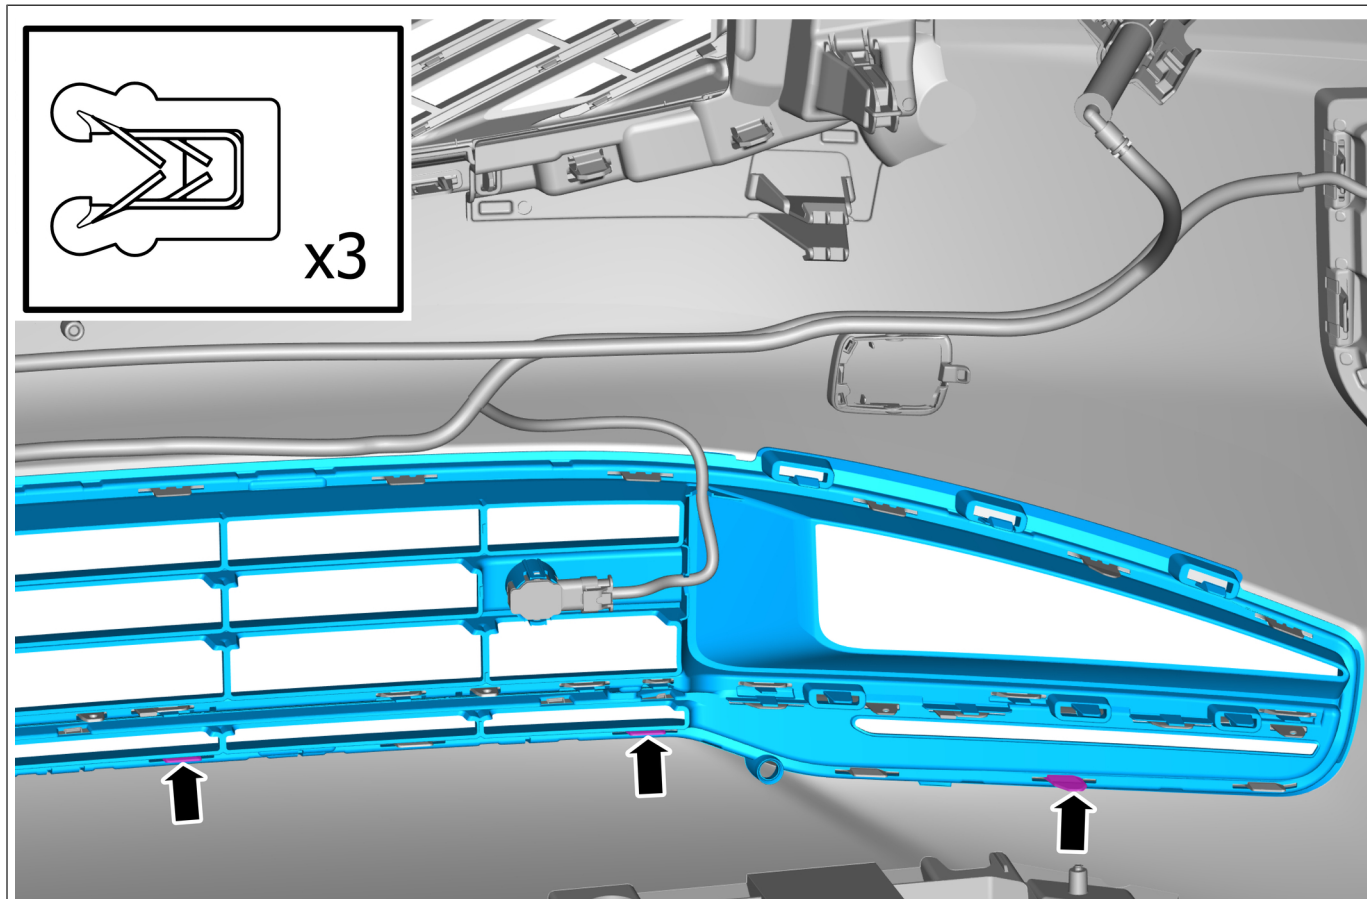
Use new clips.
