SERVICE BULLETIN

Reference number:	SB-01-1168	Issued: 11 December, 2018
Subject:	Boot-Lid Trim Clips	
Model(s):	Vanquish Zagato Volante and Vanquish Zagato Speedster	
VIN Range:	All Vanquish Zagato Volante vehicles to chassis no. K34421 All Vanquish Zagato Speedster vehicles to chassis no. K54470	
Applicable to:	All Dealers	
Distribute to:	After Sales Manager Executive Manager Service Manager Sales Manager	Warranty Staff Technician(s) Parts Staff

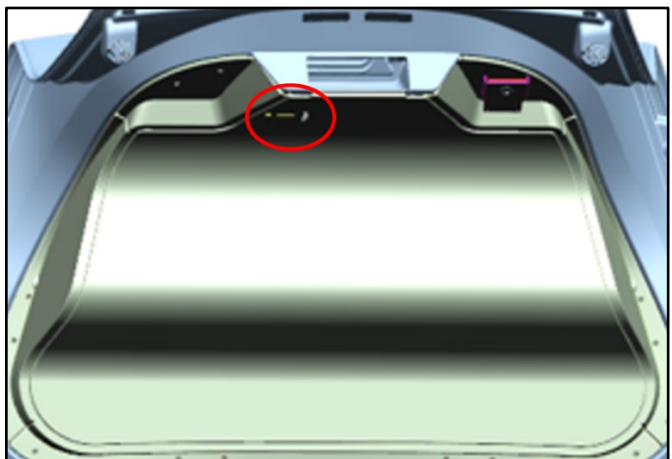
Figure 1

1. Open the boot lid.
2. Remove the emergency release handle for the boot lid (refer to Figure 1).

5. Remove the boot lid trim from the boot lid.
6. Replace the seven boot-lid trim clips with seven fir tree clips.
7. Move the boot lid trim into position in the boot lid.
8. Install the boot lid trim in the boot lid. Make sure the clips go in the center of the holes. Replace the clips if they become damaged.
9. Install the screw that attaches the boot lid trim and the pull-down-strap to the boot lid (refer to Figure 2 and Figure 3).
10. Tighten the screw to 8Nm.
11. Install the emergency release handle for the boot lid (refer to Figure 1).
12. Close the boot.

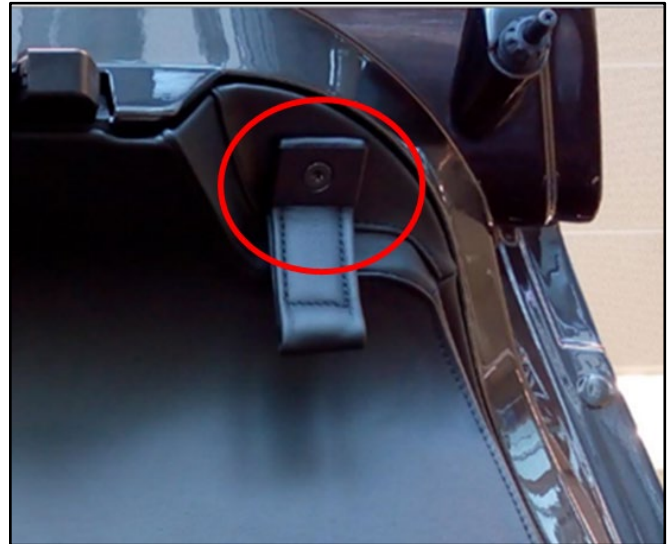
3. Remove the screw that attaches the boot lid trim and pull-down-strap to the boot lid (refer to Figure 2 and Figure 3).

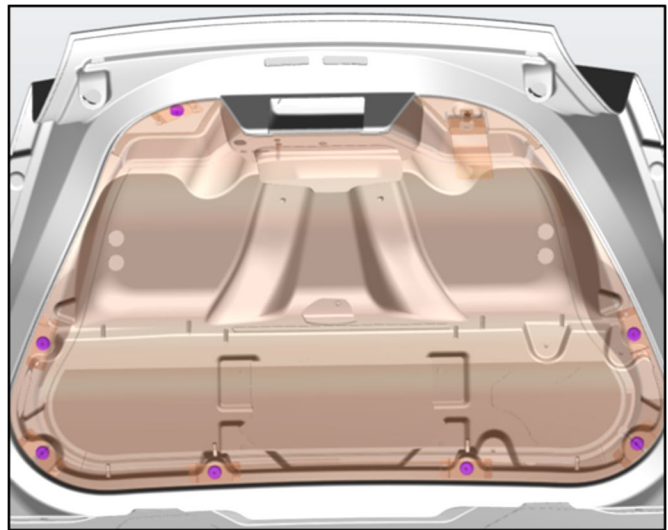
Figure 4

4. Use a trim removal tool to release the boot lid trim from the boot lid (refer to Figure 4).
