TRAFFIC CRASH REPORT

LOCAL REPORT # * 10-0363-91

REPORTING AGENCY * Ohio State Highway Patrol

DATE OF CRASH * 04/22/2008

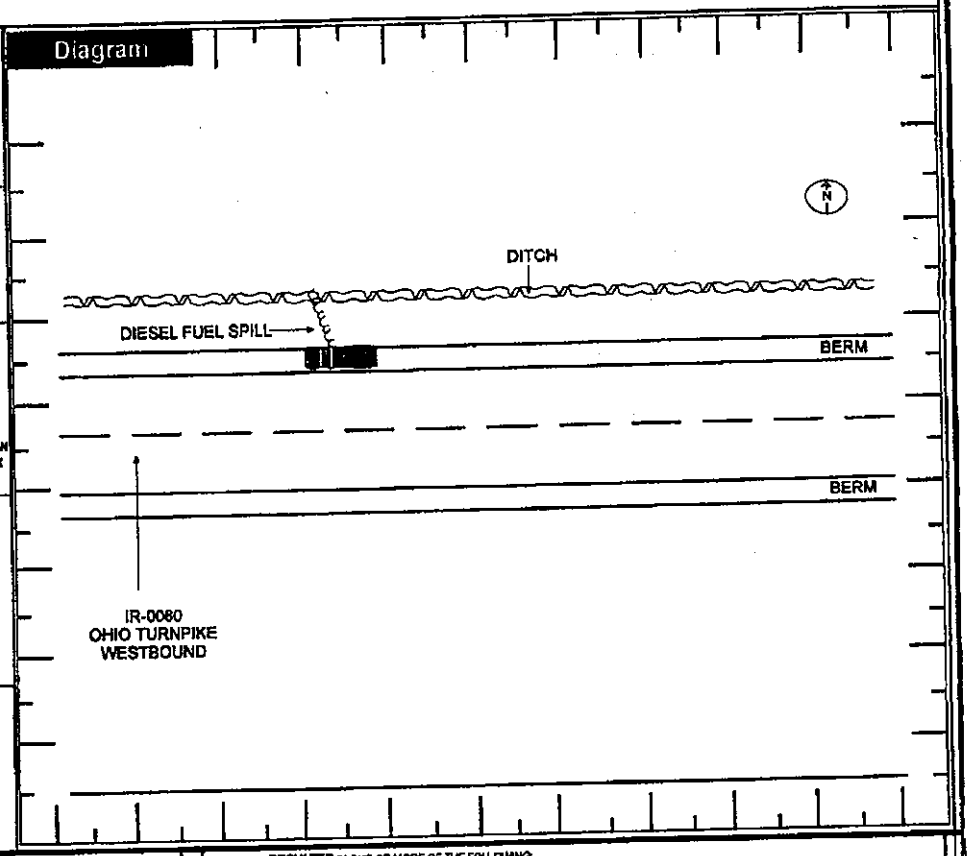
Diagram

Unit #1 was westbound on the Ohio Turnpike near milepost 184. The drive shaft from unit #1 dropped down and struck the fuel tank. The fuel tank became ruptured and spilled approximately 50 to 75 gallons of diesel fuel.
