Short Doubles 19

TRAFFIC CRASH REPORT

LOCAL REPORT #	CRASH SEVERITY	PRIVATE PROPERTY	HIT/SKIP	PHOTOS TAKEN	OH-2	OH-3	OH-1P	OTHER
10-0693-90	3 (1 FATAL, 3 PDO, 2 INJURY, 4 UNKNOWN)	'X' IF YES	1 (1 HIT/SKIP, 2 SOLVED, 3 UNSOLVED)	'X' IF YES: X	X	X

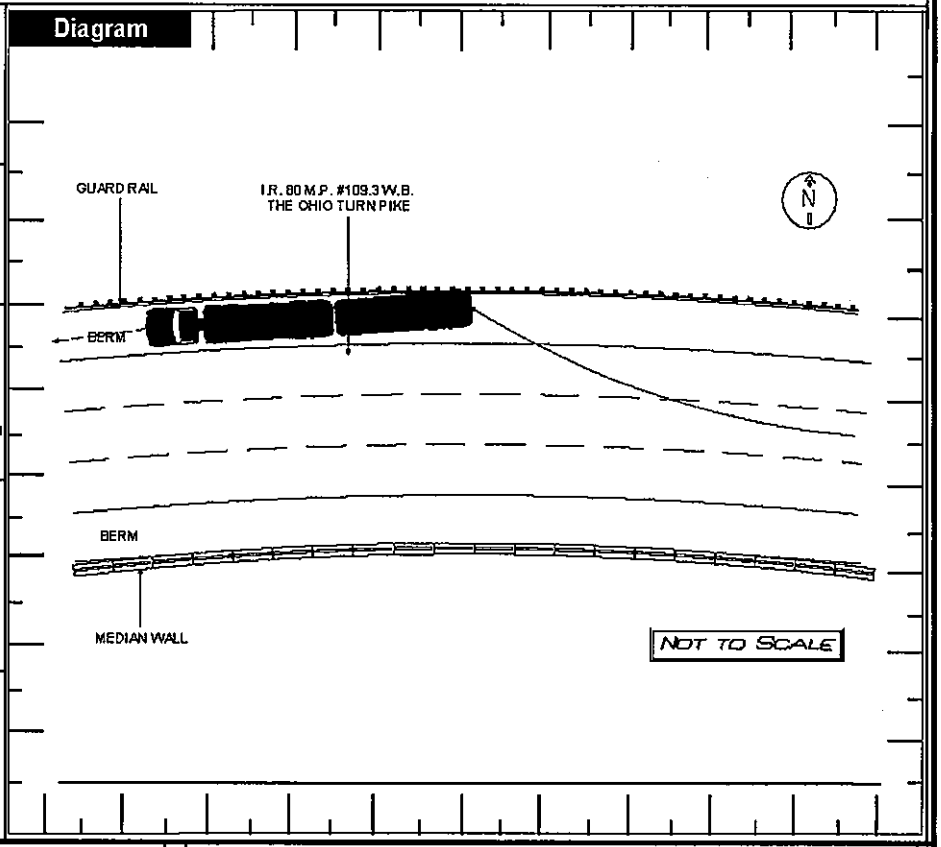
Diagram

Unit #1 was westbound on I.R. 80 at mile post #109.3. #1's air line for the trailer brakes disconnected causing the trailer brakes for the short double trailers to engage. #1's trailer brakes engaged causing the trailers tires to skid. #1's driver turned to the right to get off th roadway causing the rear trailer to strike the guard rail.

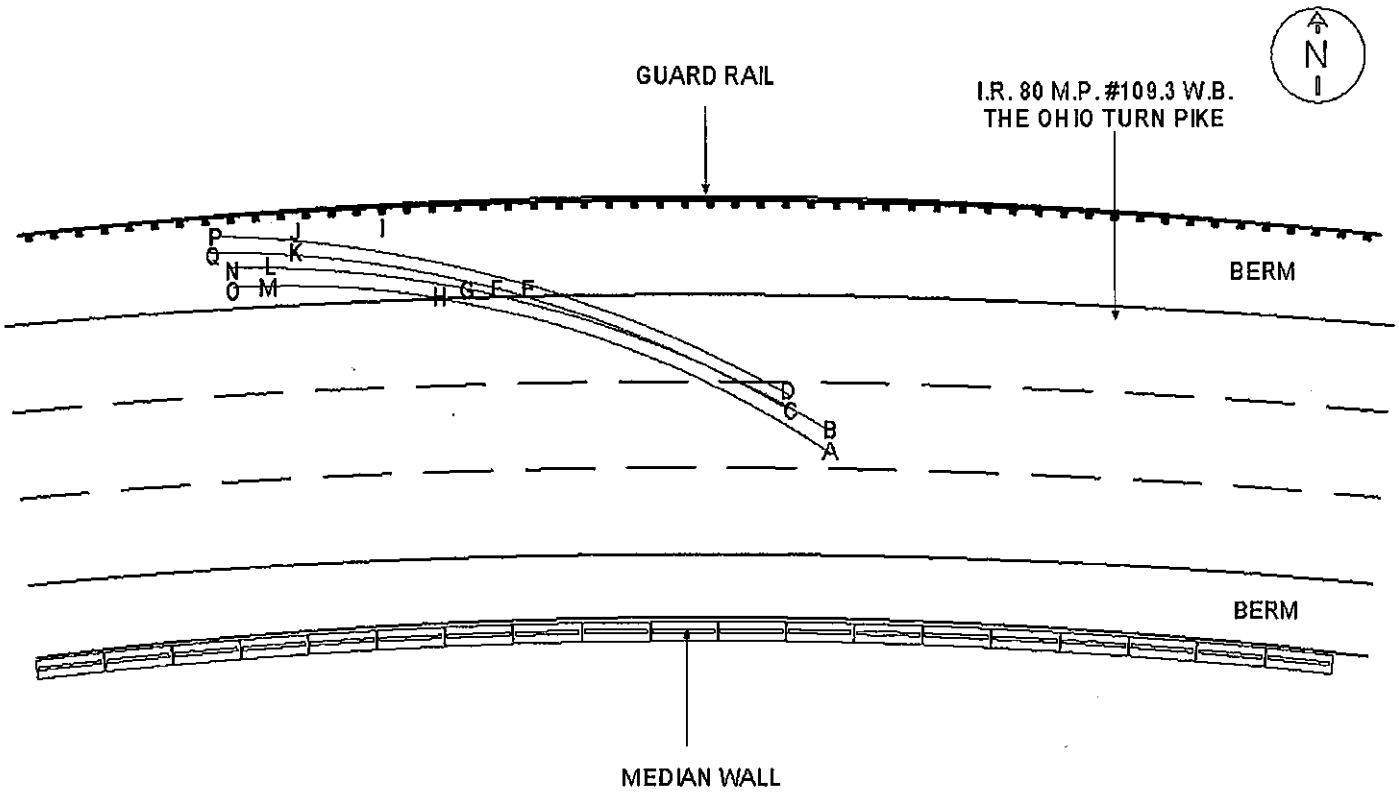
NOTE - FIELD SKETCH IS OF THE SKID MARKS ON THE ROADWAY FROM UNIT # , THE DRIVER OF UNIT # 1 MOVED THE VEHICLE OUT OF ROADWAY AND AWAY FROM THE SCENE PRIOR TO MY ARRIVAL.

AE	FE	DESCRIPTIONS
A	75.10E	14.8S	START OF LF OUTER TIRE SKID MARKS
B	76.1E	15.8S	START OF LF INNER TIRE SKID MARKS
C	105.3E	20.9S	START OF RT INNER TIRE SKID MARKS
D	106.7E	21.9S	START OF RT OUTER TIRE SKID MARKS
E	402.1E	0	RT OUTER TIRE SKID MARKS OFF ROADWAY
F	405.7E	0	RT INNER TIRE SKID MARKS OFF ROADWAY
G	435.2E	0	LF INNER TIRE SKID MARKS OFF ROADWAY
H	442.4E	0	LF OUTER TIRE SKID MARKS OFF ROADWAY
I	458.10N	11.5N	IMPACT MARK FORM UNIT #1 STRIKING GUAR RAIL
J	625.2E	10.5N	END OF RT OUTER TIRE SKID

K	625.2E	9.6N	END OF RT INNER TIRE SKID MARKS
L	646.10E	7.2N	END OF LF INNER TIRE SKID MARKS
M	646.9E	5.11N	END OF LF OUTER TIRE SKID MARKS
N	647.11E	0	END OF LF INNER TIRE SKID MARKS
O	648.1E	0	END OF LF OUTER TIRE SKID MARKS
P	650.7E	8.7N	END OF RT OUTER TIRE SKID MARKS
Q	651.5E	7.3N	END OF RT INNER TIRE SKID MARKS

RP = MILE POST # 109.3 W.B.
RP - PNT "O" = 13.0
PNT "O" = WHITE NORTH FOG LINE OF I.R. 80 W.B.
ROAD CONDITIONS = DRY,ASPHALT,CLEAN ROAD SURFACE
WEATHER CONDITIONS = DRY,CLEAR, 77 DEGREES, NO ADVERSE CONDITIONS
