REPORT NUMBER: 301R/305-CAL-12-009

SAFETY COMPLIANCE TESTING FOR FMVSS 301 & 305
Fuel System Integrity – Rear Impact
Electric Powered Vehicles: Electrolyte Spillage and Electrical Shock Protection

Toyota Motor Corporation
2012 Toyota Prius
Five Door Hatchback

NHTSA No: CC5104

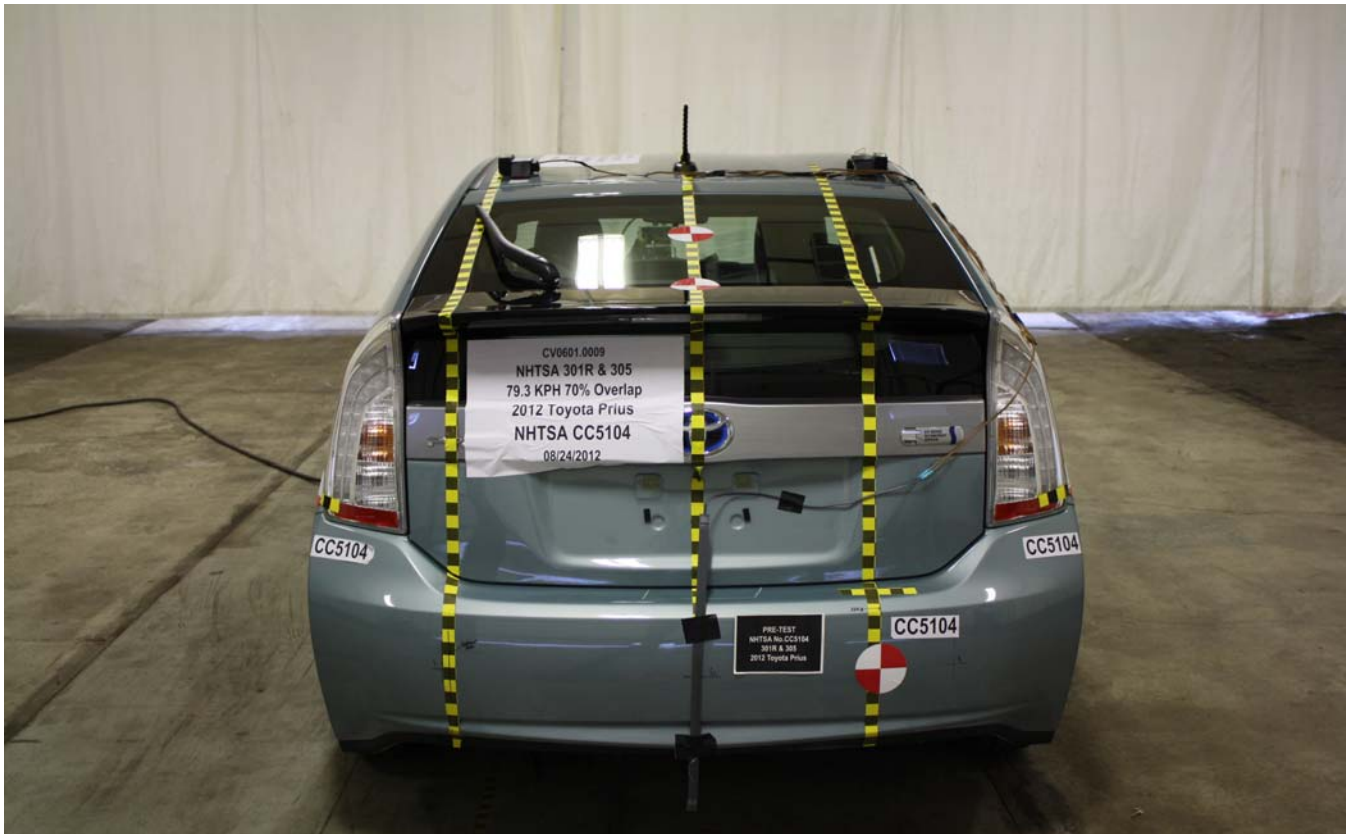
Figure A-19: Pre-Test Rear View

Critical Areas of Performance	Observations and Conclusions
Windshield Damage	None
Window Damage	None
Other Notable Effects	Rear windshield shattered
