GROUP	MODEL
	ELE	**2011-2013MY Sorento (XMa)**
	NUMBER	DATE
	179 (Rev 1, 05/13/2019	**April 2019**

TECHNICAL SERVICE BULLETIN

SUBJECT: HALOGEN LOW BEAM BULB CONNECTOR REPLACEMENT

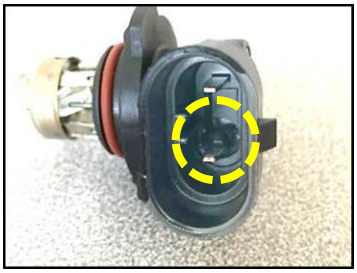
This TSB is part of Warranty Extension WTY012. Only the <u>affected</u> headlamp low beam connector should be replaced. If the low beam bulb is inoperative due to damage by the electrical connector from poor terminal contact, replace the low beam bulb after fulfilling the KVID requirement:

- **Remove the affected halogen low beam bulb from the headlamp and take one (1) KVID photo of the damaged bulb terminal(s) (Attachment Type: 'XX'). Ensure the affected area of the terminal is clearly visible in the photo.**

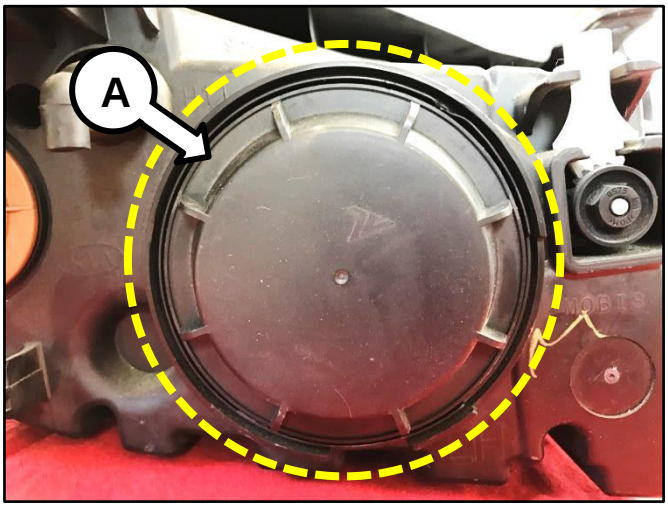
Headlamp was removed from the vehicle for demonstration purposes only.

3. Remove the low beam dust cap (A) on one side of the vehicle.

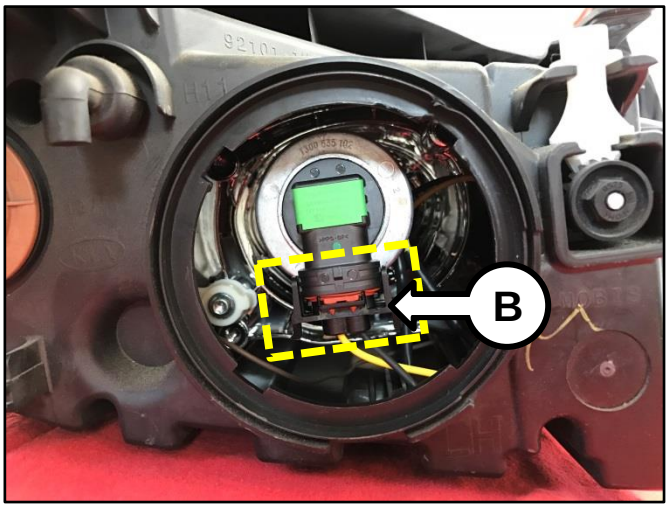
Ensure the affected area of the terminal is clearly visible in the photo (see page 1).

4. Disconnect the low beam bulb connector (B). If the low beam bulb terminal(s) is/are damaged, remove the bulb from the headlamp and take one (1) KVID photo of the damaged bulb terminal(s) (Attachment Type: 'XX').
