Replacement Batteries Not Adequately Charged

Issue #	Part Info	Group(s) Affected:		
7	Battery	Service ☐ Parts ☐ Roadside Assistance ☐ Sales ☐ Vehicle delivery/Logistics ☐

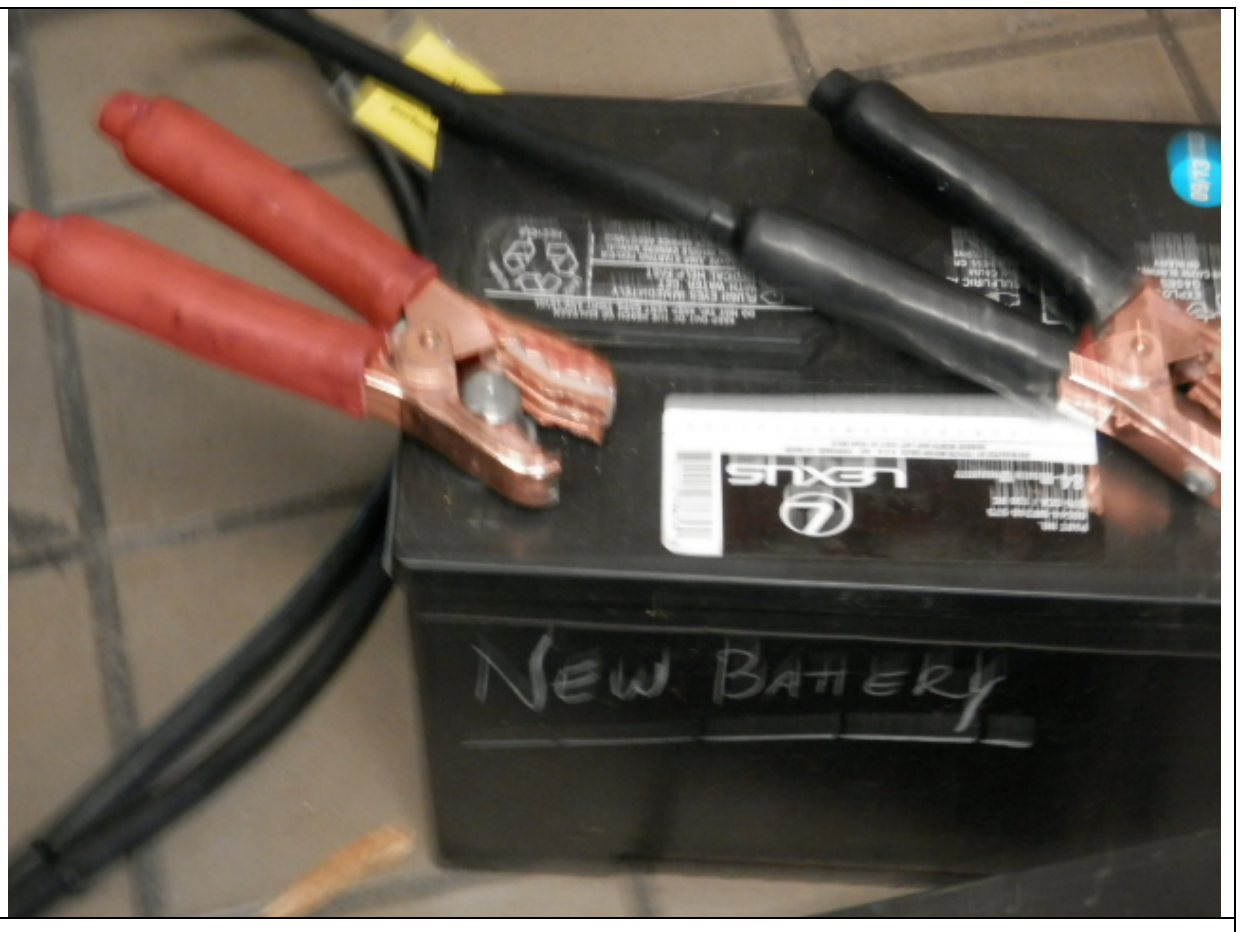
Condition
New replacement batteries may not be adequately charged coming off the Interstate Truck

Observed Situation:
Low battery voltage was observed on brand new batteries just delivered.

Concern:
Low voltage during storage may impact long term durability.

Suggested Change
Monitor incoming new replacement batteries for voltage, if low, address concern with Interstate supplier and notify TMS of the situation via DPR.
