STAR Case

Symptom/Vehicle Issue: MIL Lamp On, DTC P0335 Crankshaft Position Sensor

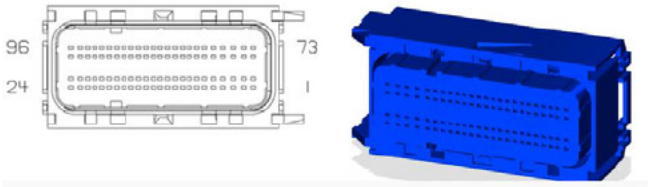
Discussion: Discussion: Check engine lamp is on at times, loss of power or hard starting, DTC p0335 Crankshaft Position Sensor may be stored or active. Inspect the F855 PK/YL and K925 DB/GY circuits at the PCM pins 67,88 Fig 1 or at the sensor pins 1,2 Fig 2. Clean and secure the terminals as needed.
