RE: RC Components Frame Recall

Reason for this Recall

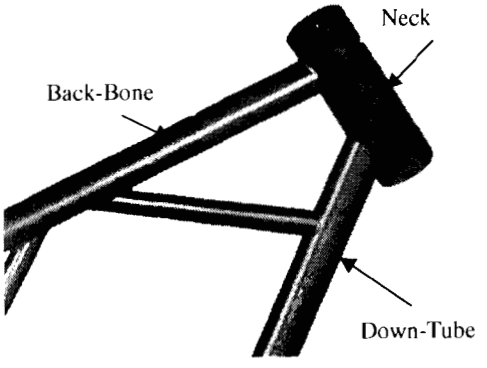
Exhibit A1

RC Components has decided that a defect exists in certain single down tube chopper frames it manufactured between January 2003 and September 2005, which did not include a factory-installed welded gusset plate connecting the frame backbone, neck and down tube (see Exhibit A1) and to which no gusset was added post-manufacture. Our records indicate you purchased a frame included in the recall group directly from RC Components.

These frames may have been subject to a breach during the manufacturing process, resulting in the possibility of rapid wear on the weld joints and possible joint separation. Cracks in the area of the weld joint may indicate unusual stress on the frame. If weld joint separation occurs while riding, the operator could lose control of the motorcycle resulting in a crash.
