# Safety Recall Launch Notification

| Campaign # | NHTSA ID | Description |
|---|---|---|
| 2026100001 | 26V636 | 26P9190323 |

# Check Driver's Seatbelt Anchorage

| SUBJECT | **Check Driver's Seatbelt Anchorage** |

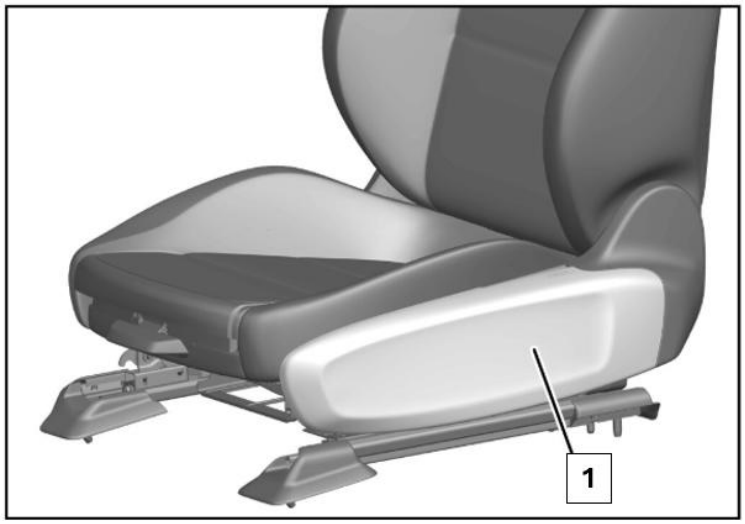
**Illustration 1:** Shown **with code 275**

1. Remove exterior trim on seat frame (1, Illustration 1).

i For basic information on **vehicles with code 275**, see **AR91.10-P-1201CLB**.
   ***Only*** the **trim** is removed (**1**, illustration 1).

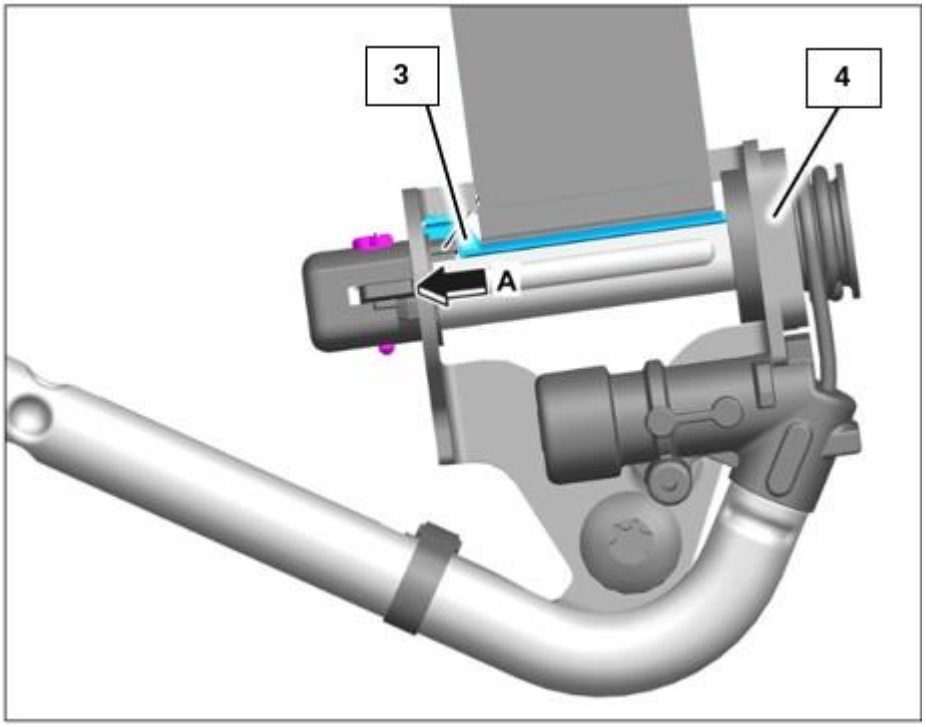
Illustration 3

2. Check seat belt end fitting (3, illustration 3) for correct installation.
   i Seat belt end fitting (3, illustration 3) must be installed **correctly**.
   i For basic information, see AR91.40-P-1030-02CLA.

a. Seat belt end fitting (3, illustration 3) is **not** connected to seat belt end-fitting tensioner (4, illustration 3) and ***not*** **correctly** installed:

b. Seat belt end fitting (3, illustration 3) is **correctly** connected to seat belt end-fitting tensioner (4, illustration 3) and **correctly** installed:

Carry out **work procedure**.

1. Install seat belt end fitting correctly (Illustration 3).

i For basic information, see **AR91.40-P-1030-02CLA.**
