RECALL 26V295 REMEDY INSTRUCTIONS

FOREST RIVER	Make(s): Crusader Model(s): CSFFAM37 Model Year(s): 2026	Repair Code: RC-632-03-00-004829 Allotted Time: 1.50 HRS Inspection Code: RC-632-05-00-004828 Allotted Time: .10 HRS
	Concern: The waste water holding tank(s) ventilation pipe may not be terminated to the exterior of the vehicle.	Photo(s) Required: No Prior Authorization Required: Yes Part(s) Kit Number: Source Locally Part(s) Return: N/A

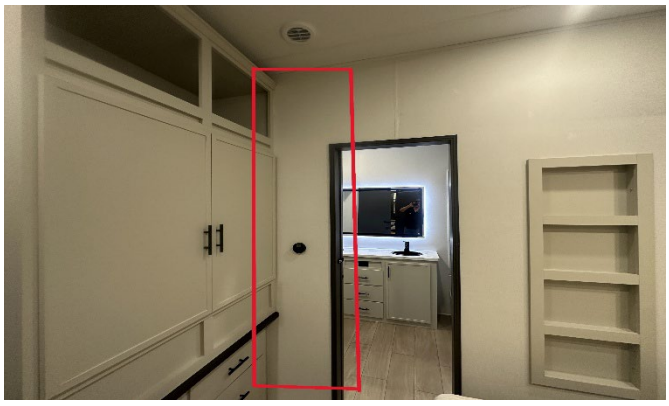
Figure 1 LOOKING INTO BATHROOM

1. REMOVE REAR BATHROOM DOOR, DOOR JAMB AND SLIDER DOOR HARDWARE.
2. LOOSEN THE PANEL TO WHERE YOU CAN ACCESS THE VENT PIPE AND ROOFLINE OF THE WALL. LOOSEN PANEL INSIDE OF THE BATHROOM. FIGURE 1 & 2 SHOW THE LOCATION OF THE VENT PIPE

3. USE A 1 ¾" HOLE SAW TO DRILL THROUGH THE WALL HEADER AND THE ROOF. DRILL HOLES DIRECTLY ABOVE UNFINISHED VENT PIPE IN THE WALL.
    A. RECOMMENDED TO DRILL WALL HEADER OUT, THEN ENSURE NO WIRES ARE VISIBLE BEFORE DRILLING THROUGH THE ROOF

4. USE A 1 ½" PIPE COUPLER TO GLUE EXISTING VENT PIPE AND A 24" PIECE OF 1 ½" PIPE THROUGH THE ROOF
    A. ENSURE BOTH SIDES OF COUPLER ARE GLUED
5. ON THE ROOF, INSTALL A VENT PIPE COVER WITH BUTYL TAPE UNDER THE SCREW HOLES

6. AFTER VENT PIPE IS SCREWED DOWN, USE APPROVED SELF-LEVELING SEAL TO SEAL TO ROOF MEMBRANE
    A. ENSURE ALL EDGES AND SCREW HOLES ARE COVERED WITH SEAL
