RECALL 26V603 REMEDY INSTRUCTIONS

FOREST RIVER	Make(s): GRAND SPORT GT Model(s): GGC45CB-600 Model Year(s): 2026 - 2027	Repair Code: RC-744-01-00-004859 Allotted Time: 1.00 HRS. Inspection Code: RC-744-05-00-004858 Allotted Time: .10 HRS.
	Concern: The "Engine Pre-Heat" option was improperly installed.	Photo(s) Required: NO Prior Authorization Required: YES Part(s) Kit Number: F100898875 Part(s) Return: FIELD DESTROY

ENGINE PRE-HEAT HOSE CONNECTIONS

TECHNICAL BULLETIN

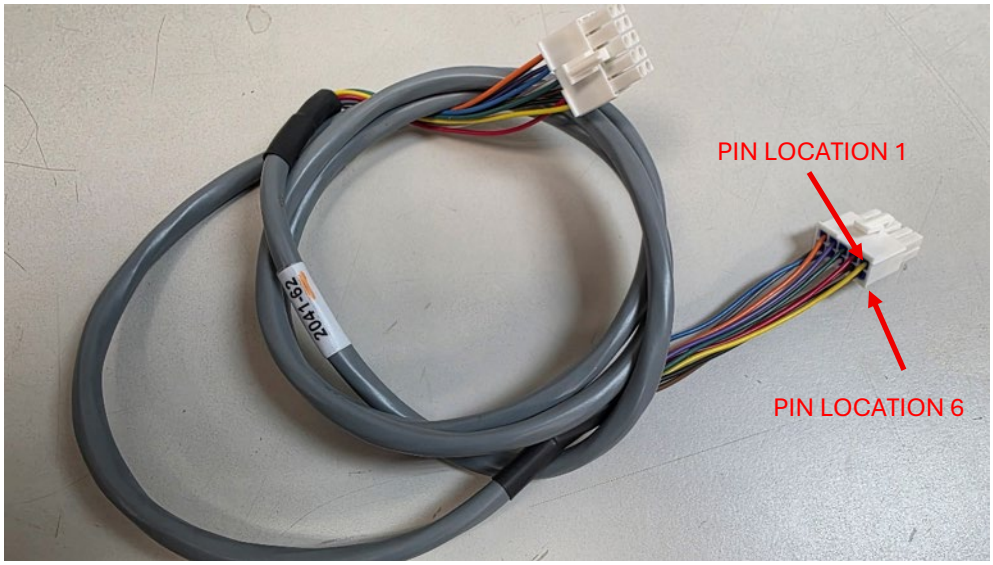
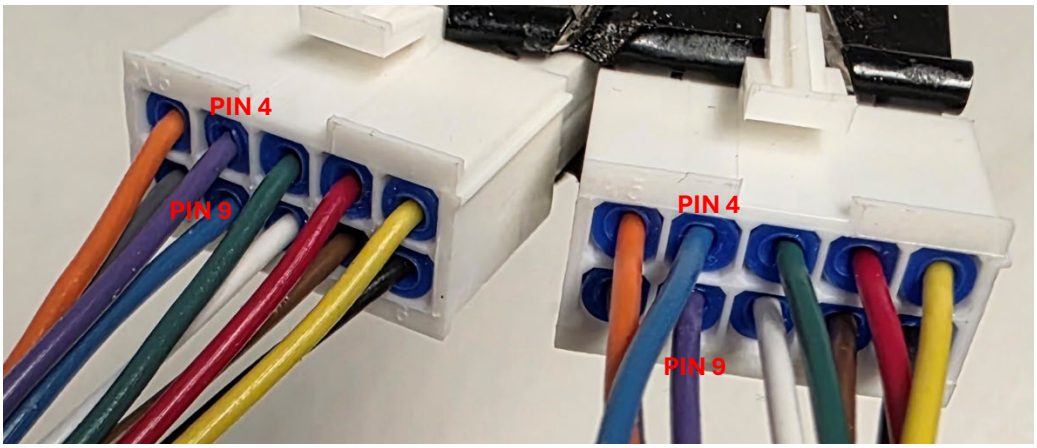
Harness pinout:

NOTE THE DIFFERENCE IN PIN CONFIGURATION BETWEEN LOCATIONS 4 AND 9 ON THE 770580-1 CONNECTORS.

2041-62 RV-C REMOTE OPERATION CABLE BETWEEN ZONE BOARD AND RV-C NODE BOARD.

STEP 1: REPLACE OR REPIN 2041-62 AT THE OASIS (REFERENCE ATTACHED DOCUMENTS); THE HARNESS IS LOCATED IN THE STORAGE BAY TO THE RIGHT OF THE OASIS BAY. IT IS IN THE UPPER LEFT CORNER OF THE STORAGE BAY

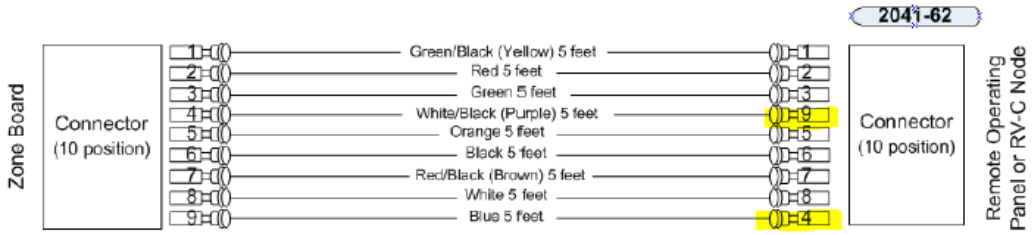
The 2041-62 harness should be pinned as follows:

Prior to August 10, 2026, the 2041-62 harness could have been manufactured with pins 4 and 9 incorrectly pinned. This will result in the engine pre-heat function not working (i.e. if the system is up to temperature and the user calls for the engine pre-heat function at the main touchscreen interface, the engine pre-heat LED on the zone board will not turn ON, and the engine pre-heat pump will not function).

If the 2041-62 harness installed in the system is not pinned as above, it will need to be corrected (swap pins 9 and 4 on one of the 10 pin connectors), or swapped out with a new 2041-62 harness.
