RECALL 26V609 / 2026-454 REMEDY INSTRUCTIONS

FOREST RIVER	Make(s): Dynamax Model(s): ISATA 3, ISATA 5, ISATA 6 Model Year(s): 2026 - 2027	Repair Code: RC-090-01-00-004865 Allotted Time:.0.50 HRS Inspection Code: RC-090-05-00-004864 Allotted Time:.0.20 HRS
	Concern: Ladder brackets may not have sufficient material to be attached to. Insufficient attachment of brackets could lead to the ladder pulling away from bunk and lead to a fall or personal injury.	Photo(s) Required: IF ONLY INSPECTION Prior Authorization Required: NO Part(s) Kit Number: SEE BELOW Part(s) Return: NO

Concern: Ladder brackets may not have sufficient material to be attached to. Insufficient attachment of brackets could lead to the ladder pulling away from bunk and lead to a fall or personal injury.

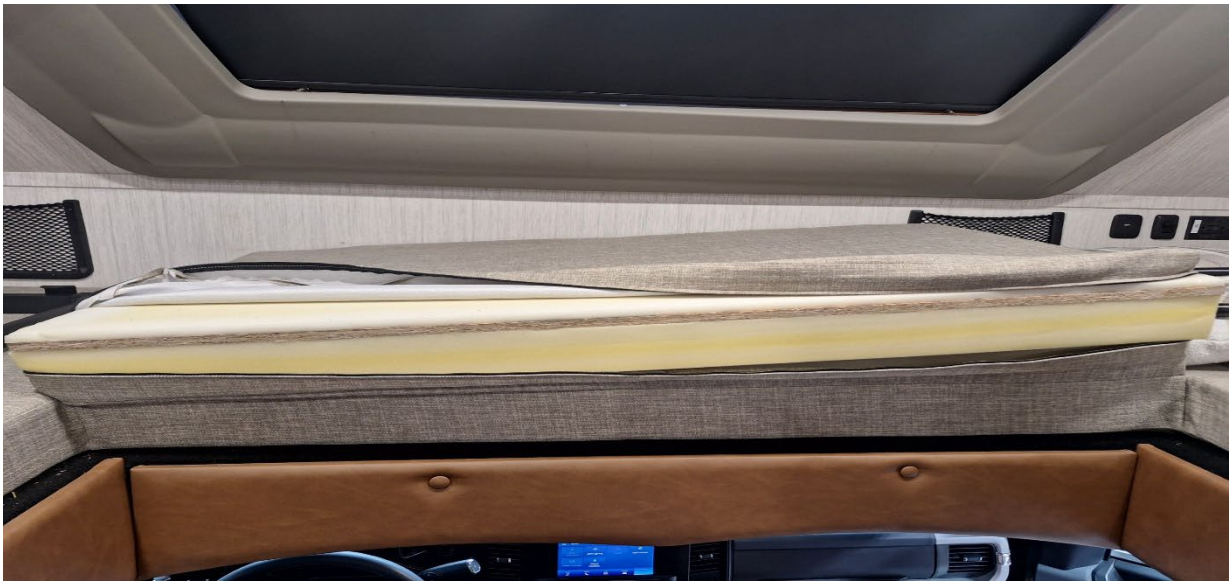
Figure 1 WOOD FRAMING MAT – INCORRECT

Figure 2 METAL FRAMING MAT - CORRECT

1. LOCATE THE BUNK MAT ABOVE THE DRIVERS SEAT CAB
2. REMOVE LADDER BRACKETS AND SAVE TO REINSTALL WHEN NEW INSERT IS INSTALLED, DISCARD SCREWS
3. FLIP UP THE FOLDABLE PART OF THE BUNK MAT TO EXPOSE THE ZIPPER (SEE FIGURE 1)
4. UNZIP THE BUNK MAT AND REMOVE THE ENTIRE FOAM AND PLYWOOD INSERT
    a. DISPOSE OF INSERT
5. REPLACE WITH FOAM INSERT WITH METAL FRAMING (SEE FIGURE 2)
6. WHEN REPLACED WITH NEW PART, ZIP BUNK MAT BACK TOGETHER AND FLIP BACK DOWN
7. AFTER FLIPPING BACK DOWN, INSTALL BUNK LADDER BRACKETS TO FRONT OF BUNK MAT
    a. ENSURE BUNK LADDER BRACKET SCREWS HIT THE METAL FRAMING
8. CLAIM REPAIR CODE
