Technical Service Bulletin

20 MIL on (DTC P045600 - EVAP System Leak Detected NVLD (very small leak))

20 13 28 2035073/2 November 14, 2013. Supersedes Technical Service Bulletin Group 20 number 13-27 dated October 16, 2013 for reasons listed below.

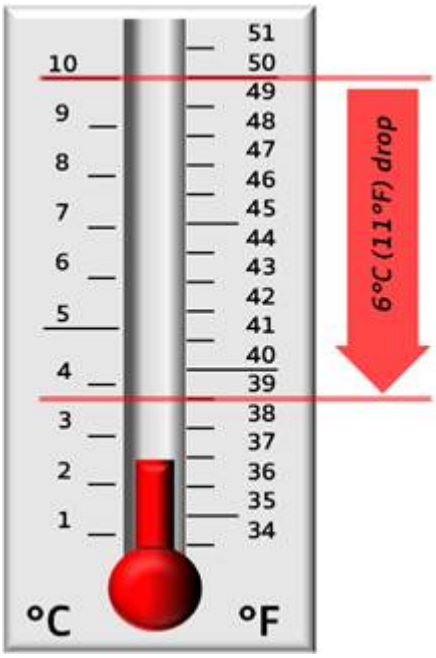
- For the self-test to initiate, the following requirements must be met:
- Ignition is off.
- Ambient air temperature is greater than -10°C (14°F).
- Fuel temperature drops for more than one hour by more than 6°C (11°F). This varies by model; see *Elsa >>Engine >> Generic Scan Tool >> ST Generic Scan Tool >> Diagnosis and Testing >> DTC Tables*.
  - Example of a 6°C (11°F) drop: From 10°C (50ºF) to 4°C (39ºF) within one hour (Figure 1).

***Figure 1**. Example of a 6°C (11°F) drop: From 10°C (50ºF) to 4°C (39ºF) within one hour.*

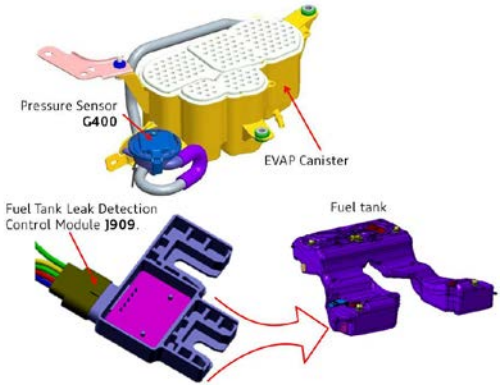
- Separate fuel tank pressure sensor, G400, and fuel tank leak detection control module, J909 (Figure 2).

***Figure 2**. Separate sensor and control module.*

- For vehicles with a fuel tank pressure sensor, G400, and a fuel tank leak detection control module, J909, that are separate (two components): part numbers 8K0906253 and 8K0906253B are superseded to **8K0906253D**.
- For vehicles with a fuel tank pressure sensor, G400, and a fuel tank leak detection control module, J909, which are integrated (one component): part numbers 8K0906253A and 8K0906253C are superseded to **8K0906253E**.

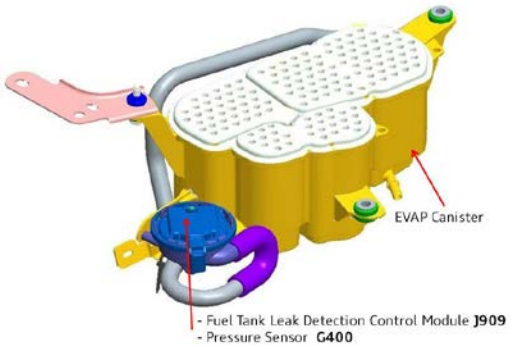
- Integrated fuel tank pressure sensor, G400, and fuel tank leak detection control module, J909 (Figure 3).

***Figure 3**. Integrated sensor and control module.*
