Rear Sunshade Binding on Package Tray

Service Category Vehicle Interior

YEAR(S)	MODEL(S)	ADDITIONAL INFORMATION
2013	Avalon, Avalon HV

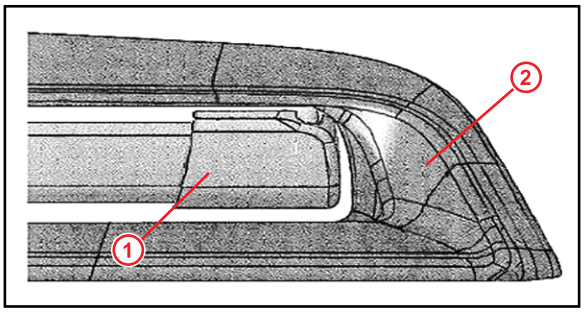
Figure 1.

Some 2013 model year Avalon and Avalon HV vehicles may exhibit a condition where the rear sunshade is inoperative and appears to be binding in the package tray. Please follow the process below to address this condition.

1. Verify condition is present by cycling the rear sunshade and confirming interference with the package tray.

1	Sunshade
2	Package Tray

2. Replace the package tray according to Repair Manual instructions.

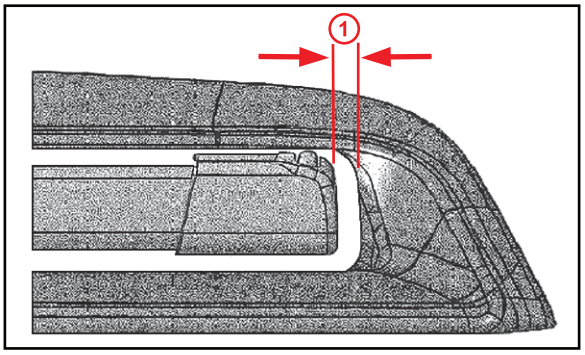
Figure 2.

1	Clearance

4. Check that there is clearance between the sunshade and package tray. Verify operation by cycling the rear sunshade.
