Bulletin No.: PIP5198A

Service Bulletin

Subject: Instrument Panel Cluster (IPC) Warning Lamps And/Or MIL Are Illuminated Diesel Exhaust Fluid (DEF) Message Displayed Various DTCs Set (Inspect Wiring Harnesses for Chafing)

Models: 2015 Chevrolet Silverado

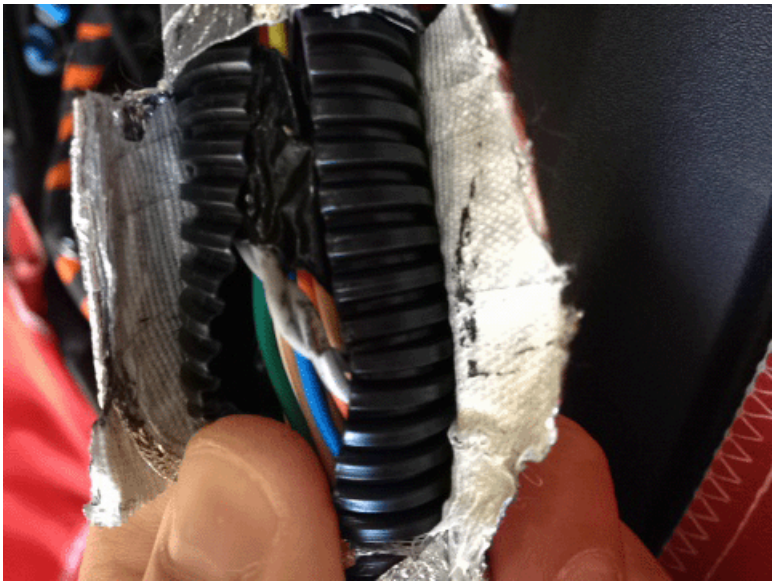
If the diagnosis does not lead to a resolution or if the symptoms or DTCs are intermittent and cannot be duplicated, check for chafing of the engine wiring harness that is routed near the EGR Valve. The wiring harness has been found chafed on a tab of the EGR Valve metal gasket.

Repair or replace the wiring harness if it is found chafed on the tab of the EGR Valve metal gasket.

Bend the tab of the EGR gasket over to prevent a re-occurrence.

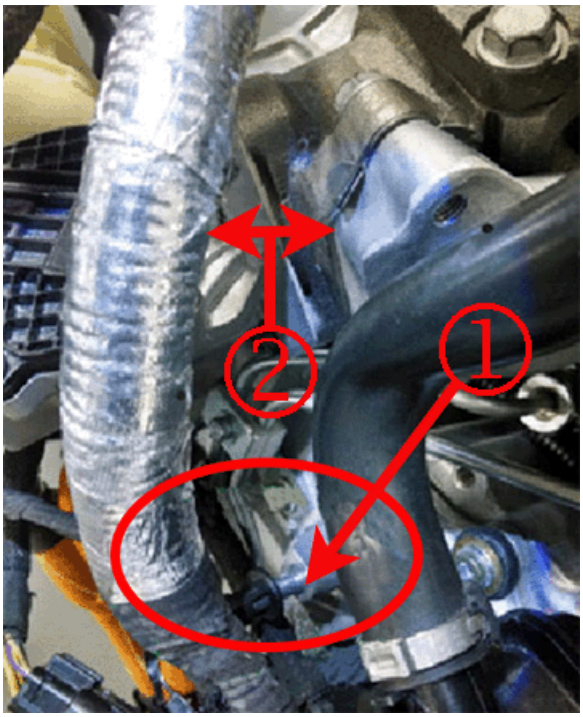
It is critical that the wiring harness retainer is fully seated onto the stud on the driver's side rocker cover. This retainer is tied to the harness and is located underneath the charged air cooler (CAC) inlet pipe near the #4 fuel injector. Proper routing and securing of the harness ensures there is clearance between the harness and the EGR valve.

1. Wiring harness retainer fully seated onto the stud on the driver's side rocker cover.
2. Proper clearance between the harness and the EGR valve.

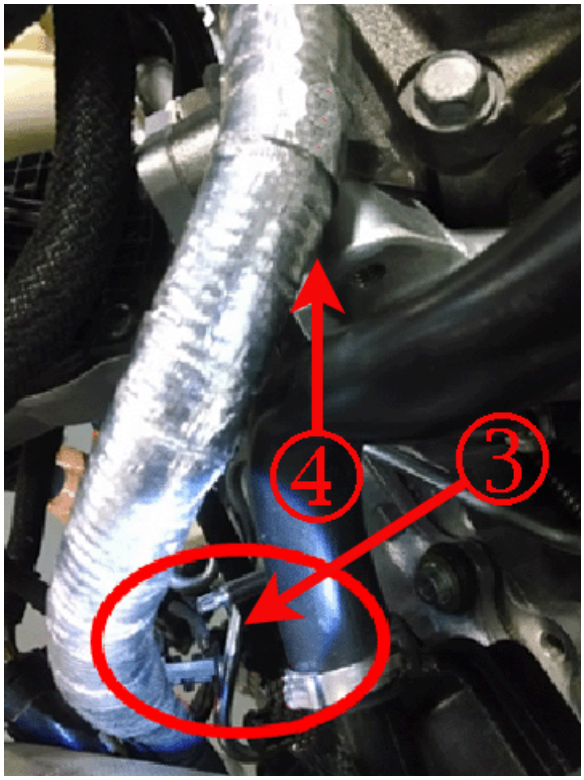
3. Wiring harness retainer NOT fully seated onto the stud on the driver's side rocker cover.
4. IMPROPER clearance between the harness and the EGR valve.
