Countries:	CANADA, UNITED STATES, MEXICO, PUERTO RICO	**Document ID:**	IK1200502
Availability:	ISIS, FleetISIS	**Revision:**	3
Major System:	ENGINES	**Created:**	5/13/2010
Current Language:	English	**Last Modified:**	2/11/2014
Other Languages:	Français, Español,	**Author:**	Jay Weston
Viewed:	1820

Title: Engine Vibration on MaxxForce® 11 and 13

Applies To: MaxxForce® 11 and 13

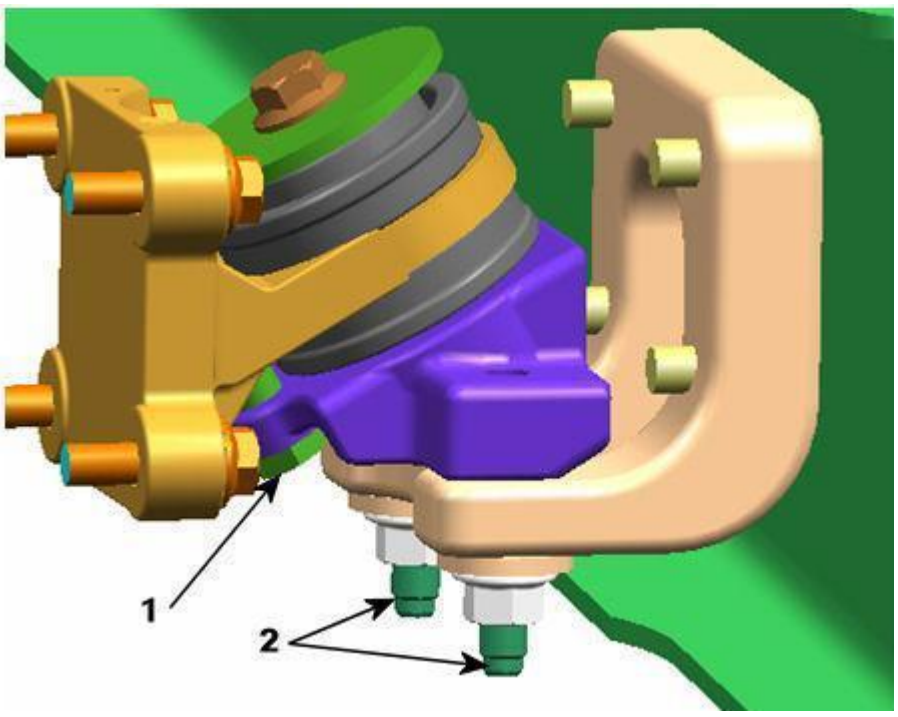
Figure 1
1. Temporary Alignment Bolt
2. Engine Mount Bolts

When installing a MaxxForce 11 or 13 engines a shoulder bolt (PN 3822703C1 or 3596321C2) must be used to align both the left and right front engine mounts. This will ensure correct alignment of front engine mount bushings. Install the shoulder bolts (as shown in Figure 2) prior to lowering the engine into the chassis. After the engine has been positioned and the front and rear engine mount bolts have been tightened to the appropriate torque, remove the alignment bolt from each of the front engine mounts. If the aligment bolts are left in, it will cause an engine vibration.

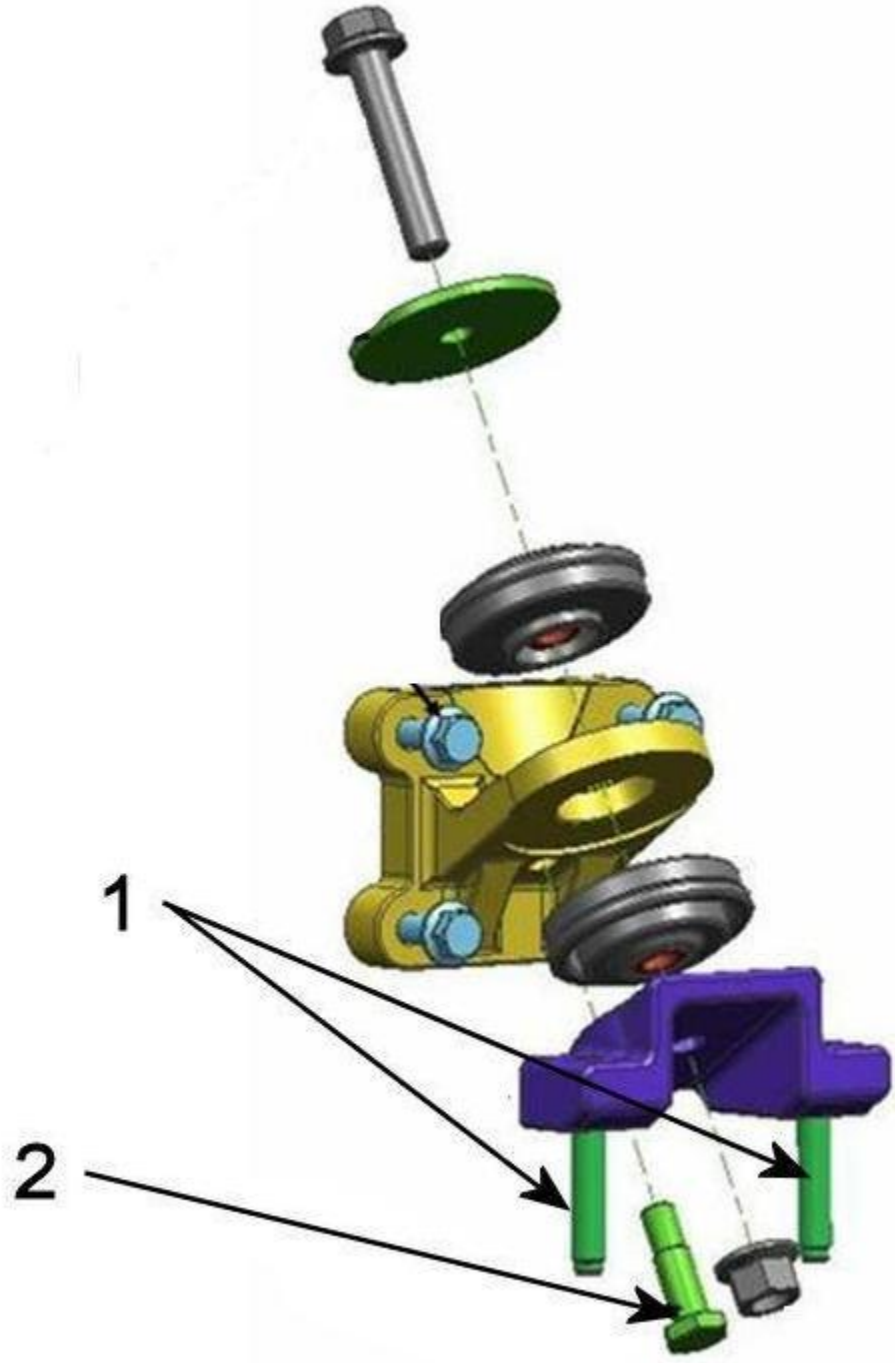
Figure 2
1. Front Engine Mount Bolts (Torque to 215-237 Nm) (160-175 Lbf-ft)
2. Temporary Alignment Bolt

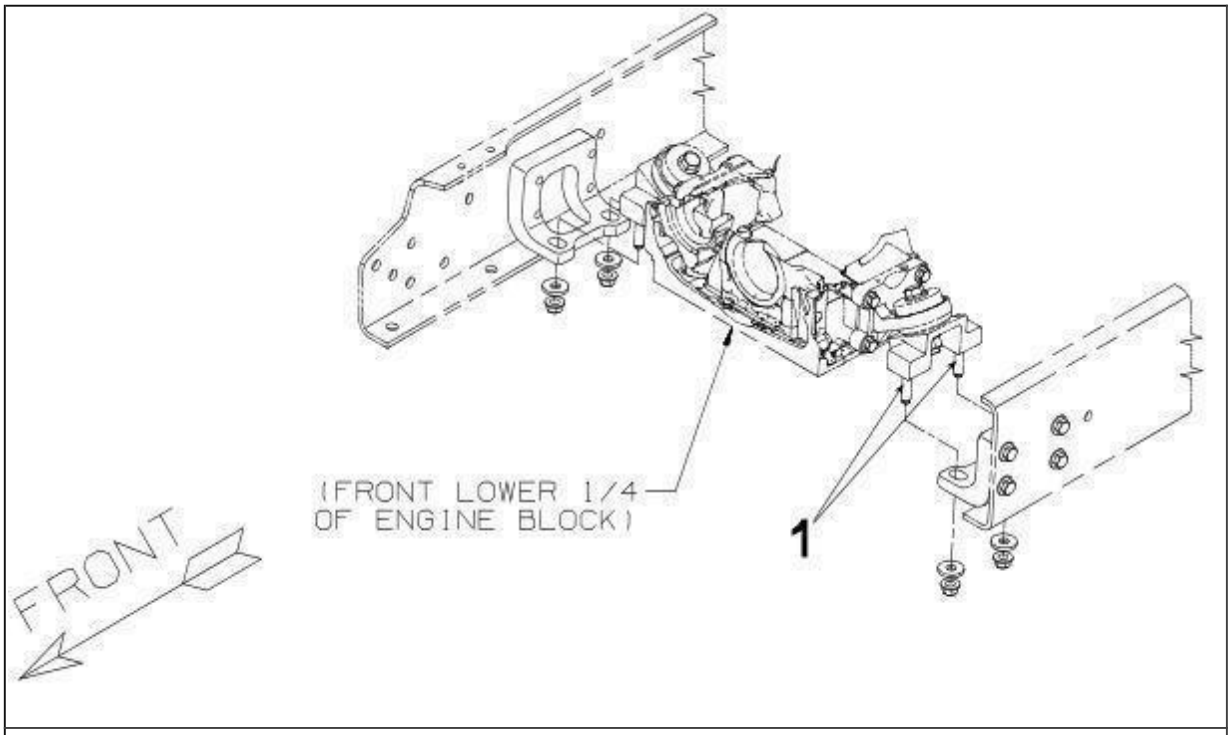
Figure 3
Front Motor Mount Bolts (Torque to 215-237 Nm) (160-175 Lbf-ft)
