SI M11 05 14
Engine

October 2014
Technical Service

**Engine Oil Residue Found Near Oil Filler Cap**

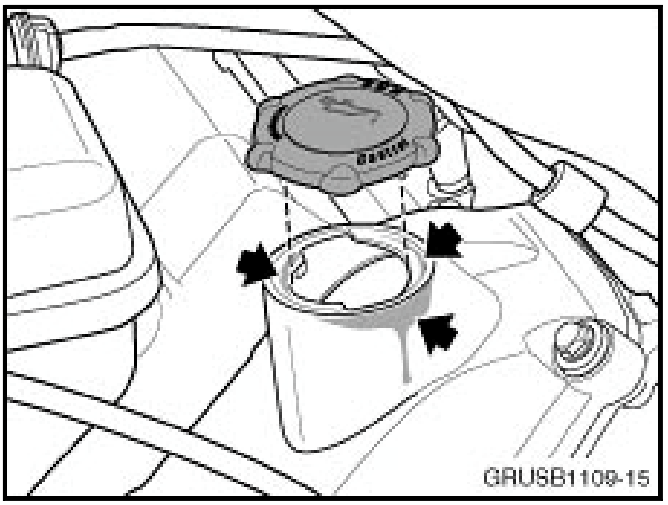
| | Oil residue may be seen on the cylinder head cover, located in the vicinity of the oil filler cap, a few days after topping or refilling the engine oil. |

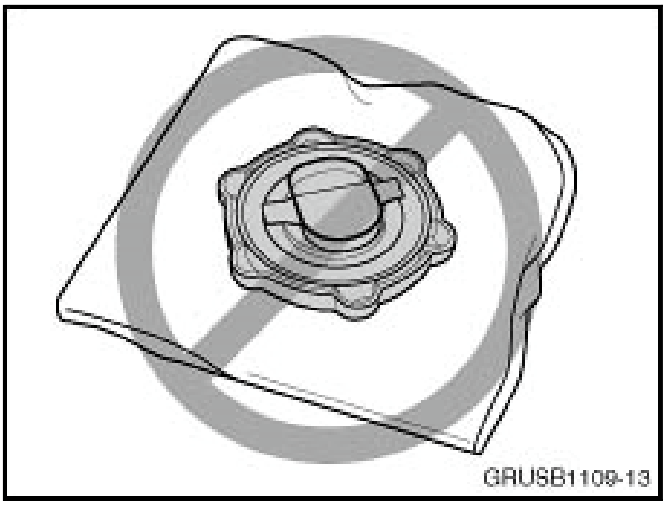
| | Very often after removing the oil cap, the cap is laid upside down to prevent the crankcase side of the cap from being contaminated. When the cap is stored upside down, it allows the engine oil to seep into the area of an oil cap plastic housing that is not sealed by the gasket. When the cap is reinstalled, the oil will leak from the unsealed area onto the cylinder head cover surface. |
