Service Bulletin

File in Section: -
Bulletin No.: PIT5321
Date: September, 2014

Subject: **Normal Characteristic - Missing Underhood Trim At Front Left Fender Area**

Models: **2015 Chevrolet Colorado**
2015 GMC Canyon

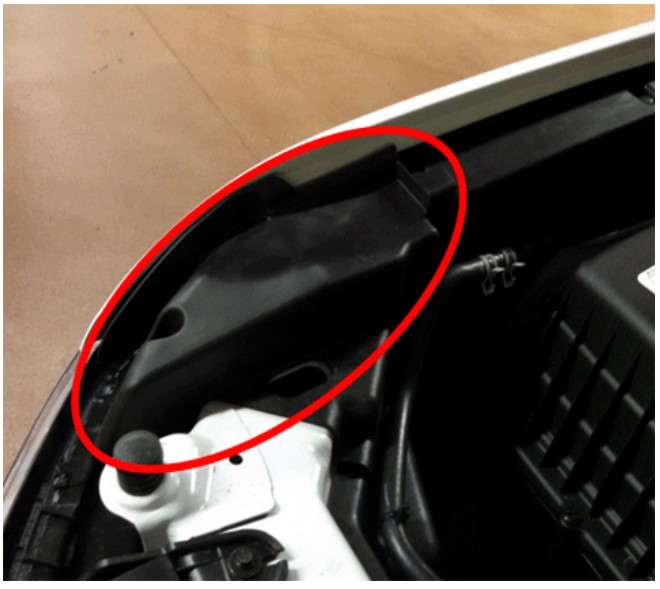
3979522

A dealer or customer may report that a trim piece is missing from the left front of the engine compartment where the fender and radiator support meet.

The upper intake air baffle is present on the right side to protect the engine air filter inlet. Since no engine air inlet exists on left side, no baffle was used there.

Make no repair attempts or modifications to the vehicle, this is built to design intent.
