Service Information Bulletin

SUBJECT	DATE
Symptom Diagnostics - Oil Present at the Turbocharger Compressor Housing	March 2015

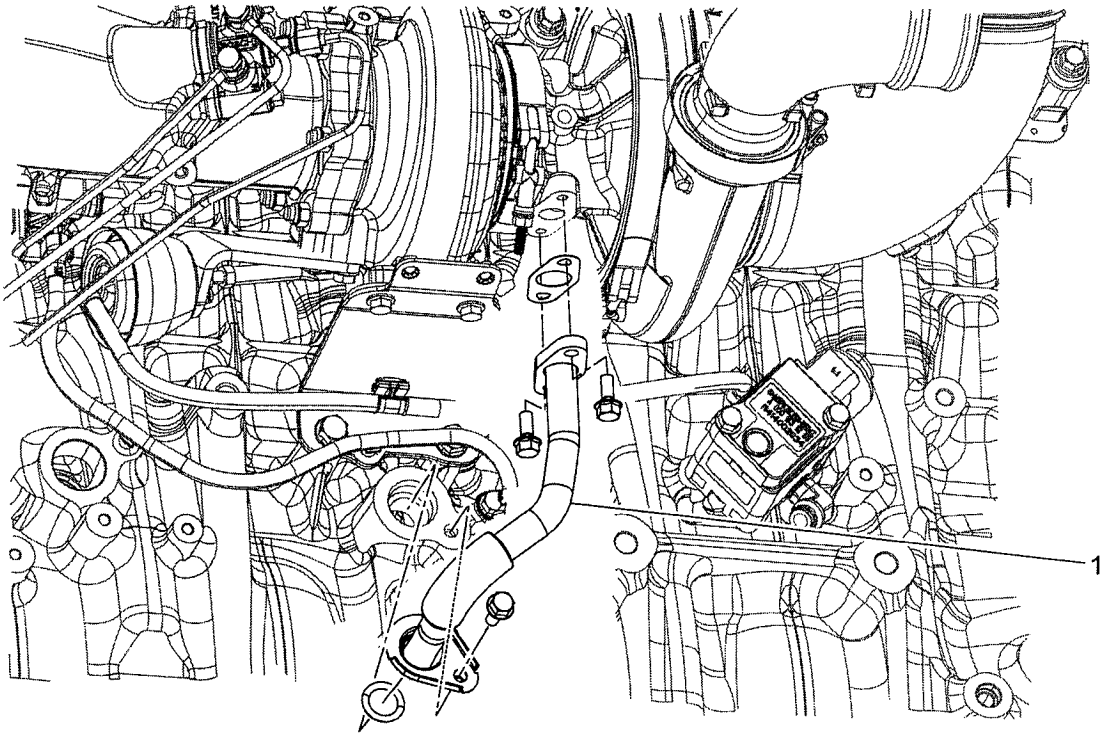
d090102a

NOTE: The turbo drain pipe gasket can cause an obstruction if installed incorrectly.

9. Remove and inspect the turbo oil drain pipe (1) and cylinder block for damage/restrictions. Was damage/restrictions found?

a. Yes; replace turbo oil drain pipe (See figure above (1)). Clean out all air systems and Go to step 11.
   b. No; Go to step 10.

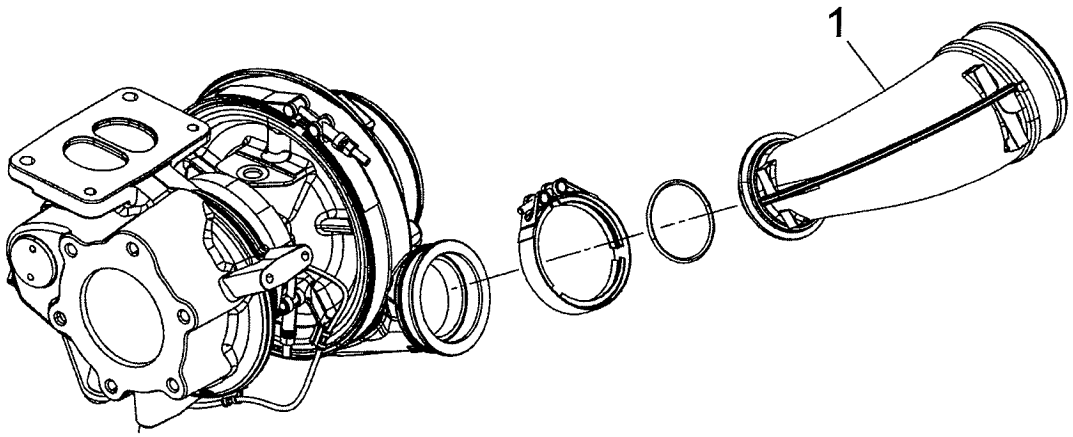
d090126

NOTE: The Turbocharger is a non-serviceable part. Do not remove the compressor housing for cleaning.

10. Clean the inside of the turbocharger compressor elbow (1) .
