SERVICE BULLETIN

Classification:	Reference:	Date:
EL15-022	NTB15-076	August 24, 2015

2012-2013 ROGUE;
AROUND VIEW™ MONITOR DTCs SERVICE INFORMATION

APPLIED VEHICLE: 2012-2013 Rogue **(S35)** with Around View™ Monitor system

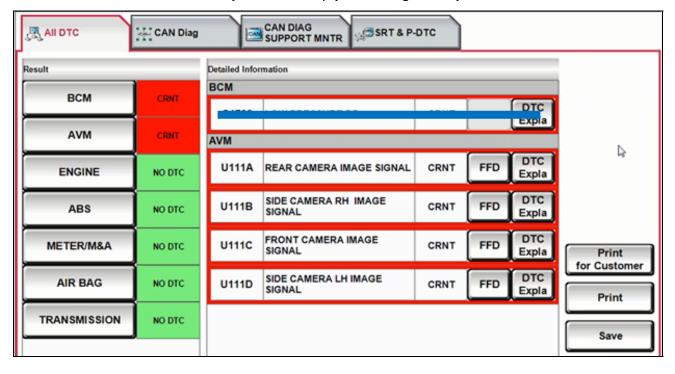
Before Selecting Diagnosis (All Systems):
- The CAMERA button needs to be pressed, or
- The view from the camera(s) need to be seen on the A/V screen.

If the above step is **not** performed:
- The four AVM related DTCs may set and display as "CURRENT".
- The four AVM related DTCs may be found during routine diagnosis (for other issues). If that should occur, these DTCs are erroneous and are to be ignored and erased.

If the four AVM related DTCs are erroneously stored:
- There will be no related symptoms, error messages, warning lights, or any other indications that the AVM system has a malfunction.
- Do not replace any parts.
- Erase the code(s), perform the **Before Selecting Diagnosis (All Systems)** step above, and then recheck for codes.
