L624-A.02.16	**To:** Official After Sales Network **Subject:** Engine & gearbox SW update **Date:** March 18,2016 **Pages** 15

Subject.
Engine & gearbox SW update

Model.
Huracan Coupè.

Model year.
2015

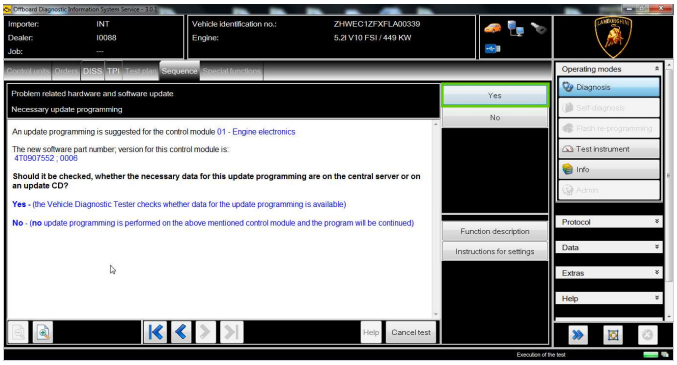
23. ECU “01 – Engine electronics” software update.

The figure below refers to software versions and part numbers of the vehicle used as example.

Click “Yes” to check the availability of the software on the Mirrorserver.

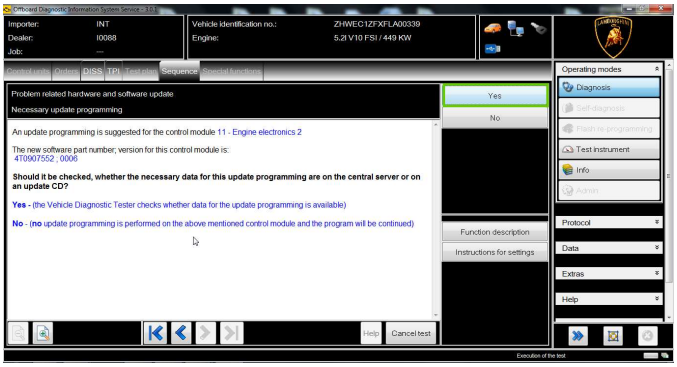
27. ECU “11 – Engine electronics2” software update.

The figure below refers to the software versions and the part numbers of the vehicle used as example.

Click “Yes” to check the availability of the software on the Mirrorserver.

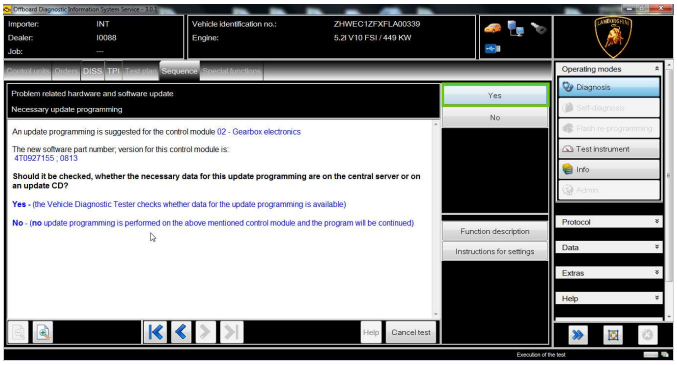
31. ECU “02 – Gearbox electronics” software update.

The figure below refers to the software versions and the part numbers of the vehicle used as example.

Click “Yes” to check the availability of the software on the Mirrorserver.

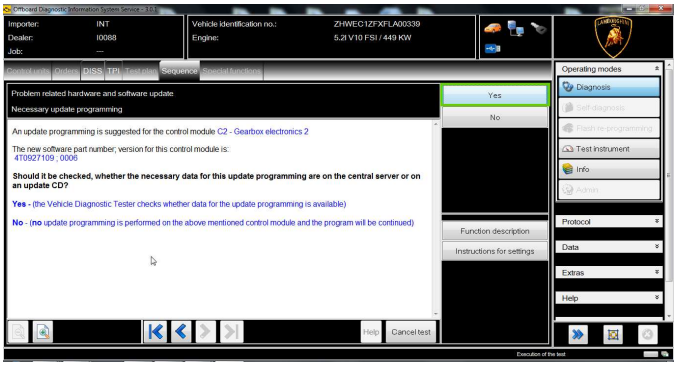
35. ECU “C2 – Gearbox electronics 2” software update.

The figure below refers to the software versions and the part numbers of the vehicle used as example.

Click “Yes” to check the availability of the software on the Mirrorserver.

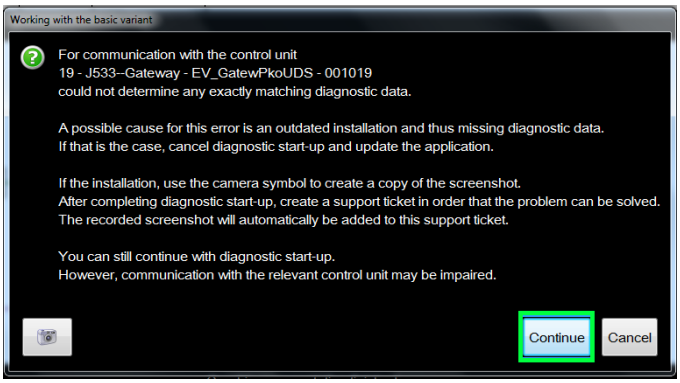
A. If the following dialogue box appears during ECUs identification:

Click “Continue”

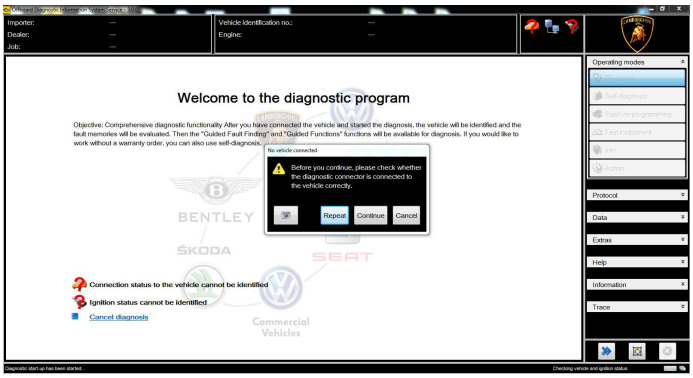
B. If the error message regarding the VAS5054 interface and the two icons for “on board connection” and “key status” are displayed as in the picture below:

- Click “Cancel”;
- Repeat the VAS5054 HW interface installation following the procedure (*) “VCI Manager v2.0”, by entering in the menu “Extras” on the right side and clicking “Diagnostic interface”.

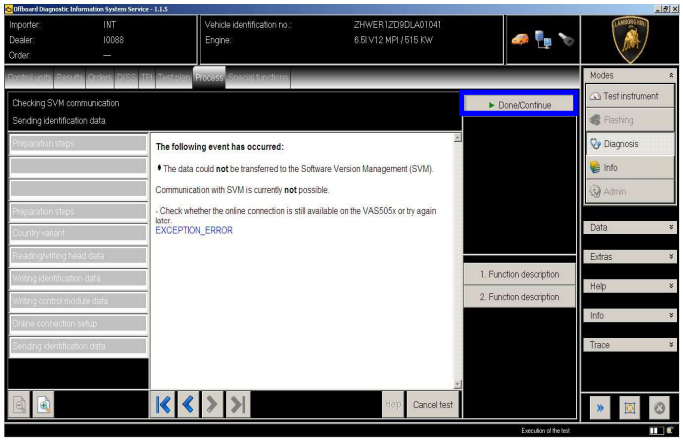
C. If one of the connection error screens is shown as in the pictures below:

- it is not possible to establish a connection with the central server. Please check carefully that the diagnosis laptop is properly connected to the internet network and retry clicking “Yes” or “Done/Continue”.

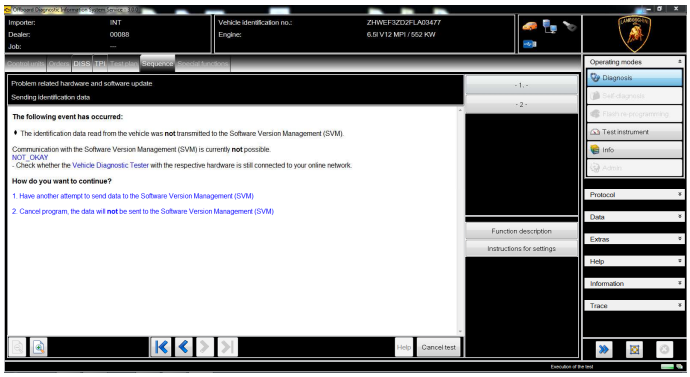
D. If the loss of connection happens during the target/actual comparison during SVM procedure:

- It is not possible to connect to central server, check the working connection of internet and retry clicking “1”.

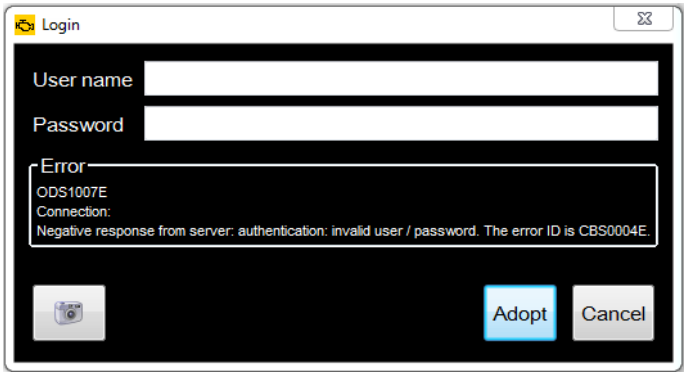
E. If the incorrect identification message is shown as in the picture below (error code: ODS1007E):

- be sure that your Geko account is valid;
- be sure that the label “Geko” is written on the token that you are using for the authentication;
- be sure the Password inserted is correct;
- click “Cancel” and perform the application test (see document “ODIS_Checking_ConnectionServer_SVM_2.0” (*)).

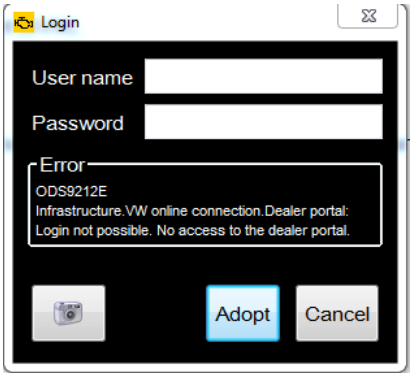
F. If the infrastructure error message is shown as in the picture below (error code: ODS9212E):

- make sure that your Geko account is valid
- check that the label “Geko” is written on the token that you are using for the authentication
- verify in ODIS settings you have “Internet” instead of “CPN” (see document “ODIS_Initial_Setup_2.0” (*))
- click on Cancel and perform the application test (see document “ODIS_Checking_ConnectionServer_SVM_2.0” (*))
