Authorized Field Change

AFC 17913

Subject File: Uptime Improvements

Subject: Update Instrument Cluster, Body Control Module (BCM), Light Control Module (LCM), Switch Pack Modules, Stalk Shifter Module, Auto-Start Feature and Auxiliary Battery Interconnects.

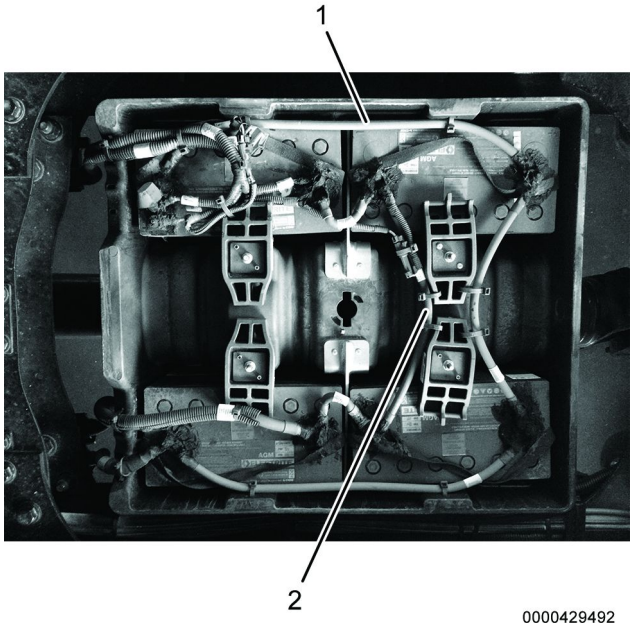
Figure 6. Battery Interconnect Cables

Multiple system module updates to mitigate false malfunction indicator light, Engine ECM parameter update, and replace auxiliary battery interconnect cables.

27. Cut tie straps and remove negative battery interconnect cable (Figure 6, Item 2).

28. Cut tie straps and remove positive battery interconnect cable (Figure 6, Item 1).

29. Install new negative battery interconnect cable.

30. Install new positive battery interconnect cable.

31. Using tie straps, secure negative and positive interconnect to same clipping points as cut in Steps 27 and 28.

32. Using a torque wrench, tighten positive battery post nuts to 142 - 177 lb-in (16 - 20 N•m).

33. Using a torque wrench, tighten negative battery post nuts to 142 - 177 lb-in (16 - 20 N•m).
