Title: CPA Base Engine Analysis Module (BEAM): Test Descriptions and Detailed Information

Applies To: MaxxForce Engines

This document will serve as detailed descriptions to the CPA BEAM Tests

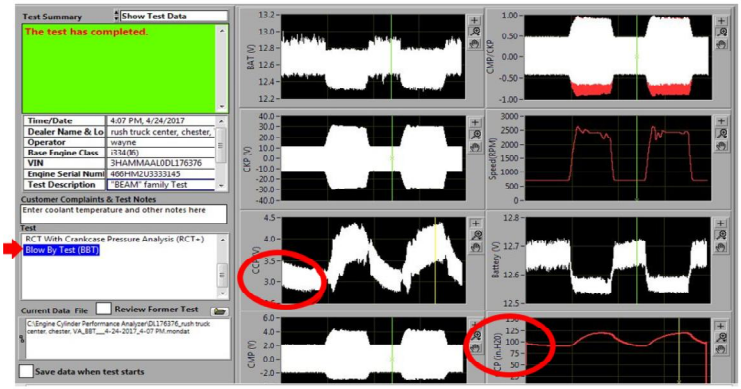
- Ensure PressurePlus Module is ***NOT*** connected to the oil fill adaptor when performing BBT. The PressurePlus Module hose connects to the the orifice tool (Crankcase Breather Outlet)
- Ensure proper channel set-up. BBT signals may OFFSET and look like the example below if connected incorrectly

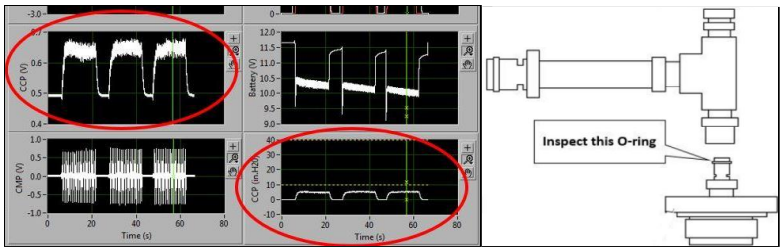
Crankcase Leak Detected Result:

This message occurs when crankcase is NOT properly sealed

- **Example 1 (RCT+): CCP not meeting minimum pressure threshold of 10"H2O (PIC Below)**
  - Confirm Crankcase Breather Outlet is properly plugged
  - Confirm Oil Dipstick (MF7 and MF11/13L ONLY) is correctly seated and properly sealed
  - Confirm oring on fill cap is NOT damaged (PIC Below)

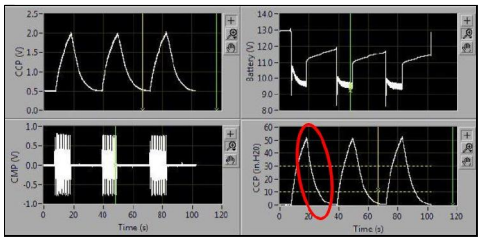
- **Example 2: CCP has rapid pressure decay**

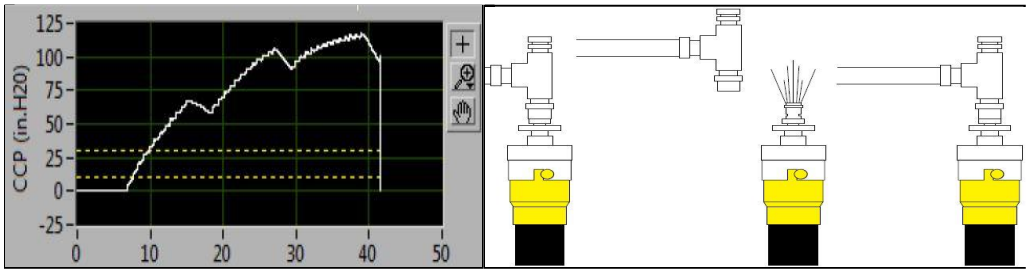
- **Example 3: CCP NOT allowed to decay between cranking events**
  - Ensure the cranking prompt is correctly followed
  - If removing cap (Applies to BB ONLY), ensure correct operation

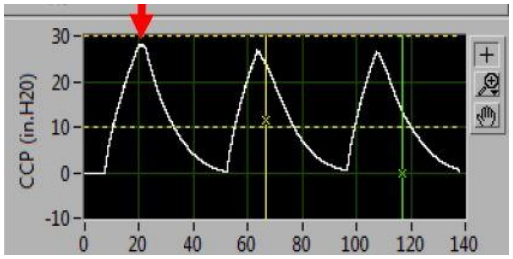
- **Example 4 : CCP not meeting middle pressure threshold of 30"H2O (PIC Below)**
  - Confirm Crankcase Breather Outlet is properly plugged
  - Confirm Oil Dipstick (MF7 and MF11/13L ONLY) is correctly seated and properly sealed
  - Confirm oring on fill cap is NOT damaged (PIC Below)

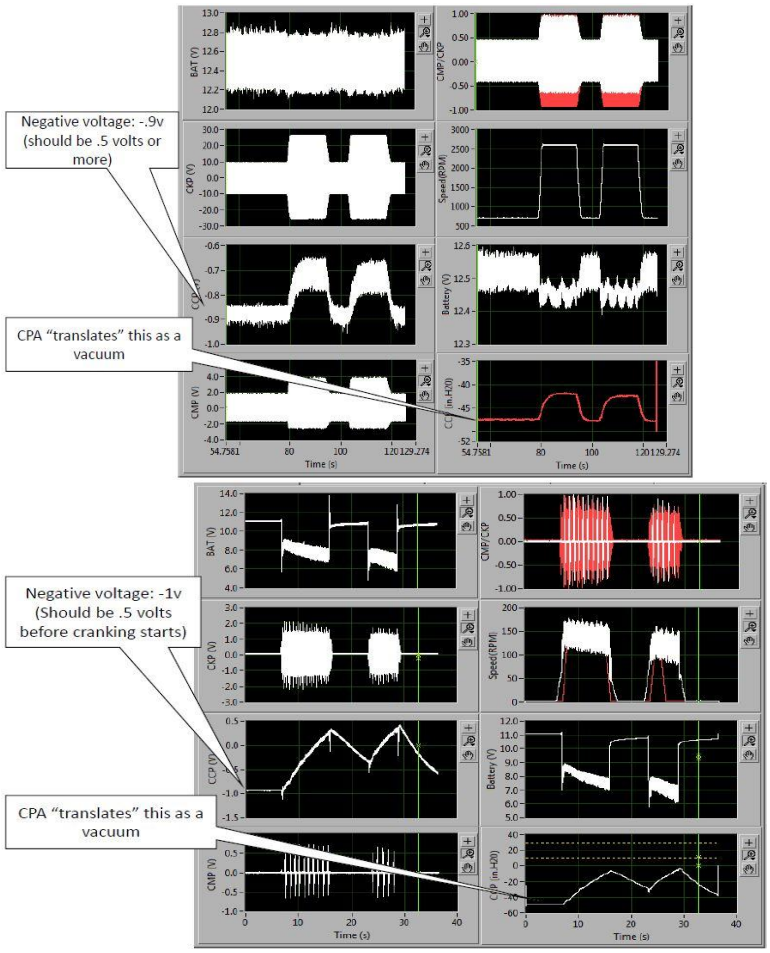
- **Example 1: CCP reading negative voltage. Signal GROUND is open or has high resistance**
  - Using a DMM- Measure the BNC end and ensure correct voltage output at KOEO
  - If voltage measured is NOT correct: Replace CPA Extension Cable and retest
